## Fractography of the fracture surface of a Small Tube

Myung Hwan Boo, Han Sang Kim, and Eun Sub Yun  
 Nuclear Engineering & Technology Institute, Korea Hydro & Nuclear Power Co. Ltd.,  
 25-1Jand-dong, Yuseong-Gu, Daejeon, KOREA, 305-343, bright@khnp.co.kr

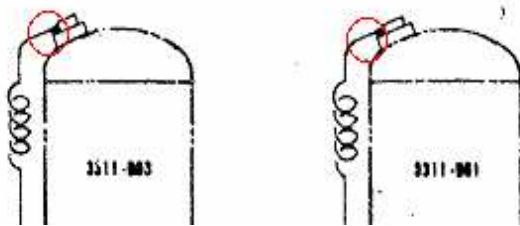
Leak-Off Lines are monitoring tubes that are installed in a high-pressure tank. They monitor for the leakage of cooling water. Figure 1 shows the location of damaged tubes. Table 1 shows the property of these tubes.

Fig. 1 Location of the damaged tube

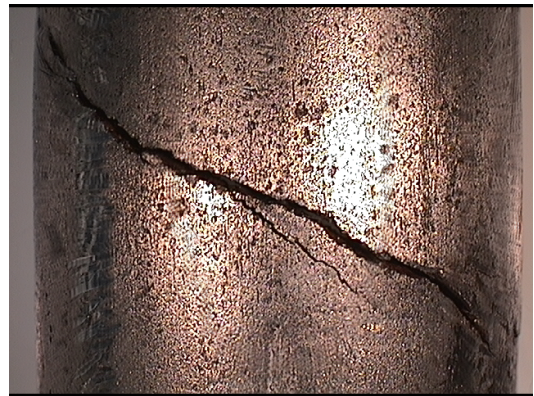
Figure 2 shows a damaged tube under observation using macro-scope. In Fig. 2, a crack was propagated at 30° in a section. In this case, the crack section is very sharp, as this tube experienced brittle fracturing.

tensional cyclic stress was larger than the torsional cyclic stress by 1.7 times.

Fig. 2 Damaged tube

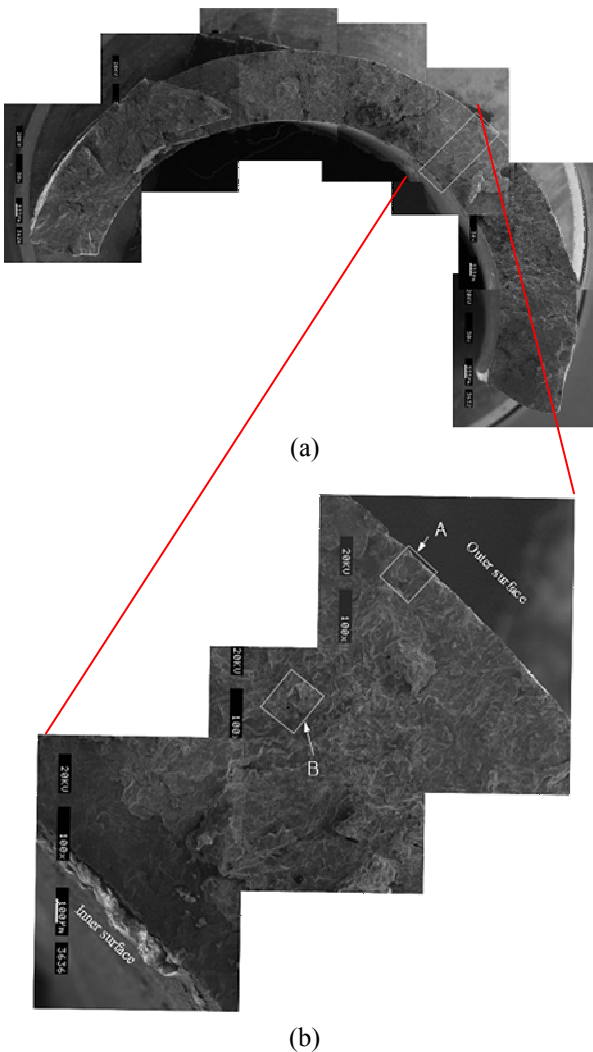
Figures 4 (a) and (b) show an image of the fracture surface taken by a SEM (Scanning Electron Microscope). In Fig. 4 (a), a secondary crack can be observed on the fracture surface. There are no shear lip and plastic deformation on the fracture surface. The crack origin on the fracture surface was not determined. In Fig. 4 (b), the outer surface has more flat compared to inner surface.

Fig. 4 The fracture surface of the tube

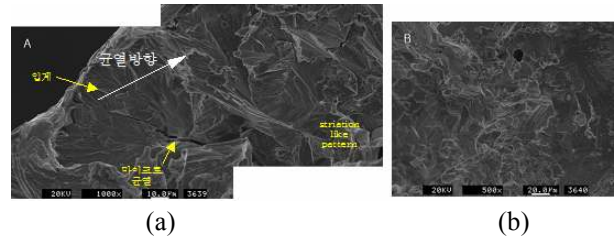
Figure 5 shows a magnified picture of Fig. 4. The cleavage fracture that is part of a transgranular fracture is shown in this figure. Again, there is no plastic deformation [2]. In Fig. 5 (a), a striation-like pattern is shown. Generally, striation is evidence that a component was damaged by a tension cyclic load. However this tube was damaged by both tensional and torsional cyclic loads; thus, striation was not observed.

Fig. 5 A magnified image of Fig. 4
