The Cause of an Eddy Current Signal Noise from a Steam Generator Tube and its Effect on the Detectability of a Crack

Deok Hyun Lee, Myung Sik Choi, Do Haeng Hur, Kyung Mo Kim, Jung Ho Han
Korea Atomic Energy Research Institute, Deokjin-dong, Yuseong-gu, Daejeon, 305-353, dhlee1@kaeri.re.kr

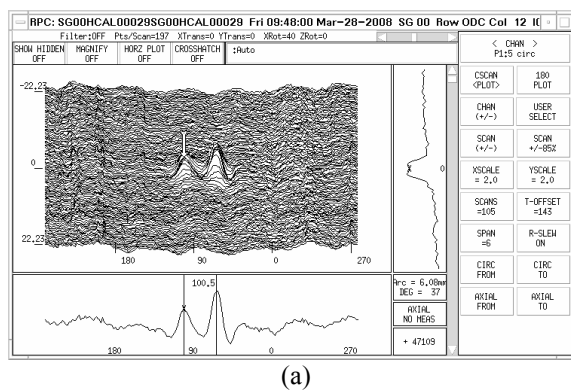
The c-scan graphs of eddy current signals from the +point coil for tubes A and B containing circumferential cracks manufactured on the OD surface are shown in Fig. 1-a and Fig. 1-b, respectively. It can be clearly seen from these figures that tube A has a lower background signal noise compared to tube B. The cracks were successfully manufactured so that the amplitudes of a signal from the two cracks were approximately equal to and two times larger than that of the background noise in each tube. The eddy current signal amplitude of the background noise, smaller crack (on the left in the figures) and larger crack (on the right in the figures) were measured to be 0.10V, 0.11V and 0.22V in the tube A (Fig. 1-a) and 0.05V, 0.06V and 0.10V in the tube B (Fig. 1-b), respectively.

Figure 1. C-scan graphs of eddy current signals from the +point coil for (a) tube A and (b) tube B containing circumferential cracks manufactured on the outer surfaces.

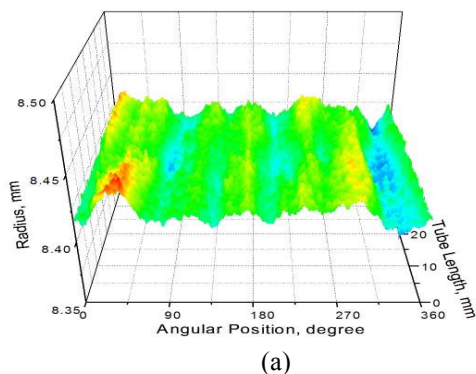
The background signal noise from the +point coil was suspected to originate from the irregularity of the tube inner surfaces, and the topograph of each tube was investigated. The results for tube A and B are shown in Fig. 2-a and Fig. 2-b, respectively. The topographs were shown in terms of radius changes along the circumferential and axial directions of each tube. In Fig. 2-a, obtained from tube A, an axial irregularity of the inner surface was observed, and the number of sharp axial ridges was six, which was coincident with that in the background noise pattern of Fig. 1-a. For tube B in Fig. 2-b, two round axial ridges were observed and it was interpreted to reflect the oval shape of the tube.

Figure 2. Topographs of the tube inner surfaces in (a) tube A and (b) tube B measured by the laser profilometry.

From these results, it can be concluded that the cause of the eddy current signal noise originates from the irregular inner surface of the tube. The variation of the micro-scale dimension with the pattern of the sharp axial ridges observed in tube A is thought to be introduced by the cold pilger rolling stage of the tube manufacturing process.
