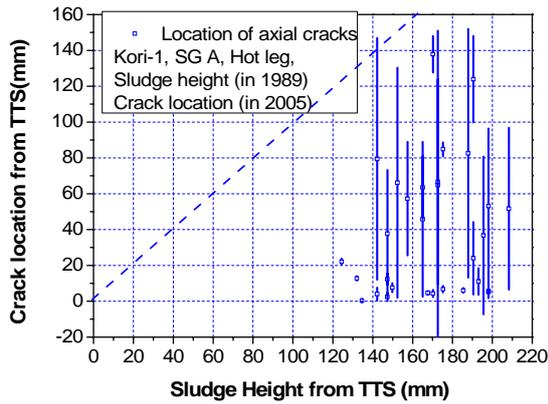
Figure 2 Relationship between the location of axial cracks and sludge accumulation

Residual stresses evaluated by X-ray show that relatively higher hoop stresses exist compared with the axial stresses. [3] The typical maximum values for standard roll-transitions were 370 MPa (54 Ksi) and 340 MPa (49 Ksi) for the hoop stress and the axial stress, respectively. It is considered from these findings that a corrosive environment inside the sludge as well as relatively high hoop stress caused the axial cracks.

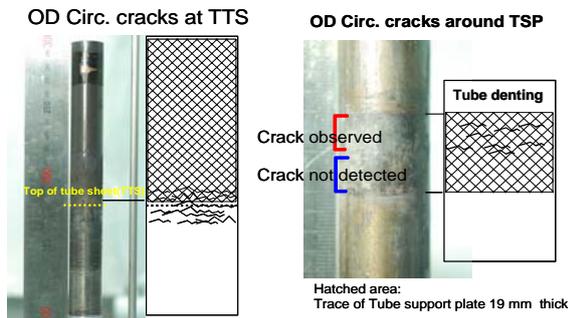
On the other hand, the circumferential cracks were in the sludge pile and below the TTS and TSP region as shown in Figure 3. It has been reported that tube sheet dents and phosphate chemistry caused OD circumferential cracks at TTS region. [4] A. Mcilree discussed that the causes of the circumferential ODSCC at the TTS were sludge pile and residual plus operating stresses at the TTS region. [4] Though the RSG had not operated with the phosphate treatments, denting could also be considered as an additional factor for the cracking at the TTS.

Figure 3 Schematics of the circumferential cracks around top of tube sheet and TSP region

Circumferential cracks were found in the shape of a band around the TTS and the TSP. The sludge accumulation may not be the only cause for the circumferential cracks. The axial stresses caused by the tube expansion process are considered to

promote the circumferential cracks around the TTS. In case of the TSP region, the circumferential cracks were detected at the upper part of the TSP crevice. The tube denting due to oxidation of the carbon steel TSP material is a causative factor of the cracking.
