The Results of a Site Repair after a High Vibration Trip of a Secondary Cooling Fan in HANARO

Yong-Chul Park,^a Yang –Gon Kim,^b Yong-Sub Lee,^b Hawn-Seong Jung,^b In-Cheol Lim,^b
HANARO Center, Korea Atomic Energy Research Institute 150 Deokjin-dong Yuseong-gu Daejeon, 305-353,
R.O.KOREA Tel : 82-42-868-8474, E-mail : ycpark@kaeri.re.kr

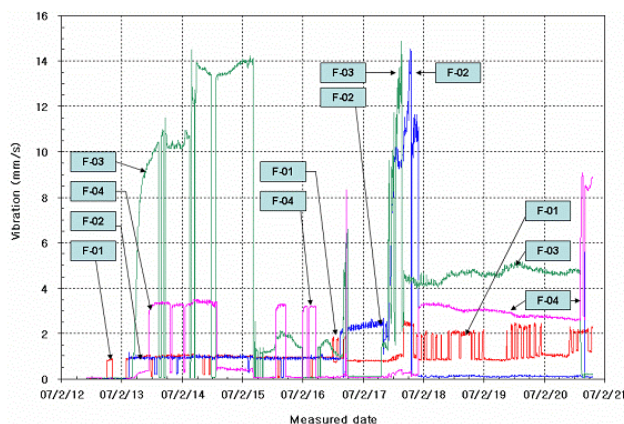
Figure 1 High vibration development of cooling fan

During a normal operation of HANARO, two high vibration trips have occurred in No. 2 cooling fan as shown in fig. 1. This figure is drawn by using the accumulated vibration values during a normal operation to analysis a high vibration development before a trip.

The first trip occurred at about four o'clock PM of Feb. 16. It is estimated that this trip was a false alarm because the vibration values did not exceed the limit and an abnormal condition was not found at the site. The fan was restarted after re-tightening the fixing bolts of the vibration switch and the vibration values were maintained at around 2 mm/s. But, after then vibration values were gradually increased as shown in the figure.

The second trip occurred at about seven o'clock PM of Feb. 17. A high vibration was recorded in about fourteen point two five millimeter per second (14.25 mm/s). Before the vibration reached the limit, the vibration rose up to four times that of the initial value of one point nine millimeter per second (1.9 mm/s) and came to a state of a lull for about five hours. After about 20 minutes the fan was restarted and run for about two and half hours.

As shown in fig. 1, No. 3 cooling fan has been operated at a low speed at the beginning. For about three days from the thirteenth to the fifteenth of February, the fan was operated five times with a high speed start without a sufficient low speed operation. During this operation period, the vibration of the fan nearly reached the limit, but a high vibration trip did not occur.

On the morning of the seventeenth in February, the vibration of the fan nearly reached the limit for three hours without a high vibration trip. After this, the fan was operated at a low speed.

When we checked the installation status of each gear reducer, we found that each gear reducer was distorted by an angle of about five degree in the same direction as the fan rotation and the reducer of No.3 fan was more distorted than that of No.2 fan. Each shaft coupling was misaligned and the rubber bushings for the shaft coupling were damaged. The wall of the No. 3 coupling connection bolt holes was worn.

When a cooling fan is started at a high speed without a sufficient low speed operation, a high speed rotary force works on the fixing bolts of the gear reducer more than a low speed start. Hence the gear reducer of No. 3 fan is more distorted than that of No. 2 fan. And it is estimated that the shaft coupling of No. 3 fan is damaged during five high speed starts, because the vibration is varied in a large range of about two times of the initial value during a low speed operation.

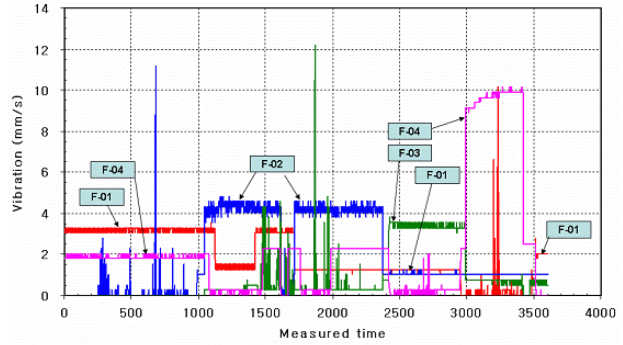
Fig. 2 Cooling fan vibrations after field repair

Fig. 2 shows the vibration trends of each cooling fan after replacing the stainless steel bolts with a high tension bolt for fixing each gear reducer and re-aligning the shaft connected to the motor and the gear reducer⁽⁴⁾. Each fan runs to a high speed after a measured time of 1000 for No.2 cooling fan and 2400 for No. 3. Each vibration value of a high speed operation is indicated below 4.2 mm/s for No. 2 cooling fan and below 3.3 mm/s for No. 3 cooling fan and stabilized below the vibration limit. Before each fan starts, the indicated unstable vibration values are due to a noise.

After the repair, the vibration values of No. 1 cooling fan are shown after a measured time of 3500. The vibration values are indicated below 2 mm/s with stability and this is reduced to about 70 % of the values before the site repair.

And the vibration values of No. 4 cooling fan are indicated after a measured time of 2900. At the beginning the vibration values are indicated at about 9 mm/s and gradually increased to about 10 mm/s. This value is higher than that before the repair but it is maintained stability below the vibration limits.

After replacing the stainless steel bolts with high tension steel bolts for fixing the gear reduce, the vibration values were stabilized and maintained below the limit of a high vibration trip.
