Study on the Dismantling technique of a Jammed State between an outer pipe and an inner combined structure for a HANARO Irradiated Instrumented Capsule (03M-06U) in IMEF

Yong-Sun CHOO, Do-Sik KIM, Wan-Ho OH, Seung-Je BAIK,
Byung-Ok YOO, Sang-Ryul BAEK, Ki-Nam JOO
Irradiated Materials Examination Facility, Korea Atomic Energy Research Institute,
P.O. Box 150, Yuseong, Korea, 305-600

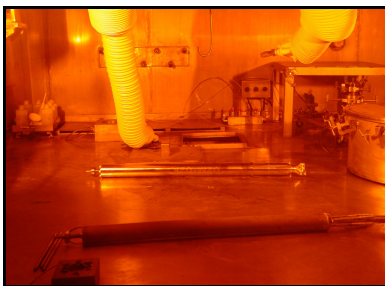
Figure 1. The appearance of 03M-06U transferred from the pool to the M1 Hot cell.

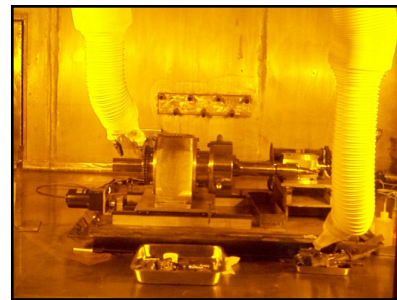
Figure 2. Cutting and dismantling 03M-06U by a capsule cutting machine in the M2 Hot cell

By above the procedure, after cutting the bottom and top of the capsule by a capsule cutting machine, the dismantling process was attempted many times by using a pair of master-slave manipulators. During this process, a little problem such as a jammed state between the outer pipe and the inner combined structure occurred.

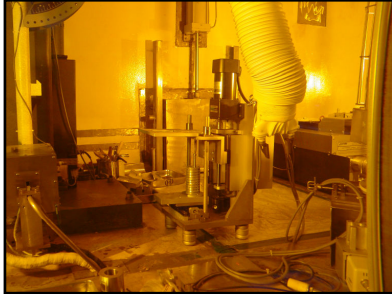
Figure 3. Specimen press machine installed in the M5a hot cell.

To dismantle the inserted test specimens from the thermal media without an outer pipe, a specimen press machine as shown in Fig. 3, installed in the M5a hot cell, is generally used. As some equipment such as a CCTV camera installed in the M5a hot cell is very weak to a radiation, it is recommended to separate the thermal

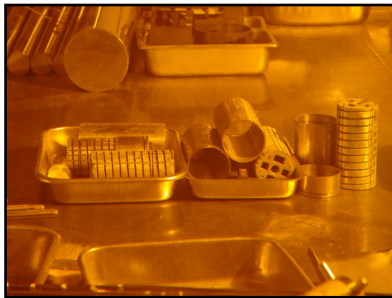
Figure 4. Cutting and dismantling the thermal media with an outer pipe.

It is assumed that this kind of problem occurred for the following reasons:

- 1) This capsule probably had a problem during the manufacturing process at the shop before an irradiation.
- 2) The gap between the outer pipe and the thermal media is not enough to meet design the criteria for a thermal expansion during an irradiation at the HANARO

To release the jammed state between the outer pipe and the inner combined structure, the capsule was cut again five(5) parts thermal media by thermal media with an outer pipe as shown in Fig. 4. And they were all cut again piece by piece to remove or reduce the outer pipe as much as we can.

During the cutting and dismantling process of a HANARO irradiated instrumented capsule(03M-06U), a phenomenon like a jammed state was observed. So to release the jammed state between the outer pipe and the inner combined structure, the outer pipe was cut piece by piece by a capsule cutting machine installed in the M2 hot cell until the outer pipe was eliminated or separated as much as we could.
