Assessment of Mismatch at Indicated Level of the Upper Side Zone of LZC on abnormal operations

Sung-min Kim, Joong-Woo Park, Dae-hack Kho, Hyung-beom Seo, Bong-gyun Han, Jin-soo Moon,
Korea Hydro Nuclear Power Co., Wolsong Nuclear Power Plant 1, Safety & Engineering Dept.,
260, Naa-ri, Yangnam-myeon, Kyeongju-si, Kyeongsangbuk-do, KOREA, wolsung@khnp.co.kr

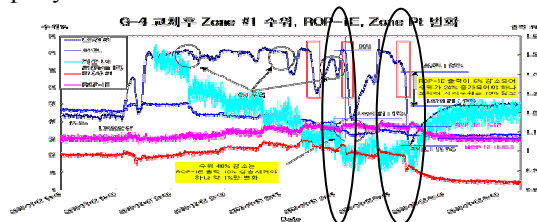
Figure 4. Comparison of indicated water level and actually assumed water level (based on ROP-1E signal) at the zone 1

Although the indicated water level on RRS showed 80%, the actual level gradually decreased to 15% as the water continuously drained from the core. So, zone power was increased slowly. Estimation for the period of recovery was done too.
