Lessons-Learned from an Event during Overhaul

Korea Institute of Nuclear Safety, P.O.Box 114, Yuseong, Daejeon, Korea

After finishing overhaul, there was an event in a domestic Nuclear Power Plant (NPP). The reactor coolant was leaked from a seal injection filter of the reactor coolant pump (RCP) while the NPP was starting for the criticality in the operating mode 3. The event sequences are as follows.

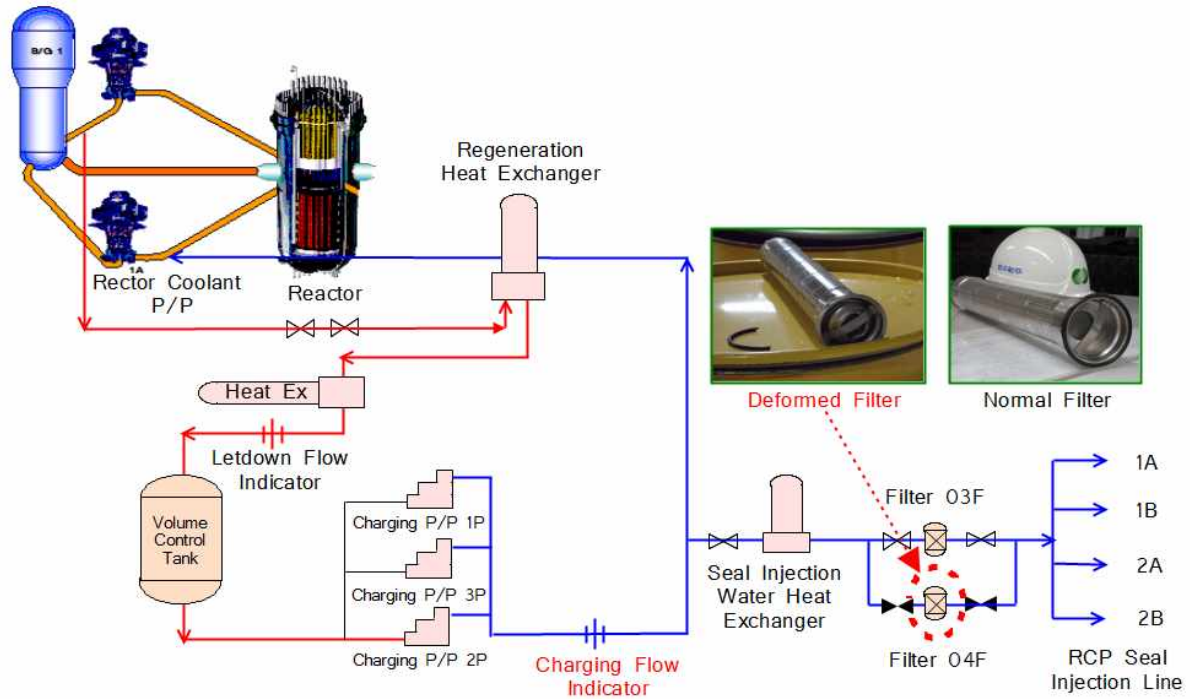
Figure 1: Diagram of the event sequences

During the event, the MCR operators, on the basis of alarms and plant parameters, thought that the leakage had been being from the charging pump or the charging line. Because there was a failure of the indicator, that was monitoring the charging flow, it indicated wrong value. At that time, it indicated only one charging pump flow even though two charging pumps had been operating. Thus, operators recognized that the leakage was from any charging pumps or after the charging line. Finally, a field operator found out that the reactor coolant had been being leaked from the RCP seal injection filter. After that, the MCR operator isolated the isolation valve of the RCP seal injection line and the leakage was blocked. The diagram of event sequences is shown in Figure 1.

This event is about the reactor coolant leakage from the RCP seal injection filter and the cause of the reactor coolant leakage is deformation of the filter due to some abnormal impact after the replacement with new one during the overhaul. Because of this problem, an O-ring of the rubber material attached inside the filter also deformed and the reactor coolant was leaked through this O-ring. After the event, the licensee replaced this filter with new one. Total amount of the reactor coolant leakage was 7.7 tons.

However, there were several problems while the operators were identifying causes of the event. First, a measuring instrument, that is an indicator in the MCR board, had been being indicated wrong value since dawn on that day. One of operators' duties was logging that parameter about the charging flow every 4 hours. However, any operators did not pay attention about the parameters of the charging flow even though the indicator did not indicate the normal charging flow as the number of the operating charging pumps. Second, even though there was an alarm related the low charging flow at that time in the MCR, both night and day shift did not pay attention this alarm.

If the operators had paid attention and performed appropriate actions for two problems mentioned above, the operators could have identified and blocked the leakage point rapidly when the reactor coolant leakage due to the RCP seal injection filter occurred. However, if the situation occurred in the normal power operation situation, there was possibility that the operators did not miss abnormalities about the logging data and the alarm. During overhaul, various maintenance works and tests are performed so operators cannot pay attention or miss when alarms are displayed or plant parameters are changed. In other words, operators can be insensible against abnormal alarms and plant parameters during overhaul in the aspect of the situation awareness.
