## Troubleshooting of Modulator DC power supply at KOMAC

Hae-Seong Jeong\*, Han-Sung Kim, Hyeok-Jung Kwon,  
Seong-Gu Kim, Dae-il Kim, Seok-geun Lee, Jae-ha Kim, Kyeong-tae Seol, Yong-Sub Cho  
KOMAC, KAERI, Gyeongju, Korea,  
jeonghs@kaeri.re.kr \*

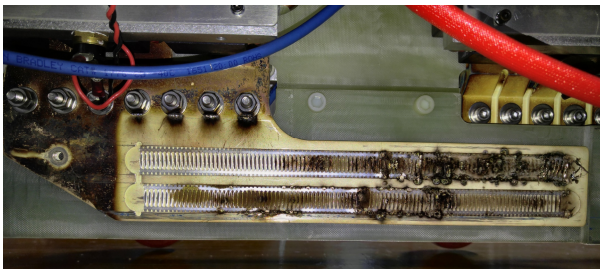
However, when the 2nd HVCM attained the 3 % duty, the contact side of 20 kHz switch plate was damaged by electrical arcing as shown in the Fig. 1.

Fig. 1. Damaged contact side of the switch plate

The predictable reason of this electrical arcing at the contact side may be the loose assembling. Nevertheless, we cannot assure the exact reason of this electrical arcing.

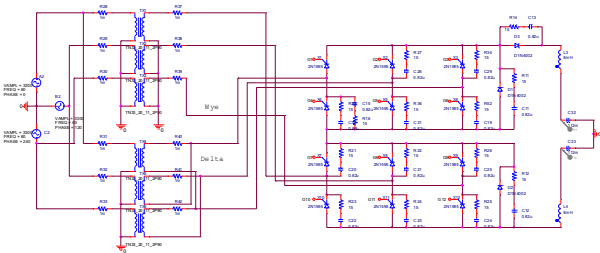
Fig. 3. PSpice schematic of the dc power supply

In the Fig. 3, the one thyristor snubber network was not connected. Instead, that snubber network parallel connected to the other thyristor. This faulty wiring was observed in our dc power supply.

Since the 2nd modulator dc power supply has troubled, the troubleshooting process conducted by the staves of KOMAC. It takes 3 months to solve the problems because it is not easy to find the faulty wiring. Nevertheless, our staves found the faulty point with a hope to operate the modulator system and the PSpice simulation helps to solve the problems. Using PSpice which is tool for simulating the circuit, the dc power supply abnormal phenomenon was simulated exactly. After corrected the faulty wiring, the modulator dc power supply operated normally.

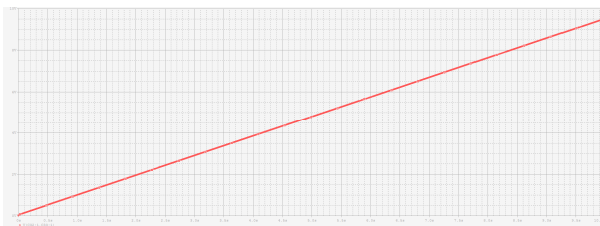
Fig. 4. PSpice simulation result (X: time, Y: voltage)

In the Fig. 4, x-axis is time and y-axis is dc output voltage of the dc power supply. The dc output voltage increases linearly and the increasing rate is 0.951 V/sec. This increasing rate is similar to that of our dc power supply at zero voltage setting.
