A Study on the Cause of Failure and a Method for Improvement of Fuses

Yeonghwa Ji, Heemoo Heo, Hyoungwan Kim

Central Research Institute, KHNP, 70, 1312-gil, Yuseong-daero, Yuseong-gu, Daejeon, Korea

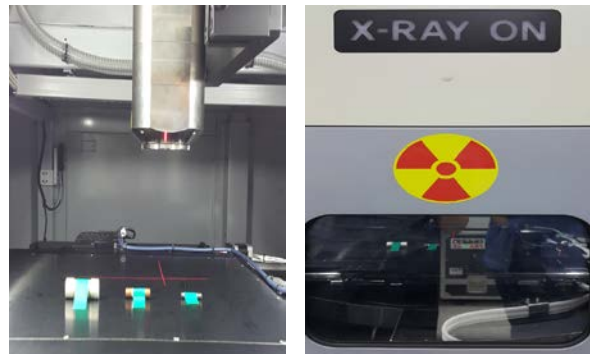
Fig. 1 The x-ray irradiation of the fuses

Our fuse blow down test used a fast-acting glass fuse. Test sequences involved an appearance inspection, a blown fuse test, x-ray irradiation and inspection of the fuse's melted element. We performed blown fuse tests with a surge (1.2/50 μ sec, 5kV & 8kV), ESD(~15kV) and an overcurrent test according to the current size. Fig. 1 shows the x-ray irradiation of the fuses.

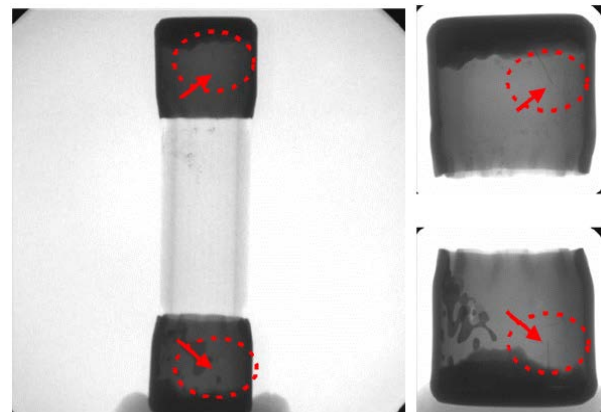
Fig. 2 The x-ray image of a fuse blown by a surge

The X-ray images of the melting of the fuse element in the surge test are shown in Fig. 2. When 1.2/50 μ sec wave 5kV was supplied to the test fuse, the element did

not melt. However about 90% of the fuse element was melted when the given voltage was 8kV.

According to the X-ray image interpretation in the surge test, the open gap of the element was relatively long and there was no vestige of melting [2].

A surge can be caused by lightning and power system failure. In order to prevent surges in electrical and I&C equipment, a surge protector of sufficient capacity should be installed and grounded properly so that the system would be designed to not blow a fuse caused by surges as well as the equipment would be protected. Fig. 4 shows the general configuration of a surge protector installed and grounded to block incoming surges.

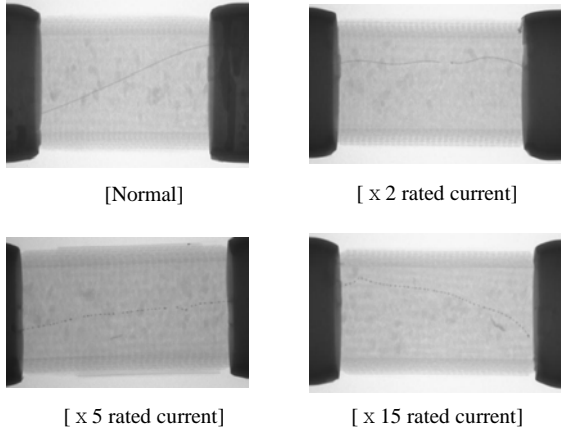
Fig. 3 An image of a fuse blown by overcurrent

For simulation on the most frequent and various situation of fuse element melting, two and five times its rated currents were used as overcurrent test voltage. X-ray images of the melted fuse elements are given in Fig. 3.

As a result of overcurrent (twice its rated current) test, one or two fuse element open is shown by X-ray image interpretation. The open gap was shorter than it was in the surge test. The melting phenomenon occurred at the end of the open part. In overcurrent (five times its rated current) test, the number of fuse element openings was significantly increased, the open gap was very short and the melting phenomenon appeared at the end of every

single open part. When overcurrent (fifteen times its rated current) test was performed, the opening gap was too short to find the element trace and the melting phenomenon was seen at the end of every single opening part [3].

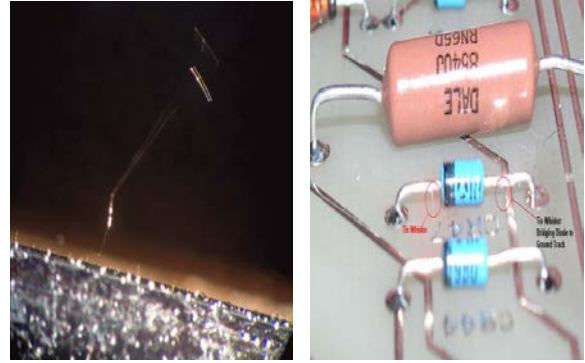
Fig. 5 An image of a tin whisker

Overcurrent can be caused by capacitive coupling of a power cable, inductive coupling between cables, inrush current when breaker and inductive loads start, instantaneous short circuit in the cable connections on terminal block. Particularly a short circuit in the cable connections on terminal block can occur to melt fuse element due to overcurrent by tin whisker (Fig. 5) [3].

When breaker and inductive loads are started, an inrush current can be controlled by inverse voltage and current protection. The tin whisker can be eliminated with the air gun, soft brush and electric circuit cleaner during maintenance.
