ASME code for RPV cladding repair by Ni electrodeposition

Seong Sik Hwang^{a*}, Min Su Kim^a, Eun Hee Lee^a, Dong Jin Kim^a,

^aKorea Atomic Energy Research Institute, 989-111 Daedeok-daero, Yuseong-gu, Daejeon 34057

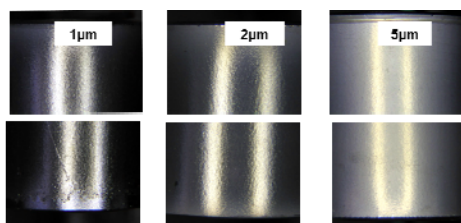
As shown in Fig. 3, the optimum thickness condition of the strike layer was 5 μm , and there was no bulging or detachment at the surface.

Fig. 3 Feature of strike layer having different thickness
