Thermal Fatigue and Life Evaluation for the Impeller of Reactor Coolant Pump

Don-Kug Lee^{a,b}, Chi-Bum Bahn^{b*}

^aMaintenance Management D, KHNP, 1655, Bulguk-ro, Yangbuk-myeon, Gyeongju-si, Gyeongbuk, 38120, Korea

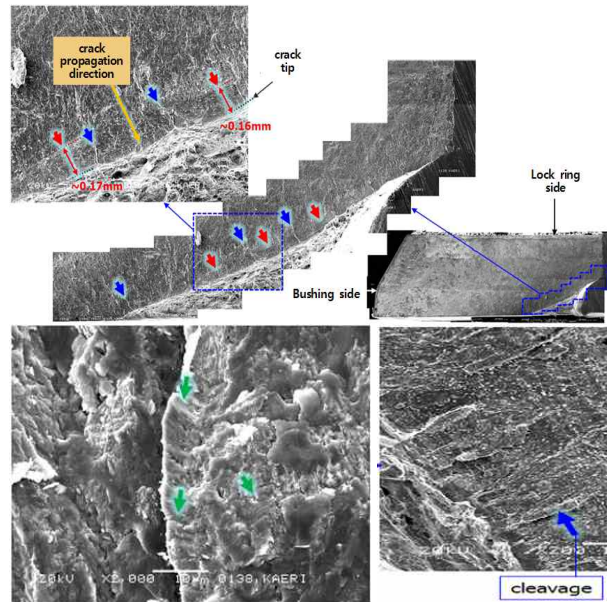
The replica analysis of the cracks shows that crack propagates into the inside of the grains rather than the grain boundaries in a certain direction without twigs (Fig. 1). At the tip of the crack, beach marks and striation appearing in the direction of crack propagation perpendicular to the direction of fatigue fracture surface are shown. And in the direction of crack propagation, the features of the cleavage appear as per fracture analysis of the cracks (Fig. 2).

Fig. 1. Replica photos of R1 & R3 location

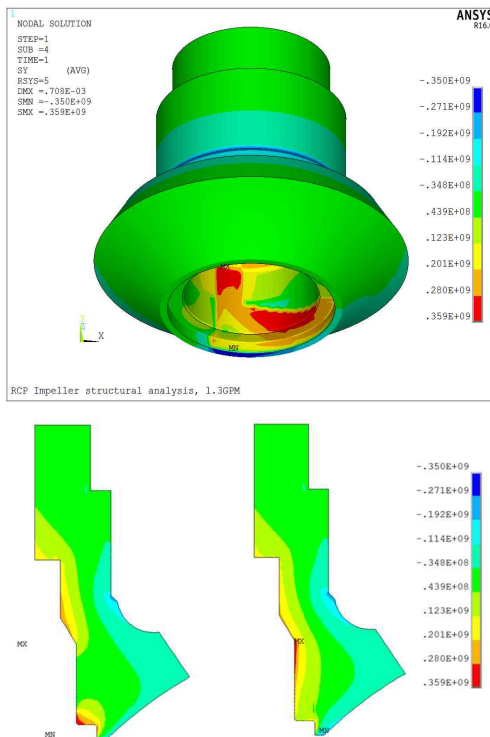
As a result of the thermal stress analysis, it was analyzed that the maximum tensile stress was formed on the inner surface and the corner surface of the impeller hub in which the sealing water flowed through the bushing outer surface in case 6 in case of circumferential direction. The stress distribution on the impeller hub surface due to the fluid fluctuation and the pump operation was in the range of about 44~359 MPa (315MPa) (Fig. 3). Comparing this value with the S-N curve of the impeller material (ASME SA487, CA6NM), it can be seen that cracks can occur after about 3×10^5 cycles [3].

This means that surface cracks may occur in the early stage of operation when this pump is operated at 1,800 rpm. It is not clear how often the fluid and thermal fluctuation appears, but it is expected that the fluctuation frequency will be considerably fast. Actually, the surface crack was generated in the impeller hub after one cycle operation (18 months) with the new impeller installed.

Fig. 3. Circumferential Stress Distribution of Impeller hub

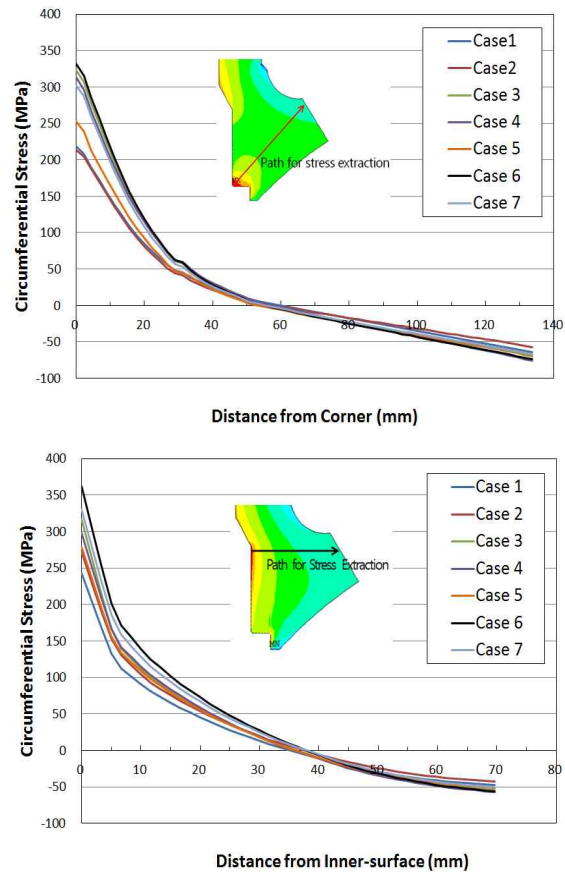
However, the thermal stress distribution in the thickness direction is maximized at the surface of the

impeller hub, and decreases toward the inside and changes from tensile stress to compressive stress. This means that cracks on the surface of the impeller hub can occur relatively early in the operation, but the crack growth rate slows down toward the inner surface, which means that the crack no longer grows at any depth. In fact, the depth of cracks in the impeller of pumps operated for more than 20 years was similar to the impeller of pumps operated one cycle, because the crack growth rate dropped significantly toward the inside.

Fig. 4. Circumferential Stress Distribution (from corner/Inner-surface to crack propagation dir.)

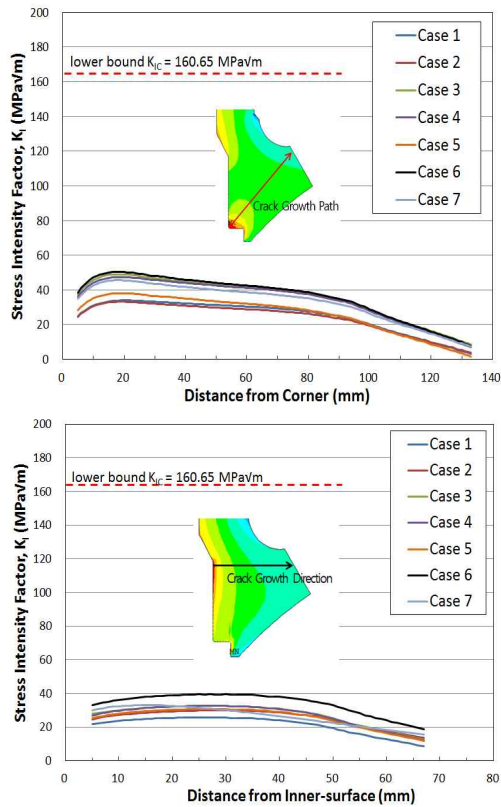
Fig. 5. K_I and K_{IC} Distribution (from corner/Inner-surface to crack propagation direction)

The calculated K_I value and the lowest fracture toughness value (K_{IC} : 160.65 MPa√m) measured on the actual impeller material were used to evaluate the crack instability according to the requirements of ASME Section XI IWB-3612. As a result, the impeller was evaluated that sudden brittle fracture would not occur due to satisfying the following formula (2)[5].

According to the results of the thermal stress evaluation, the residual life evaluation was unnecessary but was evaluated by applying 2mm/cycle, which was obtained by multiplying the last 1 cycle crack growth (approx. 0.15~0.2mm) at the crack tip confirmed by the fracture analysis of the specimen with the maximum crack depth by 10 times safety factor. This is a very conservative residual life assessment and it has been confirmed that penetration crack does not occur during the lifetime of the pump. This means that the pumps will remain sound throughout lifetime of the plant.
