A Study on CEDMCS Stabilization in Hanbit Nuclear Power Plant Units 3 and 4

Daegun Lim and Man Gyun Na*

Dept. of Nuclear Engineering, Chosun University, 309 Pilmun-daero, Dong-gu, Gwangju, Korea

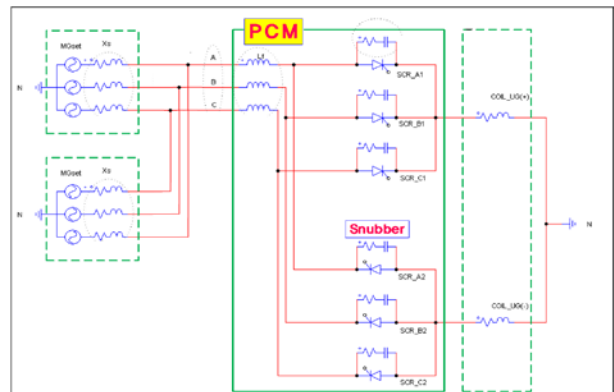
Fig. 1. MG-set and CEDMCS power circuit

As shown in Fig. 1, the harmonic voltage generation mechanism generates a harmonic current of $6N \pm 1$ in the SCR operation of the CEDMCS power conversion module (PCM) and is charged to the capacitor of the snubber. The harmonic current charged in the capacitor flows divided into a low impedance power system (MG-set), harmonic voltage is generated by the inflow

harmonic current and the MG-set generator system impedance, and this harmonic voltage and the fundamental wave voltage induced at the generator terminal are combined to distort the output voltage.

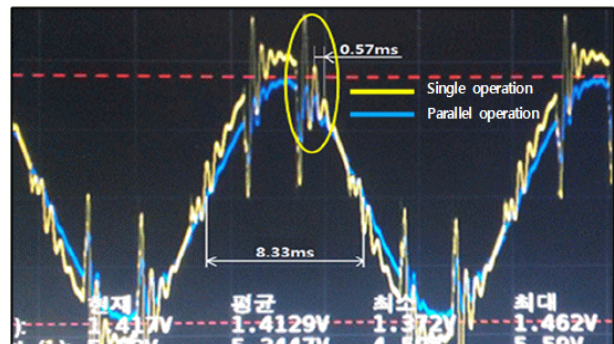
Fig. 2. Parallel and single operation waveforms

The harmonic was measured in the MG-Set of Hanbit NPP unit 3. As shown in the measurement result of Table 1, the total harmonic distortion (THD) was 33.8%, the distortion was severe, and the maximum instantaneous voltage was 283V. Thus, it was confirmed that MG-Set synchronization could not be possible and CEDMCS UVR could be damaged.

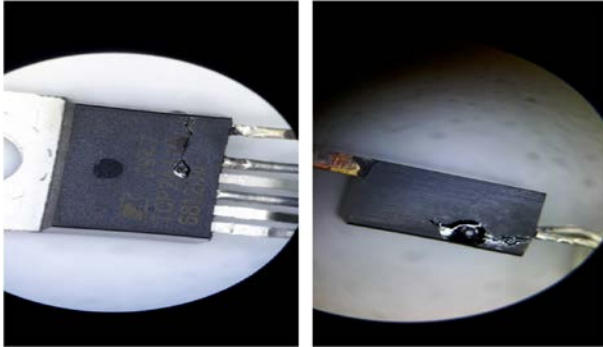
Fig. 6. The crack TOP244YN(Auxiliary power switching element)

Table 4 shows the result of checking the circuit element connected to the crack element found in the visual inspection.

※ check the normal operation after replacement of fault elements

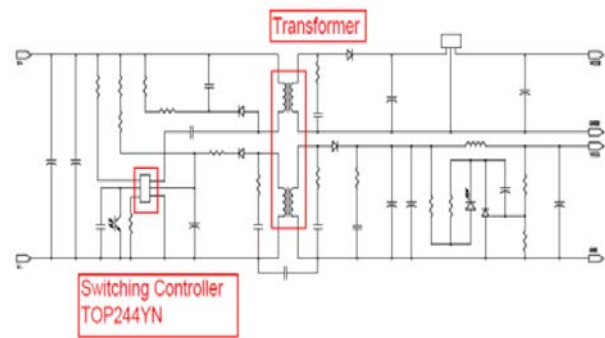
Fig. 8. Aux power circuit diagram

The auxiliary power circuit diagram is shown in Fig. 8. The parts marked with a red box in Fig. 8 are

elements that cause failures or are circuit blocks containing the elements.

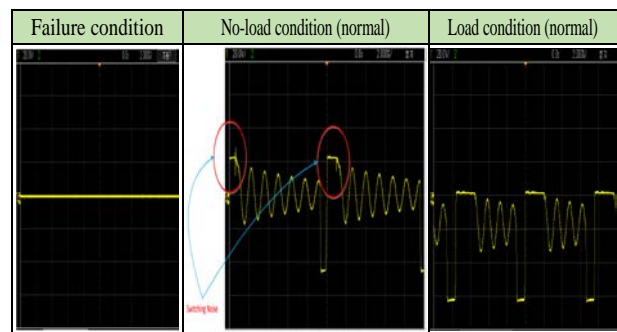
Fig. 9. Waveform of TOP244 YN

Fig. 9 shows the result of checking auxiliary power switching controller (TOP244YN).

- Failure condition: Output signal is not measured.
- No-load condition (normal): The output waveform of the element measures noise in the switch section.
- Load condition (normal): Clean waveform with noise removed in the switch section

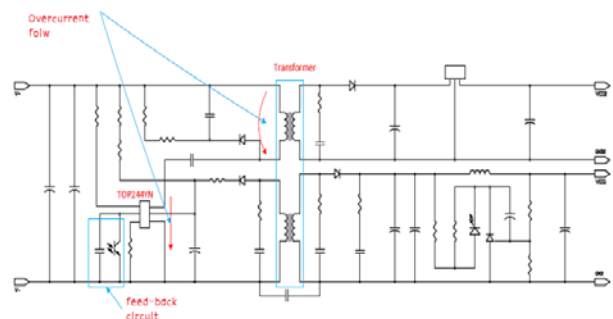
Fig. 10. Aux power circuit description

- ① Abnormal feedback signal input to TOP244YN element due to noise or signal distortion
- ② TOP244YN switch element malfunctions in short mode due to abnormal feedback signal

③ Transformer connected to TOP244YN element deteriorates

④ Due to the reduced impedance of transformer, overcurrent flows to TOP244YN switch and breakage

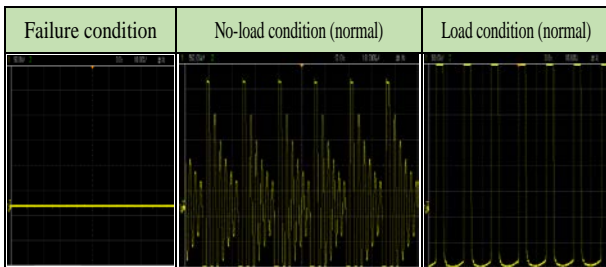
Fig. 11. Waveform of TC1413NEOA713

Fig. 11 shows the result of checking main power PFC controller (TC1413NEOA713).

Failure condition: Output signal is not measured

No-load condition (normal): The waveform is measured like a periodic chattering phenomenon without continuous operation of the FET.

Load condition (normal): The waveform is measured with a period of operation of the FET.

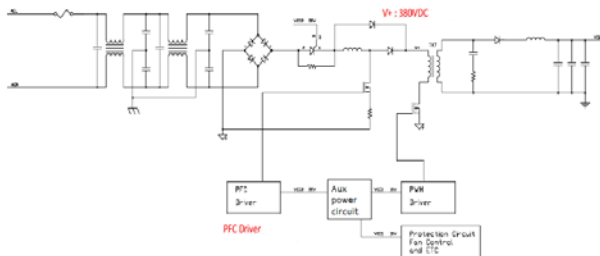
Fig. 12. PFC controller circuit description

① Operating voltage rise of the PFC controller (TC1413NEOA173) during the TOP244YN element fails

② Failure due to voltage exceeding rated voltage to the element of TC1413NEOA173
