## Torque Audit and Visual Inspection of the In-Pool Assembly for CNS in HANARO

Jin-Won Shin\*, Sang-Ik Wu, Min-Su Kim, Jae-Sam Han, and Hyung-Kyoo Kim

Korea Atomic Energy Research Institute, 989-111 Daedeok-daero, Yuseong-gu, Daejeon 305-353, Korea

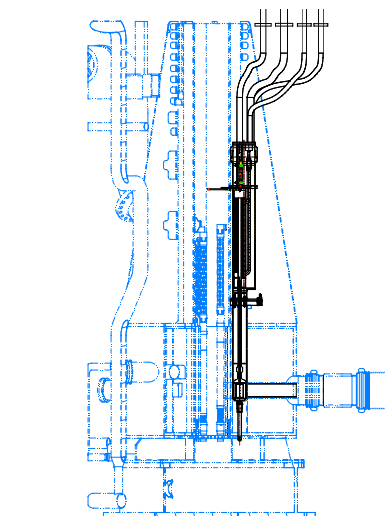
Fig. 1. Side view of the in-pool assembly installed at CN vertical hole of the reactor vessel.

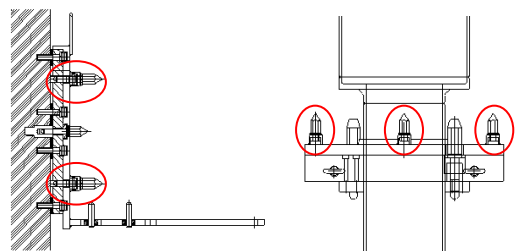
(a) Fixing bracket (b) Vacuum chamber flange  
Fig. 2. Torque audit items for the IPA

The specified torques to tighten screw bolts of the fixing bracket to the chimney and the vacuum chamber flange to the joint flange are both 450 kgf-cm. The torque audit was implemented using special long tools and the torque wrench which was calibrated and certified by Korea Testing Laboratory. It showed that all screw bolts were tightened conforming to the torque specification. The visual inspection also showed that there were no remarkable displacements of the IPA which could influence the water film gap. The joint bracket of the vacuum chamber was supported by two pins of the fixing bracket, and the gap between two brackets was the same as that of the installation stage (Fig. 4 - a, b). The vacuum chamber flange was completely tightened to the joint flange of the CN vertical hole so that there was no gap between two flanges (Fig. 4 - c, d). The joint bracket of the vacuum chamber was clamped well with the tightening bolts (Fig. 4 - e). There were also no defects at the welding surface of flexible double pipes (Fig. 4 - f).
