Case Study on Relay Malfunction by Electrochemical Migration in Nuclear Power Plants

Kwang-Hyun Lee ^{a*} and, Yong-Goo Choi ^a

^aKHNP, Central Research Institute, 70, 1312-gil, Yuseong-daero, Yuseong-gu, Daejeon, 34101, South Korea

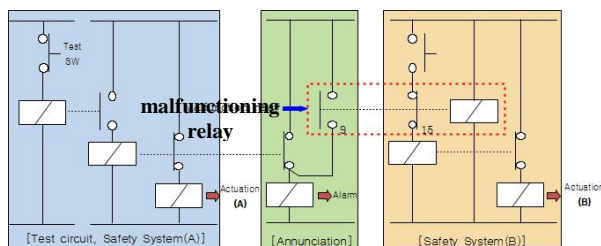
Fig. 1. Safety system test circuit

During the actual functional test in a NPP, at the moment of pushing the test switch, not only safety system (A) but also safety system (B) operated abnormally. The cause of abnormal operation of safety system (B) is reduction of the insulation resistance between contacts in a common relay(malfunctioning relay in Fig. 1.) installed in the alarm circuit and the safety system circuit.

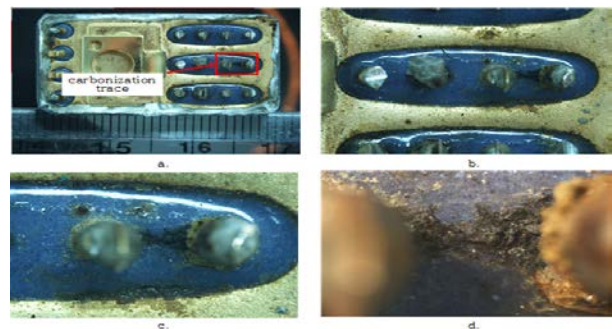
Fig. 3. Carbonization trace between pin no. 9, 15 of the malfunction relay

In order to check the inside of the malfunctioning relay, we separated pins on the base plate of the relay from part of the contacts and checked the relay by using the electro magnitude. There were scattered traces of corrosion caused by the flux while soldering pins of the relay base plate and a carbonization trace between pin no.9 and pin no.15 was also observed.

In the visual inspection of the actual malfunction relay, corrosion products due to the flux and the carbonization trace between pin no. 9, and 15 of the malfunctioning relay were observed, indicating that there is a possibility of influence by electrochemical migration.

relay installed in the safety system of NPP was energized and the inside temperature of the relay was high, which causes moisture in the flux residue to spread inside the relay. Therefore, the conditions of ECM were sustained for the relay operation time (5.3yrs). Eventually, the degradation of insulation resistance caused a short circuit between pin no. 9, and 15 of the relay and caused system failure.

Through the mechanism of reduced insulation of resistance between pin no. 9, and 15 of the malfunctioning relay, the root cause of relay malfunction can be understood and methods of improvement can accordingly be identified. First, the root cause is that an excessive amount of flux was used while soldering pins on the relay base plate and the flux residue was not removed. Therefore it is necessary to enhance the quality of the relay and production process, such as using an appropriate amount of flux, using no-clean flux and removing residue flux.

In order to eliminate the faulty relay before it is used in the systems, it is necessary to prepare a procedure to check the resistance between pins of the relay.

The manufacturing process of hermetically sealed relays includes soldering pins and using fluxes. Therefore, for relay users, it is also possible to consider replacing hermetically sealed relays with cradle type relays that have transparent plastic covers and do not require a soldering process, if the environmental conditions of the relays are good.

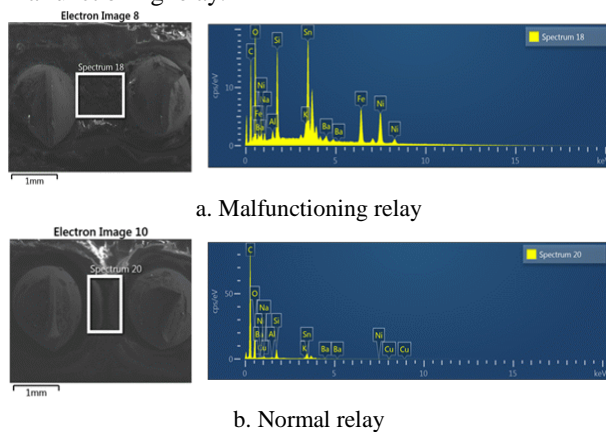
Fig. 4. ESD composition analysis and spectrum

In the EDS mapping test on the carbonization trace of the malfunctioning relay and a normal relay, greater amount of Fe, Sn and Ni were observed in the malfunctioning relay than in the normal relay. It is seen that it is possible to reduce the insulation resistance between pin no. 9 and 15 of the malfunctioning relay.

The results of the EDS chemical compositions analysis of the carbonization trace in the malfunctioning relay are presented in Table 1. and the EDS mapping test. On average, 28.95% Sn, 13.77% Ni and 10.42% Fe were detected, which are significantly higher than the corresponding values (3.91% Sn, 0.14% Ni(Fe not detected)) of the normal relay. This can be regarded as the cause of reduced insulation resistance between pin no. 9 and 15 of the malfunctioning relay.

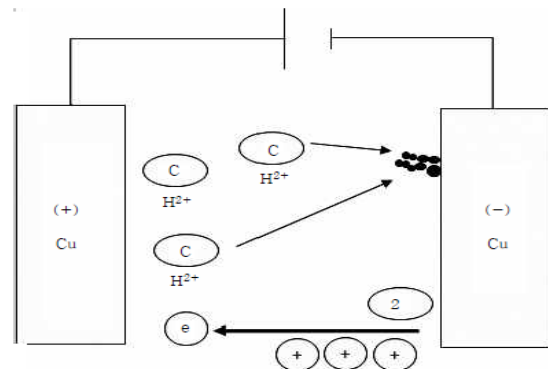
Fig. 5. Electrochemical migration

ECM is a reaction phenomenon in which metal (Ag, Sn, Cu, Au, etc.) atoms move in the form of dendrites under high humidity and an electric field.[1] In the present of a voltage and moisture in the state where flux residue is remaining, ionization at the anode and precipitation at a cathode may occur. If this precipitation reaction continues, a dendrite will grow from the cathode to the anode and eventually cause short of the two conductors.

Electrochemical migration can cause a short circuit in high temperature and high humidity conditions even in the case of using no-clean flux which is generally volatile in the soldering process by automation of electronic cards. Therefore, when soldering by hand, a rosin-based flux is generally used, and flux residues should be removed by using a cleaner after soldering.
