FAC Assessment for SA106 Pipe with Elbows and Welds

Materials Safety Technology Development Division,
Korea Atomic Energy Research Institute (KAERI)

2021. 05. 13-14.

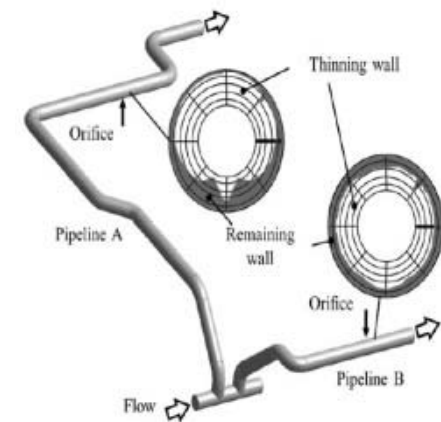
Fig. 1. Schematic layout of pipeline in Mihama nuclear power plant.

- Flow accelerated corrosion (FAC) is one of major degradation problems including human injuries in NPP.
- FAC is managed using COMSY, CICERO and CHECWORKS
- Improvement of piping management accuracy is needed for safe long term operation. Especially effect of multi components on FAC is needed. Asymmetric FAC occurred in Mihama 3 due to complex flow.

➤ Mihama 3, 2004, 11 injuries

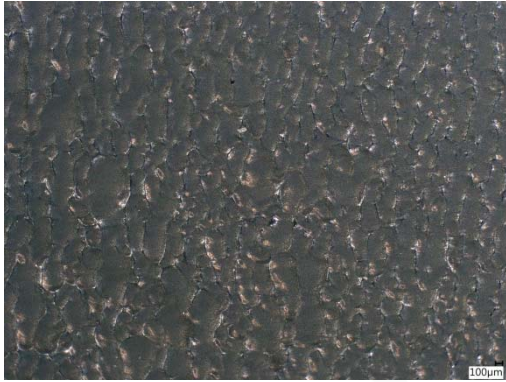
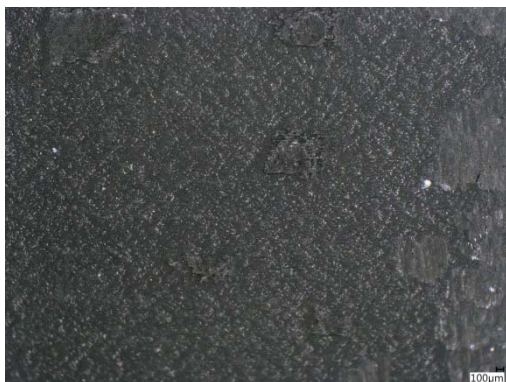
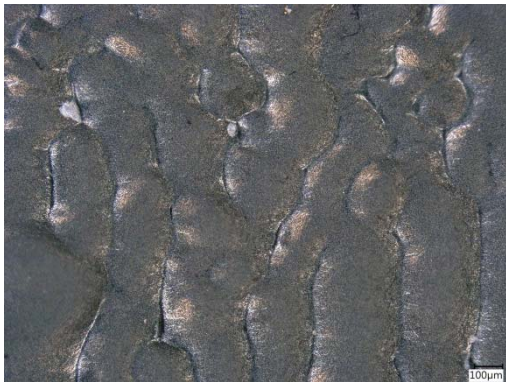
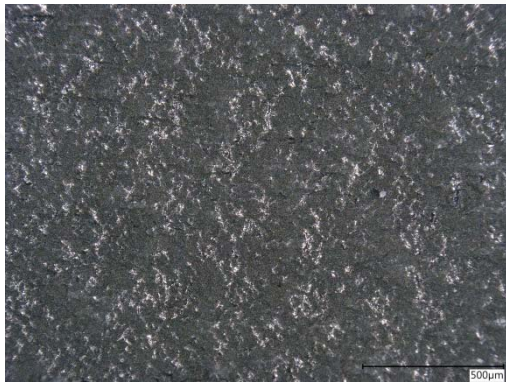
Surface appearance for test section 1

- There is an orange peel pattern for SA106.

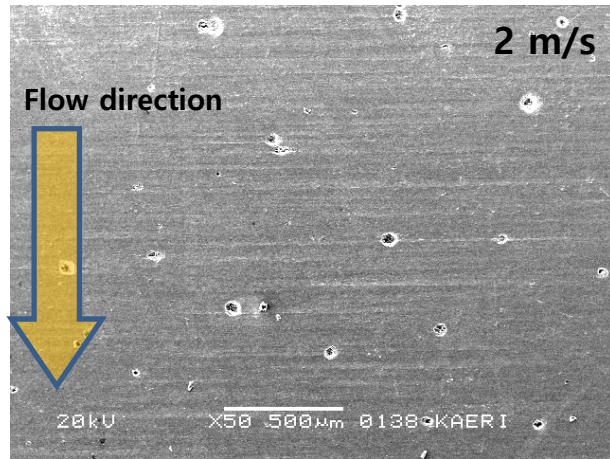
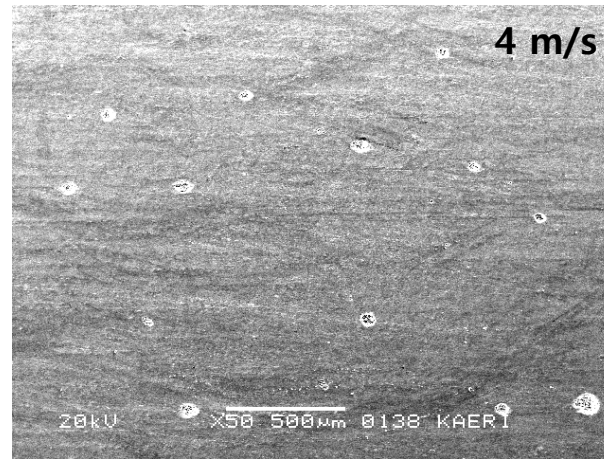
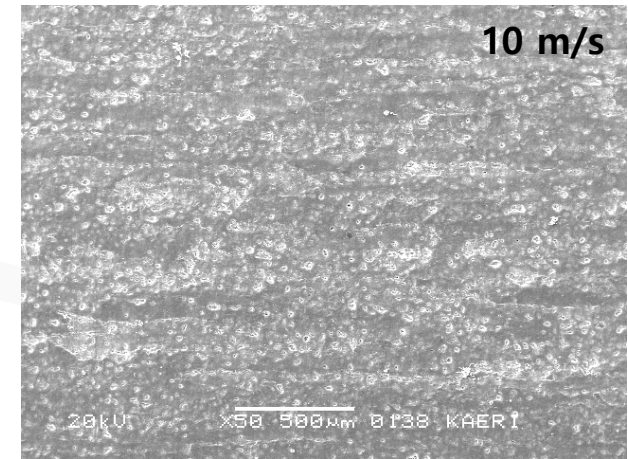
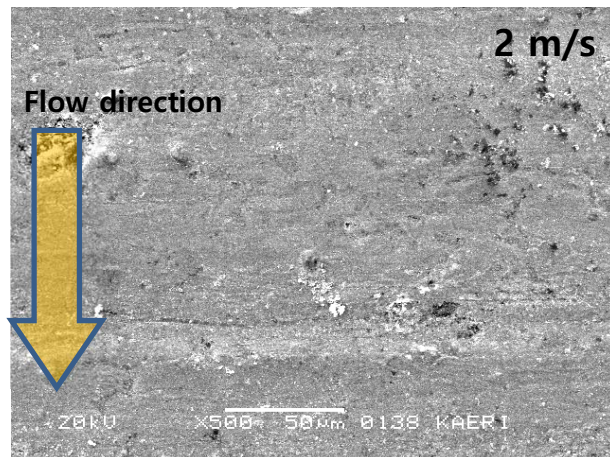
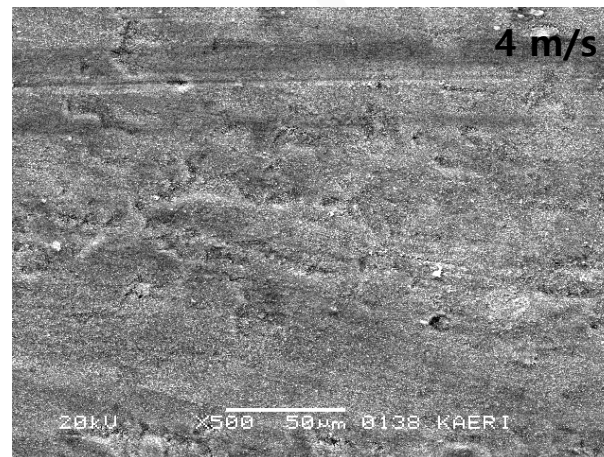
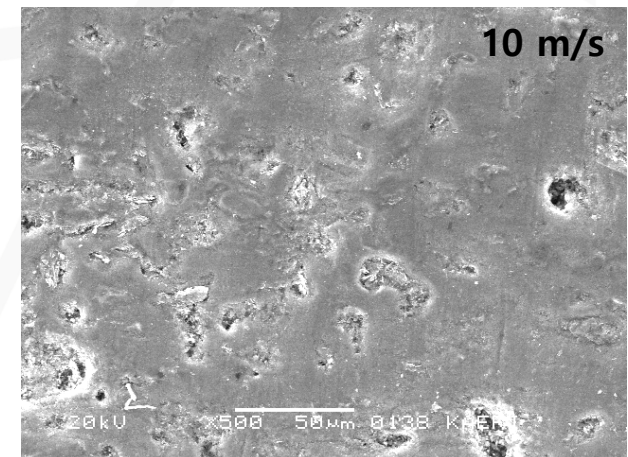
Surface appearance after 1670hrs exposure using rotating electrode

- There is no orange peel pattern.
- Pit size and density with the flow rate

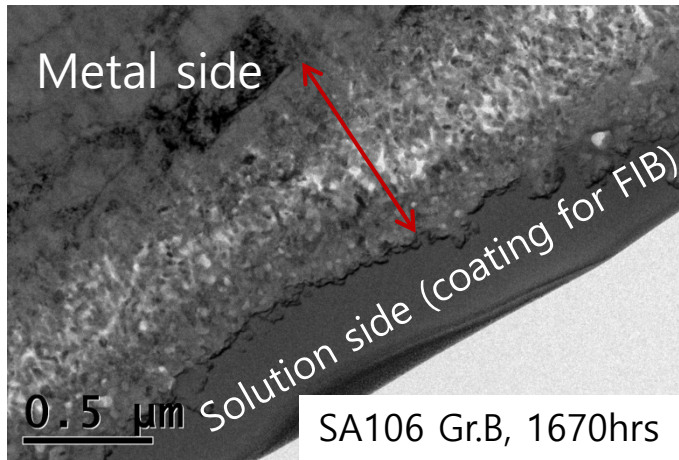
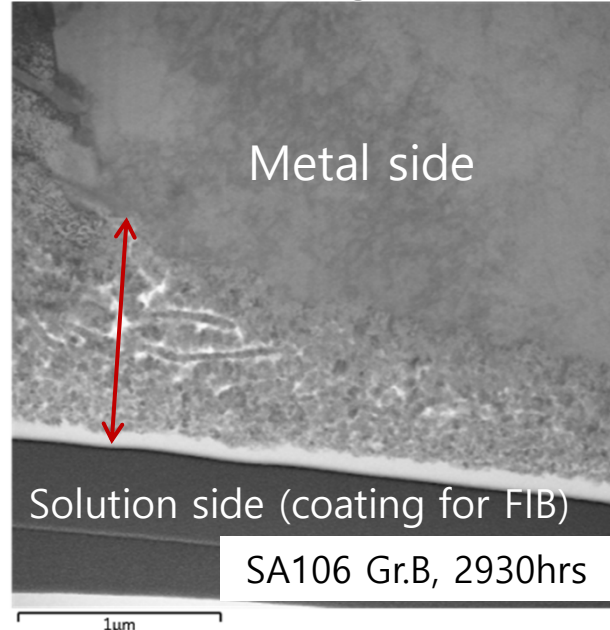
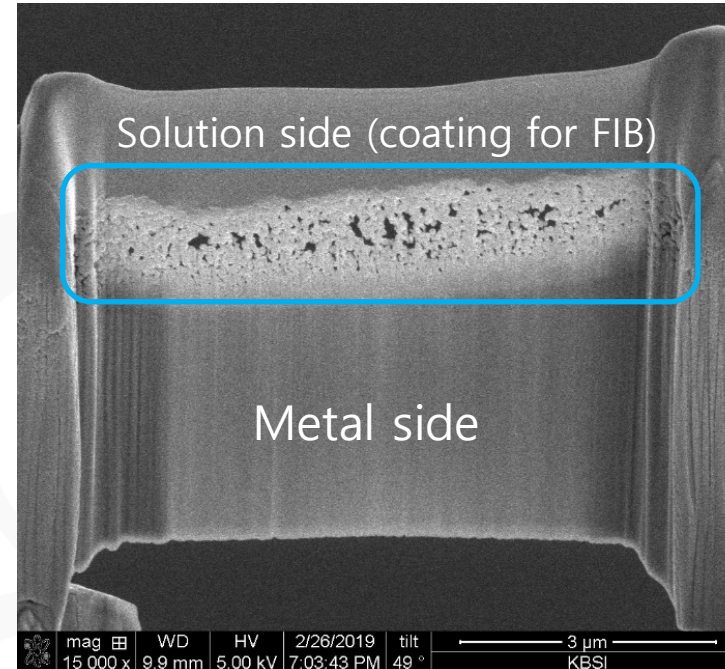
Oxide analysis (TEM)

Oxide thickness 1.3 μm

- Unlike the difference in surface shape of the two kinds of specimens (i.e. straight pipe and rotating coupon), the oxide morphology shows patterns in thickness and porosity similar for both SA106 specimens.

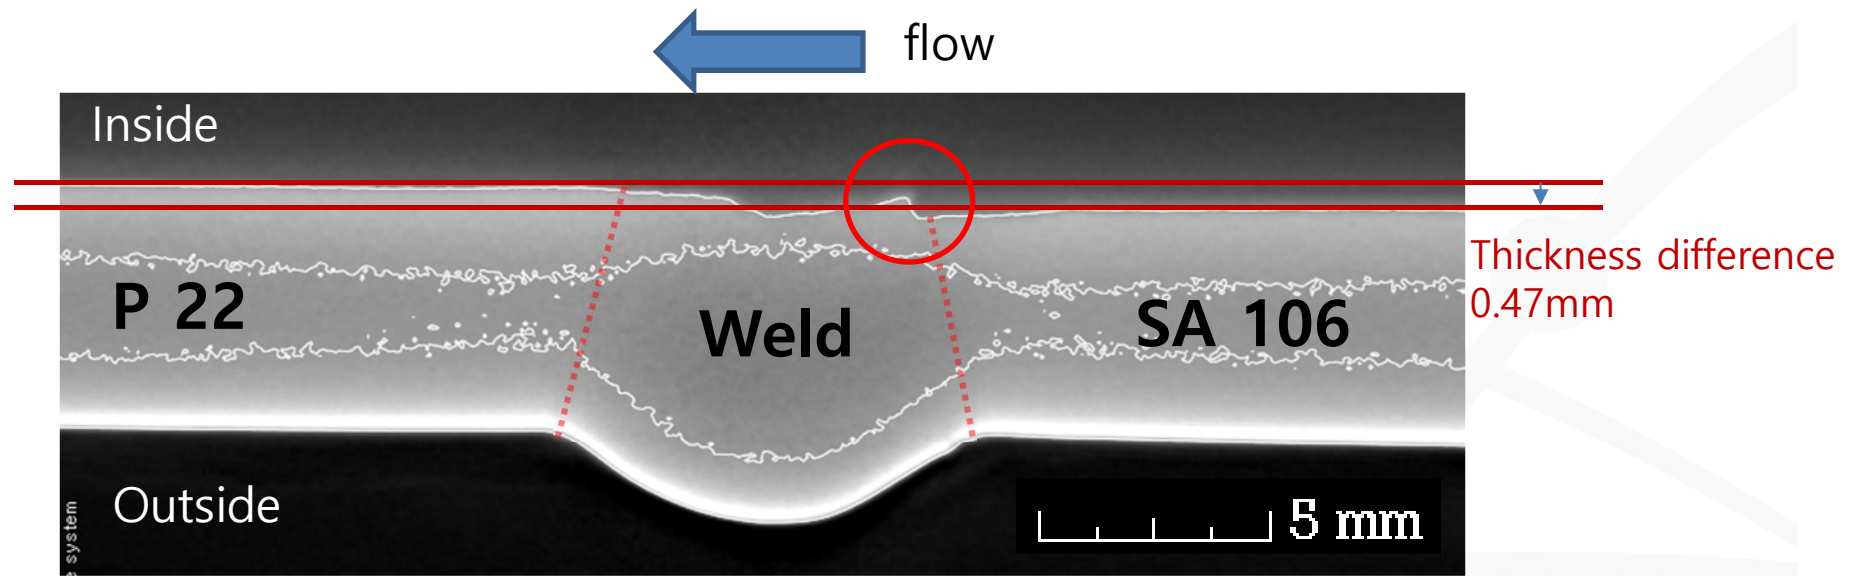
CT image for SA106-SA335 pipe section from low Cr to high Cr

- FAC rate difference between SA106 and SA335
- There is a steel vertical wall at the boundary due to FAC rate difference between SA106 and weld metal (Cr 0.15wt%) and then turbulence produced by barrier layer. This may be potential problem in view of long term maintenance.

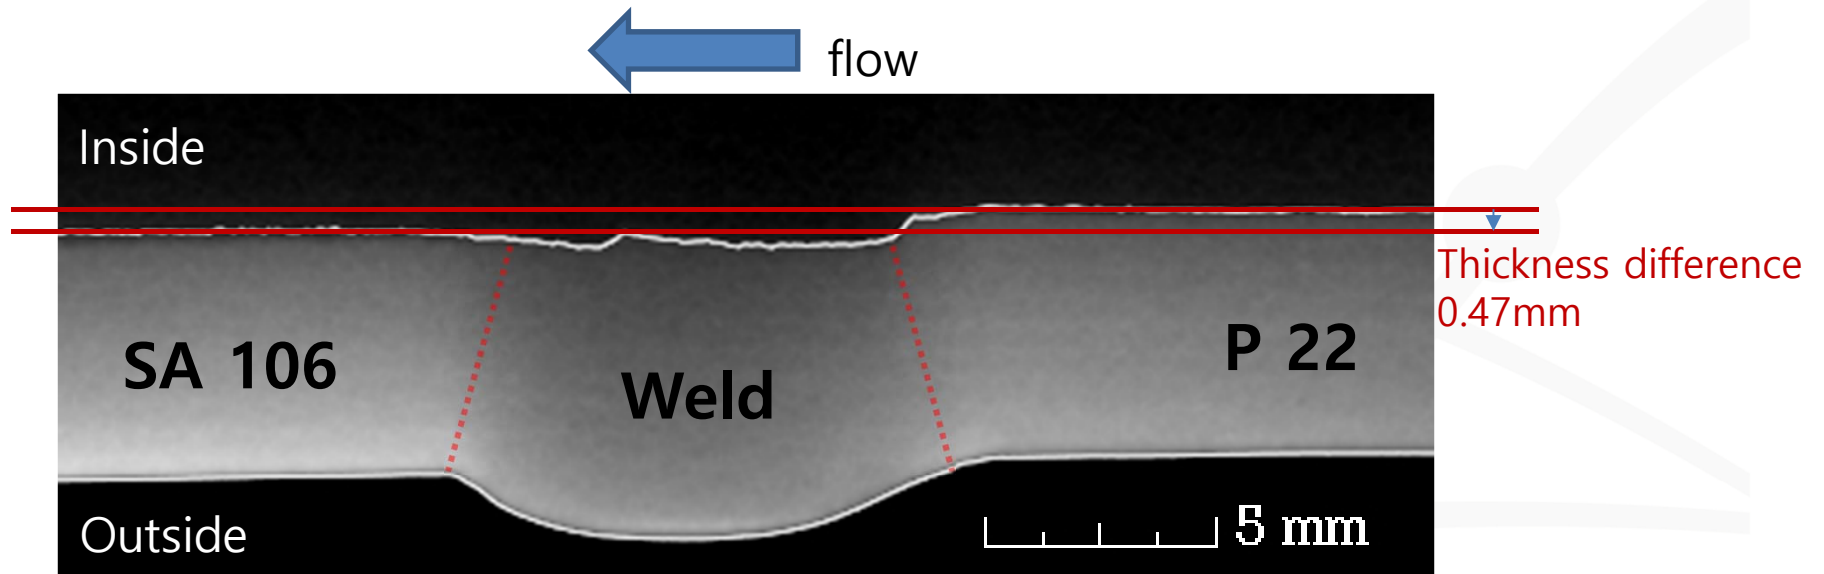
CT image for SA106-SA335 pipe section from high Cr to low Cr

- The susceptible material at the boundary between resistant material and susceptible material is thinned faster due to the concentration gradient of Fe ions in the boundary region.
- Weld metal more susceptible than P22 (SA335), and SA106 more susceptible than weld metal, were thinned more at the boundary.
- However, there was no steep vertical wall that should be considered for FAC management.

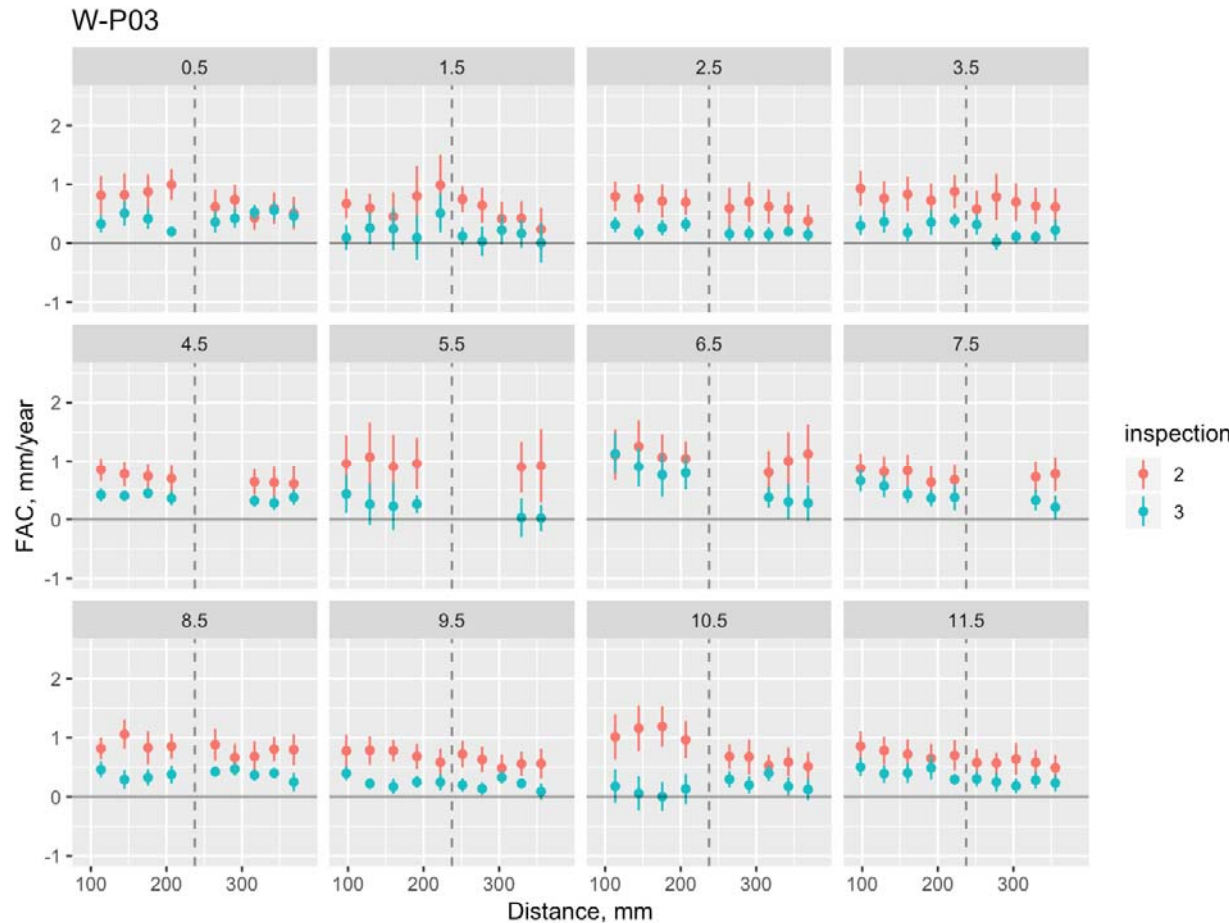
FAC rate (W-P03)

- The FAC rate of Run 2(150°C) is higher than that of Run 3 (130°C). FAC dependency on the temperature is determined by balancing the reaction rate related Fe ion solubility and the mass transfer related to the diffusion of ionic species.
- The FAC rate decreased slightly with the distance and then remained constant after 300 mm (around 6D, where D is the inner diameter of the pipe).
- There appears to be a higher FAC rate at 1.5, 5.5 and 10.5 at the angular positions in the radial direction, indicating that positions near the top and bottom are readily thinned compared to other circumferential positions after the first orifice.

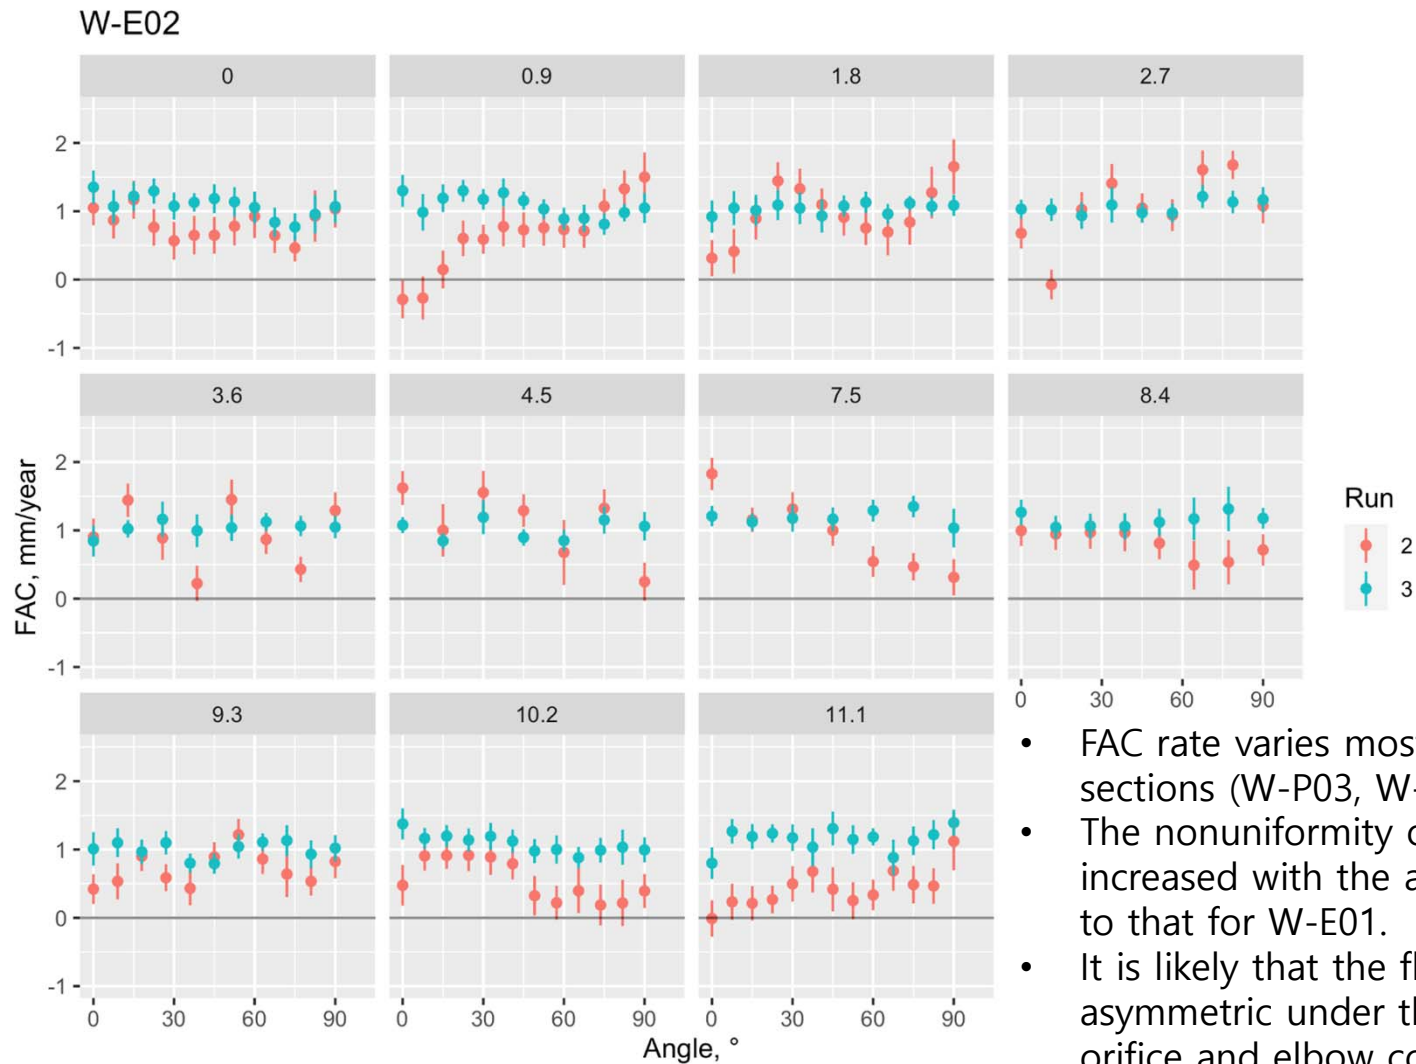
FAC rate (W-E02)

- FAC rate varies most widely among the four sections (W-P03, W-P04, W-E01 and W-E02).
- The nonuniformity of FAC rate for W-E02 increased with the angle (distance) compared to that for W-E01.
- It is likely that the flow became more asymmetric under the combined effect of the orifice and elbow compared to the effect of a single elbow.

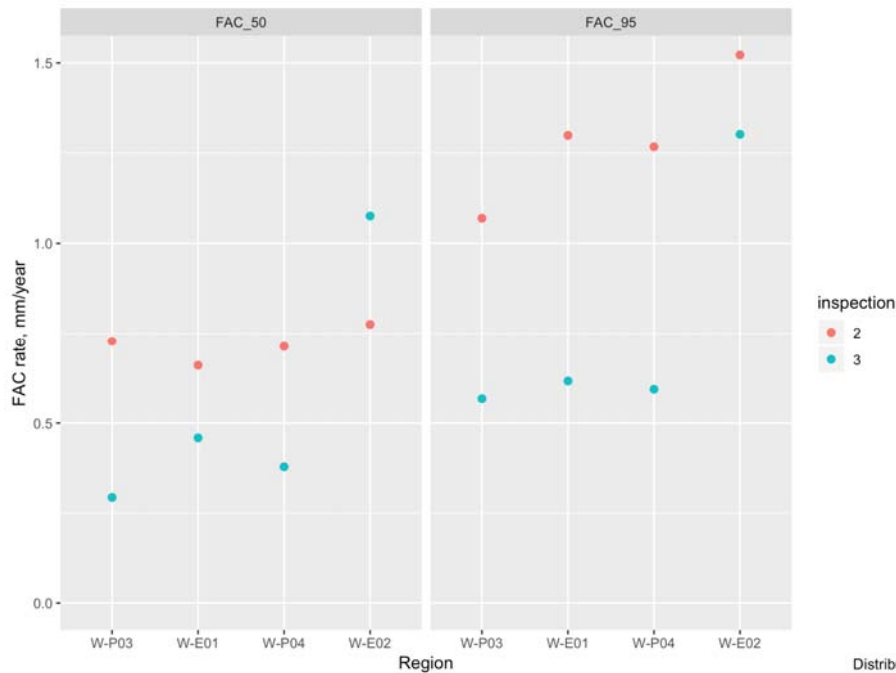
FAC rate variation

- It was found that Run 2 at 150° C and 3 m/s resulted in a wider data band than did Run 3 at 130 ° C and 3 m/s, from comparison of 50th and 95th data percentiles. Higher rate leads wider data band.
- The FAC rate increased in the order W-P03 < W-P04 < W-E01 < W-E02 from the 95th percentile data.
- It is noteworthy that the highest FAC rate was obtained at the elbow following the orifice, indicating that the most complicated flow developed from the combination of conditions at orifice and elbow, compared to those at a single elbow or single orifice.
