Analysis of Ultrasonic Inspection Defects of the High Density U3Si2 Fuel plate

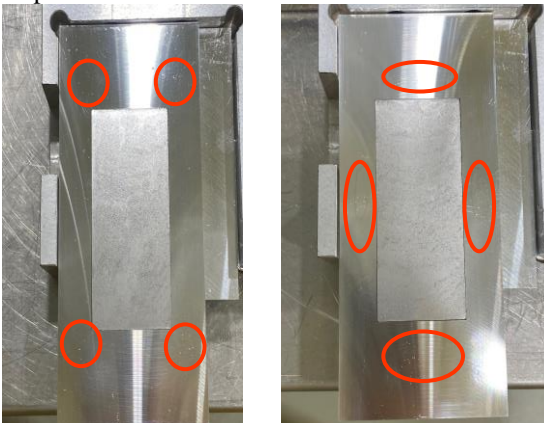
Fig. 1. Foreign bodies injected Al cladding components

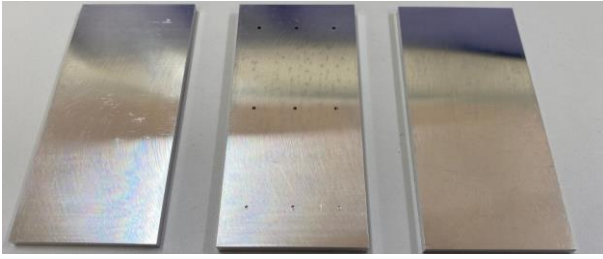
Each fuel plate is annealed at 500°C for longer than 1 hour to check non-bonding of the fuel plate after hot-rolling process. After cooling in air, non-bonded area can be visually confirmed by observing blisters, and any fuel plates containing blisters within the fueled zone of the plate are rejected. Only plates with blisters in the non-fueled area, and of a total area less than 1mm² in the UT inspection can be offered for acceptance by concession. However, some of micro pores which is highly detrimental to the reactor during the irradiation is not visually observed even after high temperature annealing. It is also hard to discriminate between particles and micro pores by the UT inspection. For that reason, KAERI prepared dummy Al fuel plates by the same hot-rolling fabrication method, and made artificial pitting on the components as described in the Table 1. The UT inspection was performed on the micro pores in the dummy plates which were not shown in the visual inspection during blistering test. The diameter of the pitting was 1mm which is acceptance criterion of the UT inspection, and affection of the depth was analyzed.

Fig. 2. Pitted Al components
