2.3 Visual Inspection of KIMQI-FUTURE fuel plates

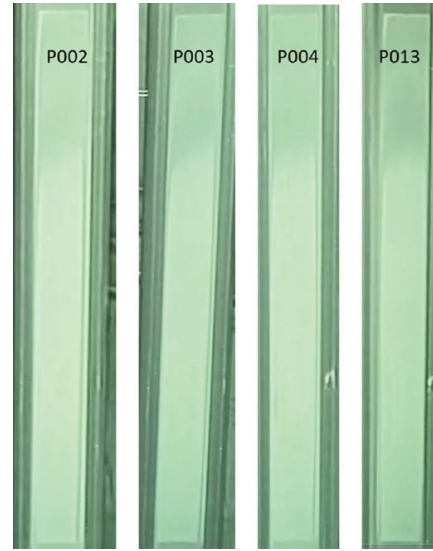
Fig. 4. Visual images of irradiated fuels after 1st Cycle

After the first cycle of irradiation, the surface images of the irradiated fuels were obtained and examined to detect any defects or deformations. In addition, the fuels were extracted from the basket and a wet shipping inspection was performed to detect any fission product released from the fuels. Fig. 4 shows the surface images of the irradiated fuels after the first cycle and its visual inspection results are summarized in Table 4. There were no meaningful defects observed from the images. Only minor shadings were observed in the HHF region except the P013 plate. The wet shipping inspection reported no detectable fission product release as well.

Plate ID	TOP	MID.	HHF	BOT.	Wet shipping inspection
P002	Clean	Clean	Minor Shading	Clean	No fission products detected
P003	Clean	Clean	Minor Shading	Clean	
P004	Clean	Clean	Minor Shading	Clean	
P013	Clean	Clean	Clean	Clean

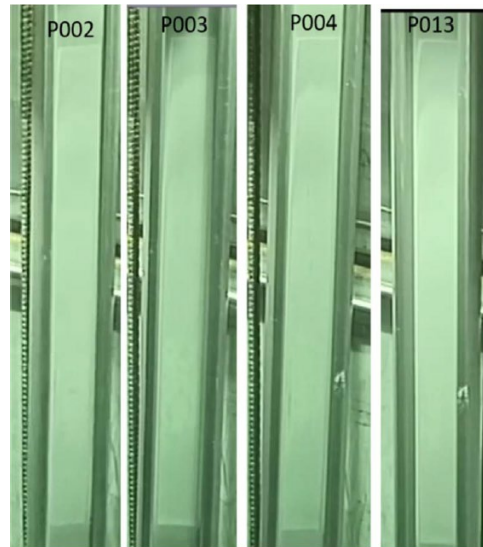
Fig. 5. Visual images of irradiated fuels after 2nd Cycle

In the same manner, the irradiated fuels were examined after the second cycle of irradiation. Fig. 5 shows the surface images of the irradiated fuels after the second cycle and its visual inspection results are summarized in Table 5. All fuels still showed stable behaviors but the P013 plate showed minor shading at the HHF region likewise other plates. However, there were no meaningful observations even after the final irradiation and no fission product release.

Plate ID	TOP	MID.	HHF	BOT.	Wet shipping inspection
P002	Clean	Clean	Minor Shading	Clean	¹³³ Xe 6.8 ¹³¹ I 1.6
P003	Clean	Clean	Minor Shading	Clean	
P004	Clean	Clean	Minor Shading	Clean	
P013	Clean	Clean	Minor Shading	Clean
