Irradiation of Metallic Fuels in BOR-60 Reactor and Non-destructive Post-Irradiation Examinations at 3 at.%

Ju-Seong Kim^a, Cheol Min Lee^a, June-Hyung Kim^a, Bong-Goo Kim^a, Byoung-Oon Lee^a, Chan-Bock Lee^a,
Igor Yu. Zhemkov^b, and Jin-Sik Cheon^a

^aKorea Atomic Energy Research Institute, 989-111 Daedeok-daero, Yuseong-gu, Daejeon 34057, Republic of Korea,

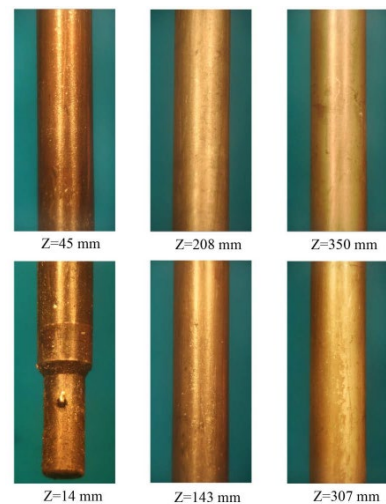
Fig. 2. Fuel rod No.2 appearance after removal of the wrapping wire, orientation 0°.

Visual examination and photographing of irradiated fuel rods were conducted with the use of optical system. The surface of the claddings is mainly reddish brown in the region of fuel slug and brownish outside the fuel slug region. Fig. 2 shows the photos of fuel rod No.2 at 0° in azimuthal orientation. The surface of claddings seems to be in satisfactory condition, and there are no any abnormal things observed.

Profilometry of fuel rods were measured by two inductive transducers (DB-810B). Diameter of the fuel rods were measured at every 1 mm axial increments at four azimuthal orientations (0°, 45°, 90° and 135°). The manufactured tolerance of cladding diameter is ± 0.02 mm. Diameters of fuel rods No.4 and No.6 are within the manufacturing tolerances. However, the diameters of fuel rod No.2 throughout its length are positioned above the upper limit of the tolerances specified in the

KAERI's fuel fabrication report. This phenomenon is shown regardless of cladding temperature, i.e., in the regions of lower part and gas plenum of the fuel rod. Judging from this, the cladding of fuel rod No.2 was likely to be manufactured above the upper limit of diameter tolerances. Claddings of all the fuel rods under examination exhibit ovality (out-of-roundness) that is evidenced by measurements of the diameter in two perpendicular orientations 0°–90° and 45°–135°. Especially, the cladding of fuel rod No. 2 has more pronounced ovality around the upper end of its fuel slug. A metallography on its cross section taken through a subsequent destructive PIE can give more detailed information.

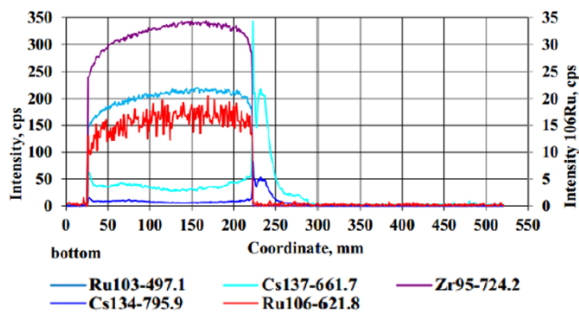
Fig. 3. Gamma ray intensities of fuel rod No. 2 in axial direction

Gamma scanning measurements of fuel rods were performed with the use of semi-automatic gamma scanning equipment with high purity Ge detector. The emitted intensity from isotopes was measured throughout the length of fuel rods using a collimator with a slot 1 mm wide. The intensity was recorded at displacement step of 1 mm. Time of exposure at every point of gamma scanning was 60 seconds. Fig. 3 shows the gamma scanning measurement data of the fuel rod No.2. Gamma ray energies from ^{137}Cs , ^{134}Cs , ^{95}Zr , ^{103}Ru and ^{106}Ru isotopes with energies of 661.7 keV, 795.9 keV, 724.2 keV, 497.1 keV and 621.8 keV, respectively, were recorded during the gamma scanning measurements. Distribution of a non-migrating fission product ^{95}Zr dissolved in uranium crystal lattice generally shows the distribution of power density and fuel burnup over the fuel rod length. No abnormalities in the ^{95}Zr distribution show that there is no mass transfer of the fuel components over the fuel column length. Distribution of ^{103}Ru and ^{106}Ru also shows the distribution of power density and fuel burnup over the fuel rod length, and evidences of no big inclusions of metallic fission products in fuel. There was axial migration of ^{134}Cs and ^{137}Cs from fuel areas into plenum regions as Cs is dissolved in the bond sodium. The majority of migrated cesium isotopes are above the fuel in sodium, and their small amount migrated into the lower area of the fuel slug.

-Intensities of Cs isotopes indicate the Cs migration occurs in liquid state.
