Effect of view port degradation on OES system in VEST

This study investigates the effects of viewport degradation on the Optical Emission Spectroscopy (OES) system within the Versatile Experiment Spherical Torus (VEST), a unique low-aspect ratio tokamak based in Korea. During the process of implementing the Charge Exchange Spectroscopy (CES) system in VEST, we unexpectedly discovered degradation in the viewport, which potentially hampers the accuracy of diagnostic measurements. This degradation, we suspect, could be influenced by boronization, a powerful wall conditioning technique. We conducted an extensive exploration of potential factors such as dust deposition and deposited film that could contribute to viewport degradation. This paper presents a detailed comparison of signals, precise measurements of window transparency, and a discussion on the possible causes. We also propose preventive measures to manage and mitigate this degradation

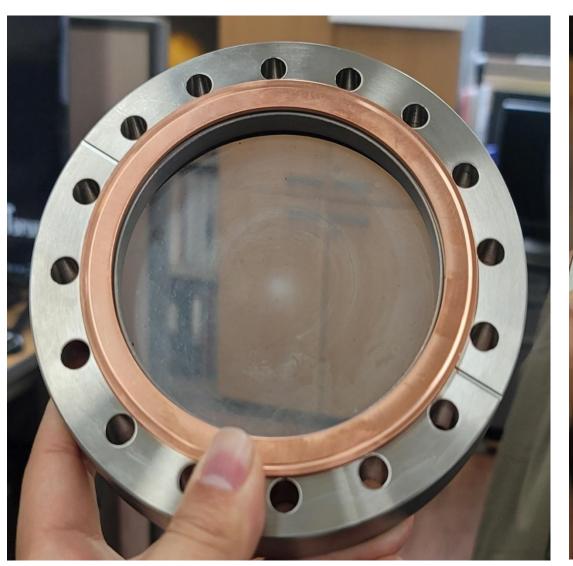
View port covered with dust

- ✓ Dust generated from sputtering of wall material during glow discharge cleaning deposits on the vessel wall and onto the inside surface of view ports too.
- ✓ Moreover, sputtering of the graphite limiters in the VEST plasma will form carbon dust also which makes carbide film on the wall and view port.
- Specifically, condensation of carborane vapor on the glass during boronization can be an important cause of the view port degradation.
- ✓ The carborane vapor flow is not even. as a result, the deposition of a-C:B/H film is also irregularly thick.
- ✓ Carborane flux affects the deposition thickness on view port glasses.

- > Summary
 - ✓ View port degradation occurred in the newly installed VEST CES signal.
 - To check the cause of this, 1) the signal is checked by changing the channel on the CCD, 2) the halogen lamp signal is measured with each fiber, and 3) the halogen lamp signal through the window is measured.
 - Only when the light passing through the window is measured, the signal degradation is confirmed.
 - ✓ Cause of view port degradation
 - Dust deposition
 - **Deposited film** caused by plasma process, boronization, etc.
- > Future Work
 - CES view ports will be replaced. And when not in use, they will be covered to prevent dust.
 - \checkmark To prevent the film, the degradation caused by the film will be periodically monitored by using retro reflector.
 - ✓ The additional quartz window will be adopted by installing it on the inner bottom plate.
