Effect of view port degradation on OES system in VEST

This paper presents an investigation into the effect of viewport degradation on the OES system in VEST. The focus is on the verification process for introducing the CES system, including the configuration of the poloidal CES system installed in VEST, measurement of the window transparency for measuring the VEST CES signal, comparison of signals, identification of factors affecting the window (dust, coating), and discussion on preventive measures and conclusions.

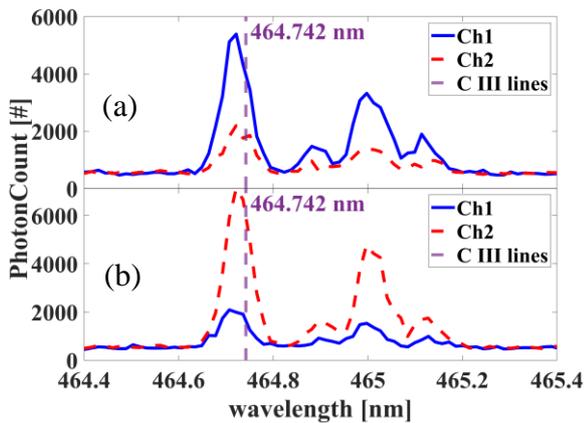
Toroidal symmetry is compared using C III lines in basic Ohmic plasma. Fig. 3-a shows that the signal of C III lines in shot #38633 connected to the 3 o'clock direction (dotted lines) is significantly smaller than the signal connected to channel 1 connected to the 9 o'clock direction. To investigate the issue, the CCD channel is changed and measured, as shown in Fig. 3-b. The same phenomenon occurs.

Fig. 3 (a) Signal of Ohmic discharge for shot #38633
(b) Signal of ohmic discharge for shot #38644

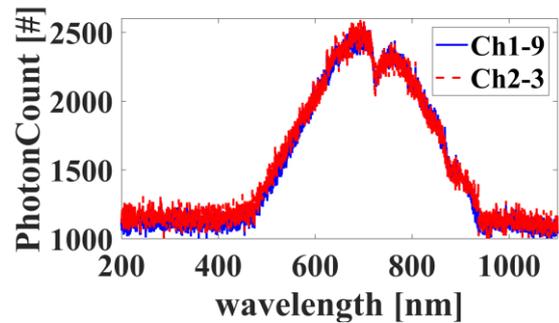
Next, the optical signal is measured by connecting each collecting optics to the same light source (halogen lamp) to check for any abnormalities in the fiber. The

same number of photon counts is observed through each optical fiber.

Fig. 4 Signal of Optics fiber for halogen lamp

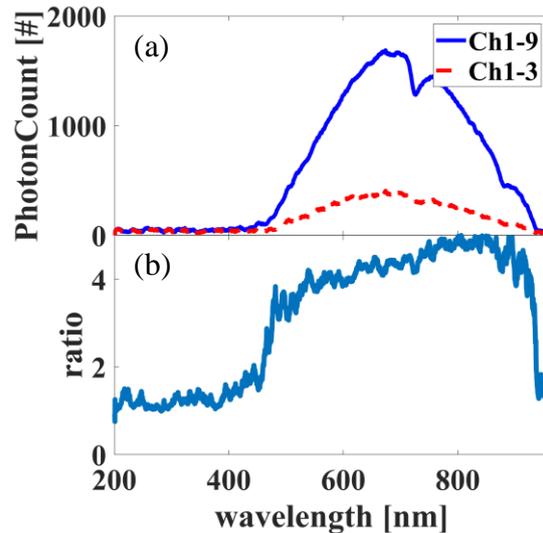
Finally, the signal for the same light source through each window is measured, as shown in Fig. 5. Based on these results, it is confirmed that there is a difference in window transparency. To investigate this more accurately, the signal measured through the halogen lamp-window-collecting lens-optic fiber is compared.

Fig. 5 (a) Signal of each window for halogen lamp
(b) Ratio of signal for 9 o'clock direction window to 3 o'clock direction window.

Specifically, condensation of carborane vapor on the glass during boronization can be an important cause of

the deterioration. The carborane vapor flow is not even. As a result, the deposition of a-C:Br/H film is also irregularly thick. Carborane flux affects the deposition thickness on view port glasses at 3 and 9 o'clock. The window which shows the significant decrease of transparency in Fig. 3-1 has been installed at near the path of strong carborane vapor flow indeed.

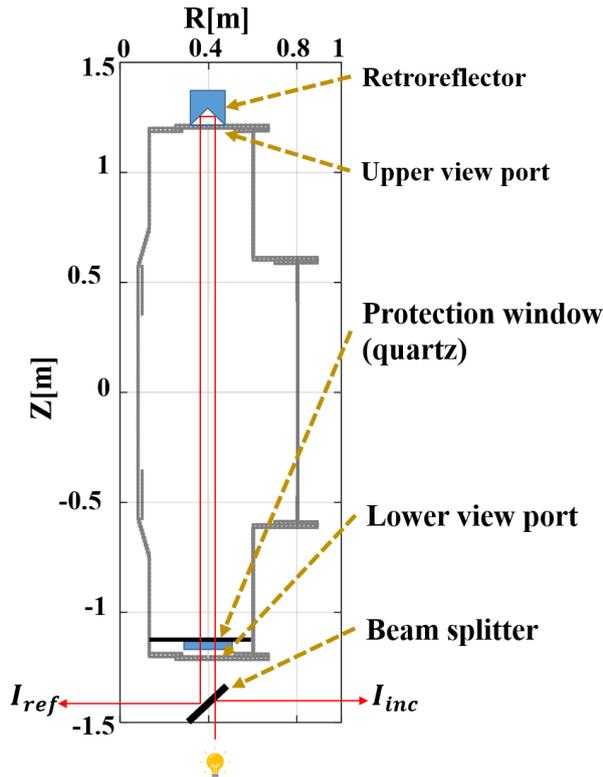
Fig. 6 Light path of the degradation check method using retro reflector.

By covering view ports when not in use, dust deposition on exterior side can be stopped or considerably reduced. A shutter system over window will replace difficult direct access. Deposition of dust generated inside the vessel on the wall and windows, nevertheless, is inevitable and proceeds with discharge. Thus, an alarm is necessary to get the time to replace the window. A transparency probe to check degradation process is useful. Schematic diagram of a trial system is illustrated in Fig. 6. Light from a source is split into two beams on a beam splitter. The reflected beam on the beam splitter enters to a detector to measure incident intensity I_{inc} . The beam passing through the beam splitter proceeds through the view ports and then reflects on the retroreflector which is positioned outside of view port. The back-reflected beam travels through the vessel and passes through the lower view port again. Then, it is reflected on the beam splitter and arrives at a second photodetector which gives the reflect intensity I_{ref} . The

ratio α between the reflect intensity I_{ref} and the incident intensity I_{inc} ,

I_{ref} / I_{inc} tells the progress of transparency degradation i.e., opacity. When all windows are clean, the ratio $\alpha = 1$, while dirty windows will result in the value approaching 0. We can choose an appropriate threshold value which corresponds to permissible opacity limit. Measuring α will alert the moment to change view port glass.

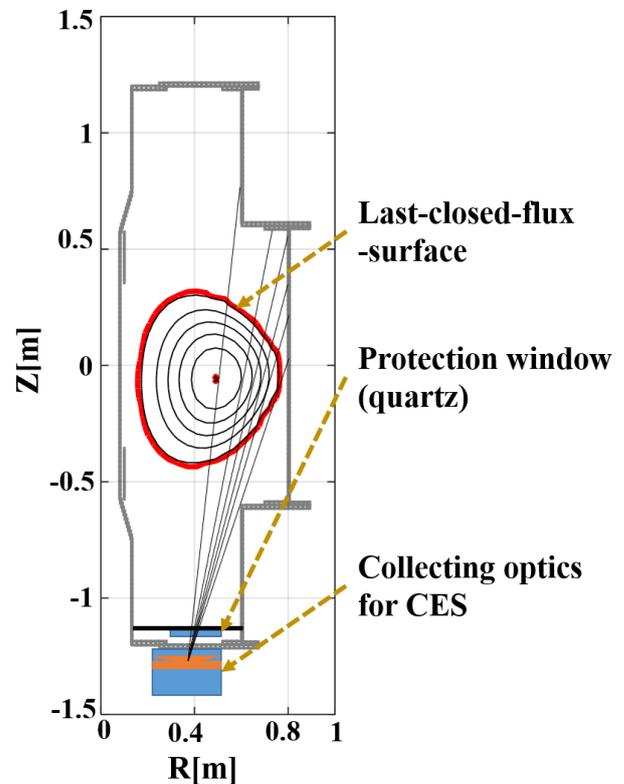
Fig. 7 The location of protection window(quartz)

In the case of the bottom view port of the VEST, it has a very difficult environment to replace, so by configuring a protection quartz window in VEST as shown in the Fig. 7, it is possible to prevent the coating from forming on the bottom view port and make the replacement work much easier because only the quartz on the plate needs to be replaced.
