Result of the Third Visual Inspection of In-pool Components in HANARO

Jin-Won Shin^{a*}, Jung-Hee Lee^a, Hyung-Kyoo Kim^a, Kyung-Su Park^b, Chang-Ho Kim^b

^a Korea Atomic Energy Research Institute, 989-111 Daedeok-daero, Yuseong-gu, Daejeon 305-353, Korea

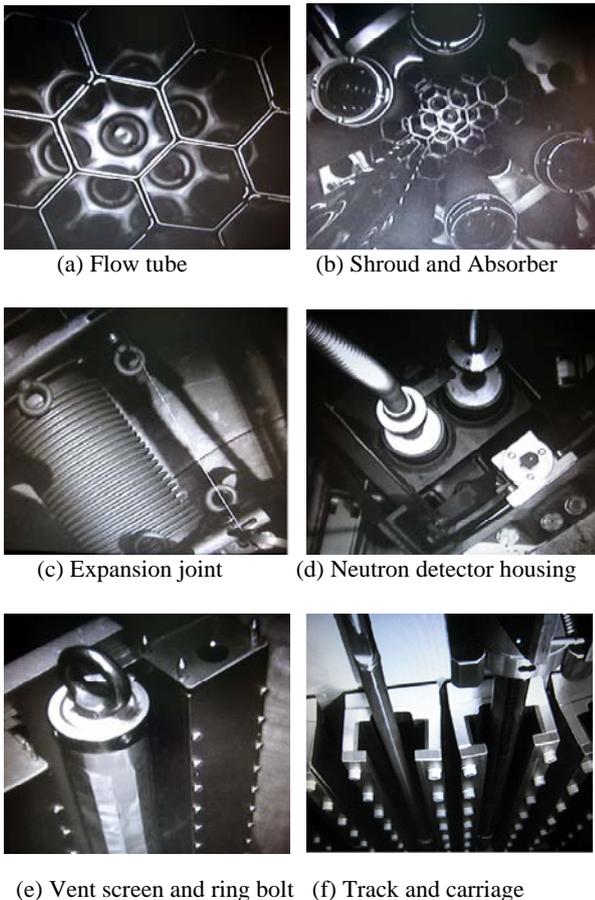
Fig. 3. Pictures of in-pool components examined

There was no defect of the surface and welding joint of reactor structure and beam tubes. It was also found that the locking conditions of the clamping bolts have been kept well. Clearances of hexagonal flow tubes were the same conditions as those of installation stage. The mechanical and structural integrity of shutoff units and control absorber units were also maintained well and no remarkable defect was found. Fig. 3 shows several pictures of examined components such as flow tube, shroud, absorber, expansion joint of beam tube, neutron detector housing, vent screen, ring bolt, track, and carriage.
