VLF Tan Delta Measurement for Used XLPE Power Cables

Woo-Sang Lim, Che-Wung Ha, Kwang-Ho Joo
Nuclear Engineering & Technology Institute, Korea Hydro & Nuclear Power Co., LTD, Korea
*Corresponding author: wslim@khnp.co.kr

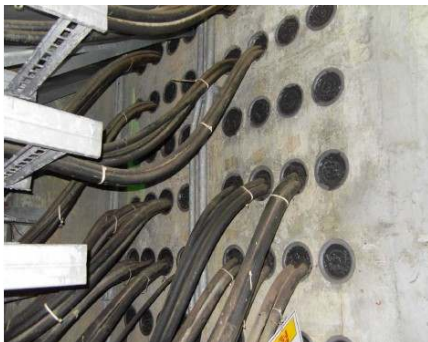
The removed cables comprised 12 lines and approximate 400m totally. They were 5kV rated, 4/0 AWG, and insulation materials were cross-linked polyethylene (XLPE). As shown in Fig. 1, they passed duct banks in a concrete structure located in the turbine building basement to supply 4.16kV of power to four raw service water (RSW) pumps located in a separate building.

Fig. 1. RSW pump cables passing through duct banks before removal

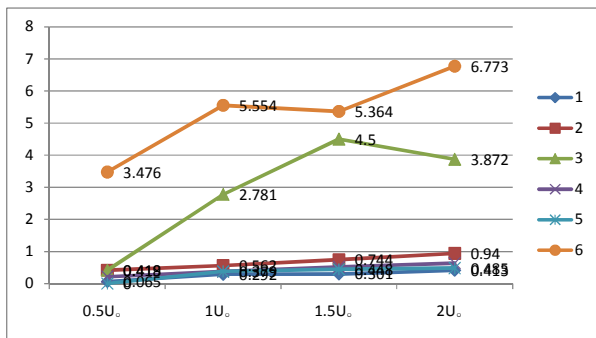
The applied voltages were $0.5U_0$ (U_0 ; phase-to-ground operating voltage in RMS), $1.0U_0$, $1.5U_0$ and $2.0U_0$ as an ordinary way. The resulting measured values of $\tan \delta$ are shown in Fig. 3. With regard to the $\Delta \tan \delta (2U_0 - 1U_0)$, if the state of cable is good, the $\tan \delta$ value should remain stable or increase very slightly as the induced voltage is raised. Specimen 3 and 6 can be assessed to be in a highly degraded condition according to the $\tan \delta$ at $2U_0$, $\Delta \tan \delta$ and drop down curve of $\tan \delta$ values. IEEE Std. 400 as shown in table I was referred for the assessment criteria of XLPE insulation. When the semiconductor layer of specimen no. 6 was shaved off, a hole caused by the conductor wire was found as shown in Fig. 4. The highest $\tan \delta$ and $\Delta \tan \delta$ was caused by this hole, and it might be created by inappropriate treatment during removal or transportation.

Fig. 3. VLF $\tan \delta$ profile with guide ring installed

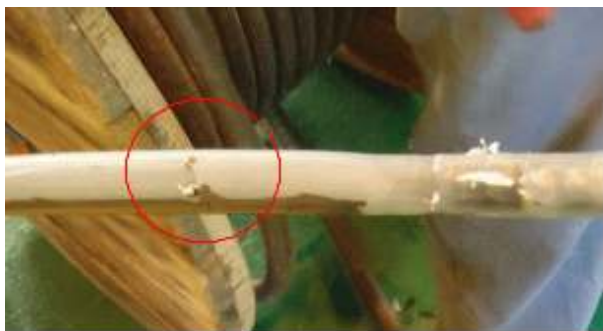
Fig. 4. A hole in cable insulation of specimen no. 6

With the guide ring installed, specimen 3 and 6 had $\tan \delta$ and $\Delta \tan \delta$ values which exceed the limitation based on IEEE Std. 400. Especially specimen no. 6 has a hole on insulation. The defect can decrease the accuracy of $\tan \delta$ and $\Delta \tan \delta$ significantly.

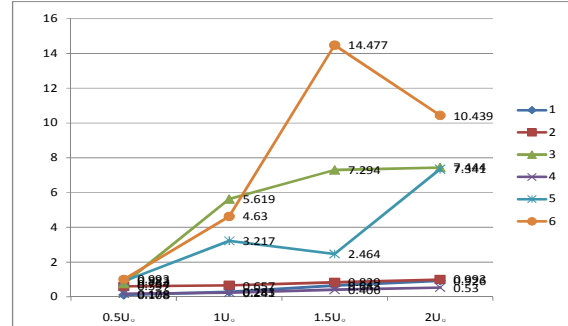
Without the guard ring, measured values of $\tan \delta$ are shown in Fig. 4. Specimen 3, 5 and 6 are in a poor state. This is different with the result of measurement with guide ring installed. It means guard ring affects on the accuracy of $\tan \delta$ measurement severely, and resistive current increases without the guard ring.

Fig.4. VLF $\tan \delta$ profile without guide ring

In order to reduce the impact of leakage current for accurate VLF $\tan \delta$ measurement, guard ring installation is much more useful than cleaning with alcohol of cable insulation surface.
