Comparison of Intergranular Attack Observed in Plant and Laboratory

Do Haeng Hur*, Myung Sik Choi, Jung Ho Han, Deok Hyun Lee
Korea Atomic Energy Research Institute, 150 Deokjin-dong, Yuseong-gu, Daejeon, 305-353, Korea
*Corresponding author: dhhur@kaeri.re.kr

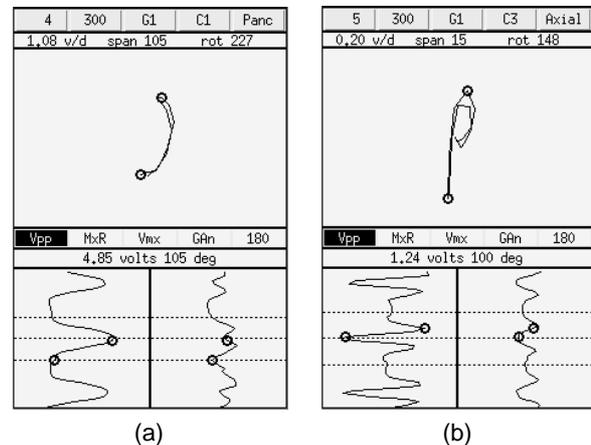
The major different characteristics of the EC signals from a drill hole were first analyzed using a 20% flat bottom hole, simulating a volumetric defect. Fig. 1 shows the impedance plane responses and the corresponding vertical and horizontal components by pancake coil and plus point coil probe. The main discriminating feature was found in the behavior of the vertical component. That is, the vertical component of the pancake coil always indicated a positive direction relative to that of the defect-free region, whereas the signals of the vertical component of the plus coil showed a zigzag pattern.

Fig. 1. Impedance plane responses and the corresponding vertical and horizontal components of a drill hole by (a) pancake coil and (b) plus point coil probe at 300 kHz.

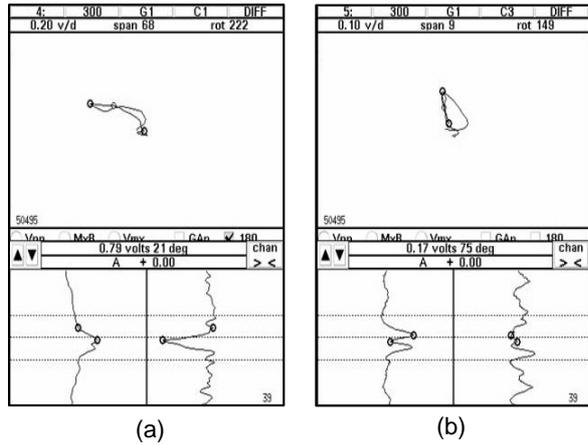
Fig. 2 shows the ECT signals of the laboratory-grown IGA. By comparison with the signals in Fig. 1, this indication showed just a characteristic feature of a drill hole, volumetric defect. From the phase angle of the signal on the impedance plane, this defect was evaluated to be located in the OD side of the tube. The maximum depth of penetration was also estimated to be about 40% of the wall thickness based on the phase angle to flaw depth correlation. It should be noted that ID noise signal was mixed in the Lissajous curve of pancake coil probe.

Fig. 2. Impedance plane responses and the corresponding vertical and horizontal components of a laboratory-grown IGA by (a) pancake coil and (b) plus point coil probe at 300 kHz.

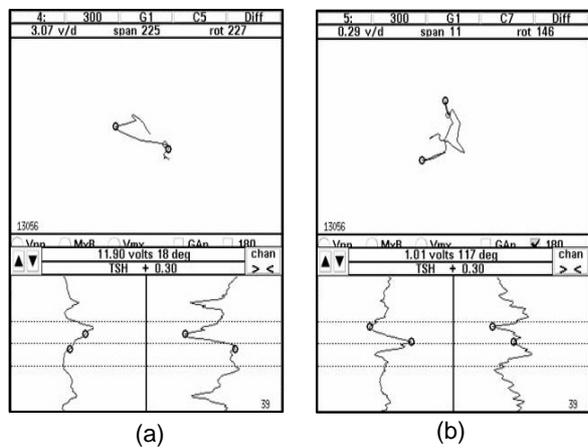
Fig. 3 shows the ECT signals of the IGA occurred in an operating steam generator tube. Although it was weak, the characteristic feature of a volumetric defect was observed in the vertical component of the plus coil signal. The maximum depth of the defect was measured to be 26% of the tube wall thickness by destructive metallographic examination.

Fig. 3. Impedance plane responses and the corresponding vertical and horizontal components of IGA occurred in an operating steam generator by (a) pancake coil and (b) plus point coil probe at 300 kHz.

IGA with a maximum penetration depth of 26% was found within the region of sludge piles in the hot-leg side of the operating steam generator. Its main causes were analyzed as follows;

- The sludge piles around the defective tube formed crevices to concentrate corrosive impurities.
- The grain boundaries of the defective tube were slightly sensitized although they were decorated with chromium carbides.
- The MRI data and relative depletion of chromium in the oxide film suggested that the local environment of the IGA was alkaline.
- Sulfur detected in the deposits could have contributed to the IGA.
- The high operating temperature of the primary side was considered to be another cause of IGA.
