Repair Technology Development and Application of Alloy 600 Vent pipe

Kong Chang Sig*, Lee Seon Ho, Park Kwang Soo, Byun Jin Gwi, Lee Sang Cheol
Doosan Heavy Industries & Construction Co., Advanced Process Development Team
555 Gwigok-dong, Changwon, Gyeongnam, 641-792, Korea
*Corresponding author: Changsig.kong@doosan.com

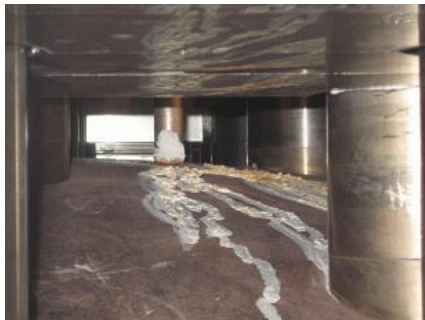
Alloy 600 and weld materials are subjected to primary water stress corrosion cracking (PWSCC) with the increase of the power plant operation period. Therefore, each utility is inspected and repaired to improve the integrity of Alloy 600. Alloy 600 is located at the CEDM nozzle, omega seal and vent pipe in upper closure head and these locations are known to have many damages in the reactor. In 2009, the boron deposit is detected for the first time during the refueling outage at the vent pipe on the surface of the upper closure head in Yongkwang unit 3 as shown in figure 1.

Fig. 1 The boron deposit on the closure head

This paper shall introduce the repair process developed and experience applied to Alloy 600 vent pipe in Yongkwang unit 3.

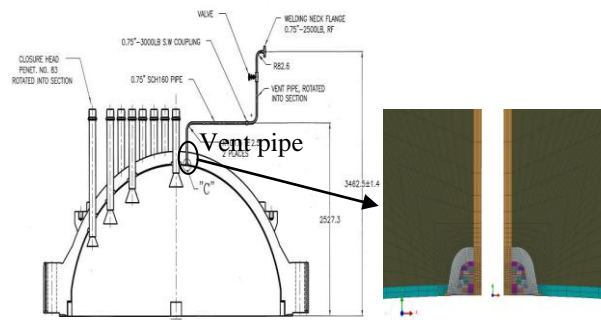
Fig. 2 Vent pipe drawing

Vent pipe is installed to J-Groove welding in the center of No.3 and No.4 CRDM nozzles in closure head and has a function to drain the air in the reactor. The orifice is installed inside the vent pipe to control the flow rate. The vent pipe in closure head is shown in figure 2.

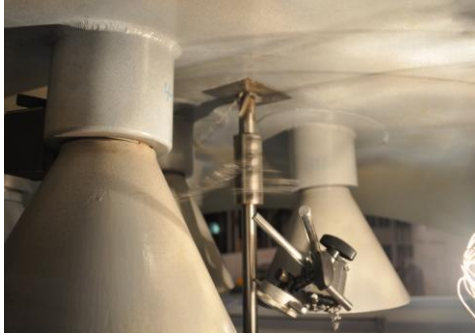
Fig. 3 The machine scene of vent pipe

The machining is an important process for analyzing damages and for an accurate repair. If the defects exist in vent pipe and weld region, the volume of the defects needs to demount to analyze the cause of defect by boat sampling method. The machining processes consist of the removal of vent pipe and the J-Groove machining. The detail processes of machining are as follow. Firstly, the vent pipe is machined in order to separate the vent pipe from weld region and cut the coupling region of the pipe and then the vent pipe is removed from outer closure head. Secondly, the J-Groove region is machined to the same shape and dimension as the origin of J-Groove. The machining scene of vent pipe is shown in figure 3.

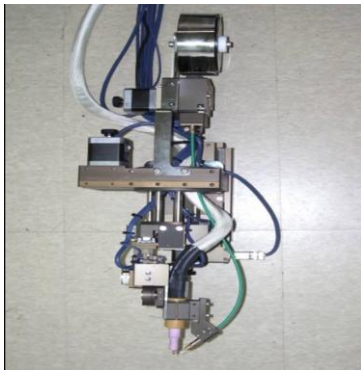
Fig. 4 Welding head

The welding of Alloy 690 vent pipe consists of two steps. The first step is to insert Alloy 690 vent pipe in the hole inside the head. The next step is to weld the J-Groove using Alloy 52M filler metal which has a high PWSCC resistance. In the case of Alloy 690 vent pipe and Alloy 600 weld, the repair welding process includes machining the original Alloy 600 weld surface and welding two layers on the Alloy 600 weld surface using Alloy 52M filler metal. The requirement of Cr concentration in repaired weld of the Alloy 52M must be above 24% so that the welding condition could reach the required satisfaction. The welding head is shown in figure 4.

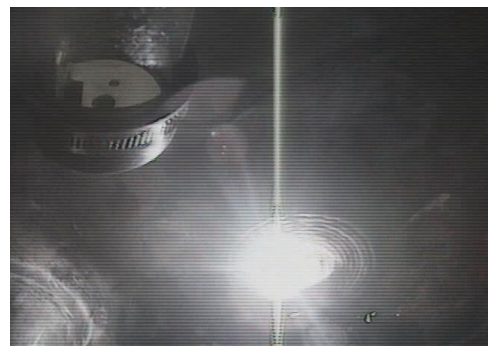
Fig. 5 The welding scene of vent pipe

Doosan had repaired successfully to replace Alloy 600 with Alloy 690 vent pipe. The repair process consists of the removal of origin Alloy 600 vent pipe, J-Groove machining, repair welding, and inspection. The welding scenes are shown in figure 5.
