Visual Inspection of the Flow Distribution Plates of Ulchin NPP #3 SG

Woo-tae Jeong^{a*}, Seok-tae Kim^a, Seok-chul Kang^b, Young-kug Kim^b

^aKorea Electric Power Research Institute, Nuclear Power Lab., 103-16 Munji-dong, Yusung-gu, Daejeon, Korea 305-380

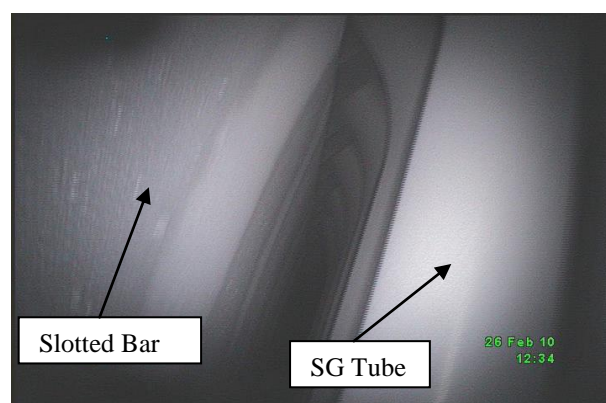
Fig.3 SG tubes and Slotted Bar

Figure 3 shows the tubes and the slotted bar of Ulchin NPP #3 SG which was taken when an operator inserted the video probe through the gap between the slotted bar and the SG tubes. The surface of the slot bar and the tubes were covered with black sludge powder. Therefore, when the lens of the video probe contacted

the surface of the slot bar or the tubes, we often had difficulty in getting bright image. We found that the black sludge power on the surface of the lens of the video probe prevented light from emitting.

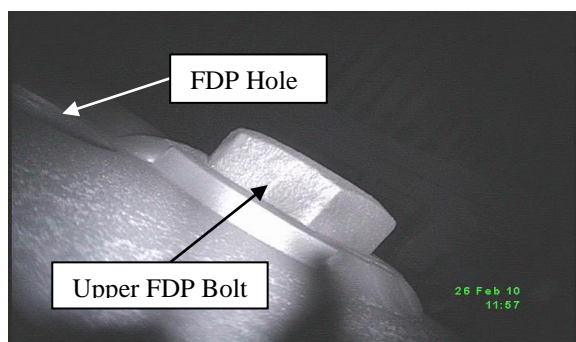
When the tip of the video probe reached the FDP, we could see the FDP bolts as shown in figure 4. Figure 4 was taken when we approached a FDP bolt. As we see in the picture, we could easily identify that the bolt, hex head cap screw, was in good condition. We could not find any defect or loss of the FDP bolts.

Fig.4 Upper FDP bolt

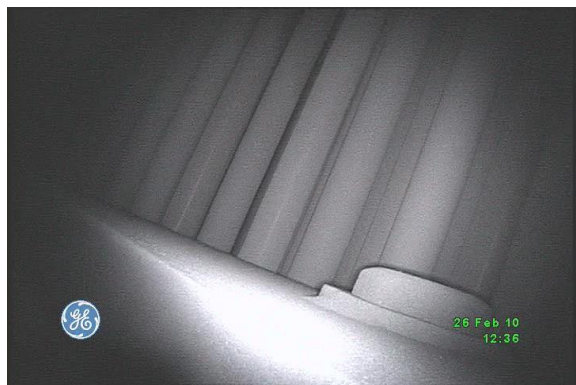
However, we could not approach several FDP bolts located at the outer edge. Figure 5 is a picture of the FDP bolt located at the outer edge. In this case, we could confirm that the bolt exists and has no defect in washer.

Fig.5 Upper FDP bolt at the Edge

From the image of figure 5, we suggest to fill water in SG to remove blurring effect caused by moisture and dust after inserting the video probe through the upper FDP hole. Secondary coolant water is so clean that clear and sharp image having no blurring effect may be obtained. However, it should be tested whether the probe floats or not in water. If the probe does not float, water may be filled before inserting the video probe through the upper FDP hole.

We could enlarge the bolt image of figure 5 by making the video probe to approach to the bolt. In this case, experiments should be made to confirm that the probe may be retrieved without any problem. By replacing of the video probe lens with narrow view angle, we also could have larger image.

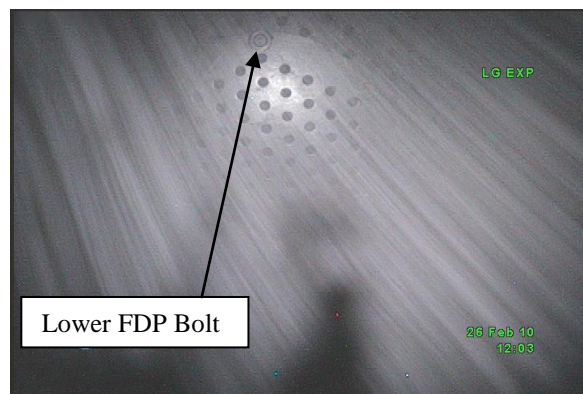
We inserted the tip of the video probe through the FDP hole to see the lower FDP bolts. When we insert the video probe tip, it was so dark that capturing a bright image of the FDP bolts was not easy. Therefore, we changed setup of the video probe system to long exposure mode and took image of the bolts as shown in figure 6. However, flow of moisture and dust prevented us from acquiring bright and clear image. Only several lower FDP bolts could be observed because of the distance of 1,008mm between the two FDPs.

Fig.6 Lower FDP bolt
