A Study on Performance Evaluation of Safety-Related Protective Coating for Yonggwang Unit 1&2

^a Sung-Young Kim, ^a Young-Bum Kim, ^b Won-Sang Lee

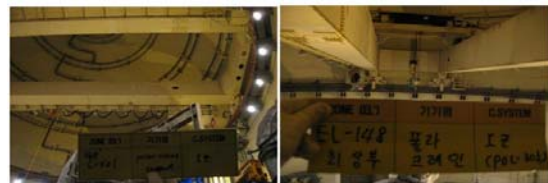
Figure 2. Polar Crane located at Upper Side of Containment Building of Yonggwang Unit 1&2

It was impossible to measure the size of polar crane because it was located at inaccessible area due to its structure, so its surface area was calculated reflecting the information from FSAR and drawing. Also, as shown in Figure 2, we took its picture and measured coating thickness directly. Measured values were 174, 182, 188, 192, and 77 μm (162.6 μm Average). It was coated with Penoline paint and the coating of polar crane inside containment building was identified as qualified coating. Its details are described in FSAR Table 6.2-30 of Yonggwang Unit 1&2

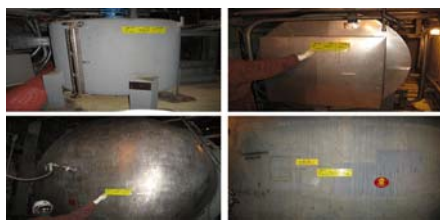
Figure 4. Tanks inside Containment Building

Various kinds of storage tanks (Figure 4) are located inside containment building and they are used for different purpose. Accumulator tank, Pressurizer relief tank, and RCP oil tank are typical examples of the tanks. The coating system consisted of inorganic zinc + epoxy and it was in good status. The coating thickness of accumulator was measured to average 500 μm (498, 502, 505, 492, 503 μm).
