# Causes of PWSCC in a Alloy 600 Nozzle of a PWR

Seong Sik Hwang, Yun Soo Lim, Jangyul Park, and Hong Pyo Kim Nuclear Materials Research Division, Korea Atomic Energy Research Institute, 1045 Daedeog-daero, Yuseong-gu, Daejeon, 305-353, sshwang@kaeri.re.kr

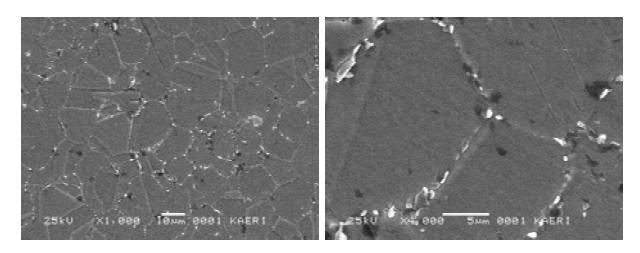
Solution treatment temperature of 980 oC is considered to be a little too low to dissolve all the carbides in the nozzle material with 0.04% carbon. Grain boundary carbides were relatively well developed in the material as shown in Fig. 3. A Cr-depletion was not observed near the grain boundaries. From the

Intergranular carbides are well developed Fig. 3 Microstructure of the analyzed alloy 600 nozzle

observed SCC resistant microstructure [1,2], it was considered that the material itself was not the cause of the cracking. Rather, the weld residual stress could be the main cause of the PWSCC of the alloy 600 nozzle.

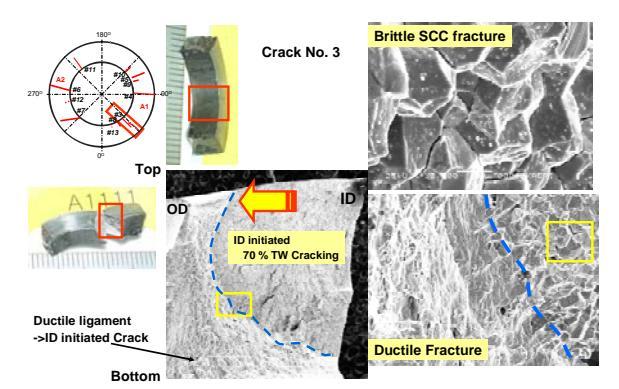
A typical morphology of the cracks is shown in Fig. 4. The cracks were developed from the inside of the pipe wall and propagated outward. Intergranular nature of the cracks suggests that the nozzle was attacked by a PWSCC.

Fig. 4 Feature of cracks developed on the nozzle

It was found that two cracks out of twelve had fully penetrated the pipe wall, and the maximum length was 7.2 mm. Because the upper part of the nozzle was ground out during the pulling process, the longest crack length could be longer than the measured value by the destructive examination.

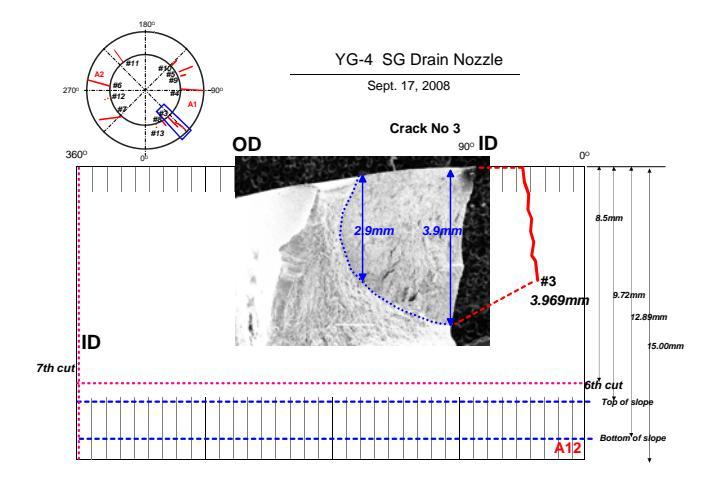
Fig. 5 represents a schematic of the crack locations. The cracks were observed in the alloy 600 base material, not on the weld metals, and distributed near the bottom of the J weld. This suggests that a high tensile stress in the region caused the PWSCC of the nozzle.

There was no indication of a crack initiated at the OD (outer diameter).

Fig. 5 Location and depth of the no. 3 crack
