원전 1차측 환경에서 표면산화 특성이 니켈기 합금의 균열개시 저항성에 미치는 영향

(Influence of surface oxidation on the resistance to crack initiation
of Ni-base alloys in PWR primary water)

Yun Soo Lim*, Sung Woo Kim, Dong Jin Kim, Seong Sik Hwang, Hong Pyo Kim,
Min Jae Choi, Sung Hwan Cho, Jong Yeon Lee

Safe Materials Technology Development Division
Korea Atomic Energy Research Institute

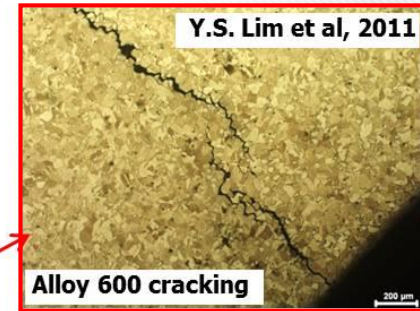
Cracking issues in PWR primary water

- Frequent cracking damage occurs in the RPVH penetration nozzles and SG tubes.
- PWSCC was found to be the main failure mechanism.
- Alloys 600 and Alloy 182 are very susceptible to PWSCC.
- Alloy 600: Ni-16Cr-7Fe (wt%), Alloy 690: Ni-30Cr-9Fe (wt%)
- Alloys 690 and 152 are much higher resistant to PWSCC than Alloys 600 and 182.
- The surface oxidation behavior of Alloy 690 can be quite different from that of Alloy 600 because of the different Cr concentration.

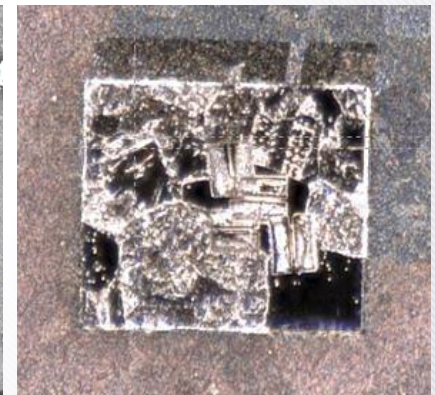
Maximum force : 10 mN

Maximum displacement : 5 μm

in-situ nano-indentation testing of Alloy 600 and 690 after oxidation test

Fracture test of the grain boundaries below the internal oxidation layers of Alloys 600 and 690

The fracture strength of an oxidized GB decreased to 200 - 300 MPa with a brittle manner, from above 900 MPa for the alloy with a non-oxidized GB.
