Preliminary Tests of a Creep-fatigue Crack Initiation and Growth for a G91 Tubular Specimen with a Defect

Jong-Bum Kim, Chang-Gyu Park, Hyeong-Yeon Lee, Jae-Han Lee

Korea Atomic Energy Research Institute, 150 Dukjindong, Yuseong, Deajeon, 305-353, Korea, jbkim@kaeri.re.kr

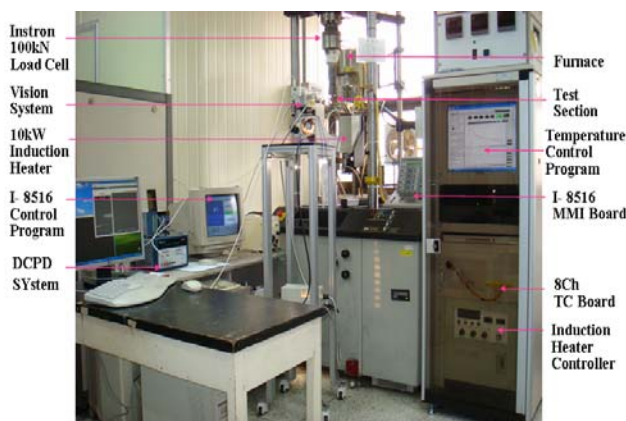
A creep-fatigue crack initiation and growth test facility was installed as shown in Fig. 1. It is composed of three sections; i.e., (1) 100kN hydraulic actuator system, (2) 10kW induction heating and cooling system, and (3) measurement system.

Fig. 1 A creep-fatigue crack test facility

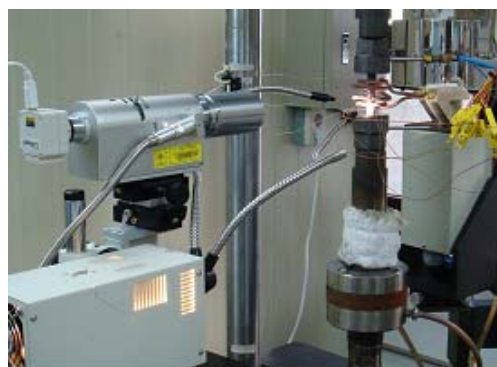
Five channels of K-type thermocouples were spot welded along the center region of a specimen to acquire and control the temperature of the test specimen as shown in Fig. 3. A through-wall defect was prepared by an electric discharge machining along the circumferential direction to obtain a crack initiation and growth development ahead of a defect front. Its width and length are 0.18mm and 3mm, respectively, and the corner radius is 0.1mm.

Fig. 3 Measurement system arrangement

Long working distance zoom microscope system with a maximum magnification ratio of 325 times at a distance of 285 mm was used to monitor the crack initiation and growth behavior ahead of a defect front as shown in Fig. 3. And a DCPD (Direct Current Potential Drop) measurement system was installed to measure a voltage drop across the defect as a crack grows. The capacity of a power supply is 5A and a nonresistance nickel wire was spot welded across a defect of a specimen to measure a voltage drop. High temperature extensometer, whose gage length is 12.5mm, was installed by a ceramic cord to measure the strain changes.
