Fig. 1 Leak and burst testing system of KAERI

Table 1 Information of the leak and burst test on EDM notched tubes

Table 2 Summary of the leak and burst test on mechanical flawed SG tubes

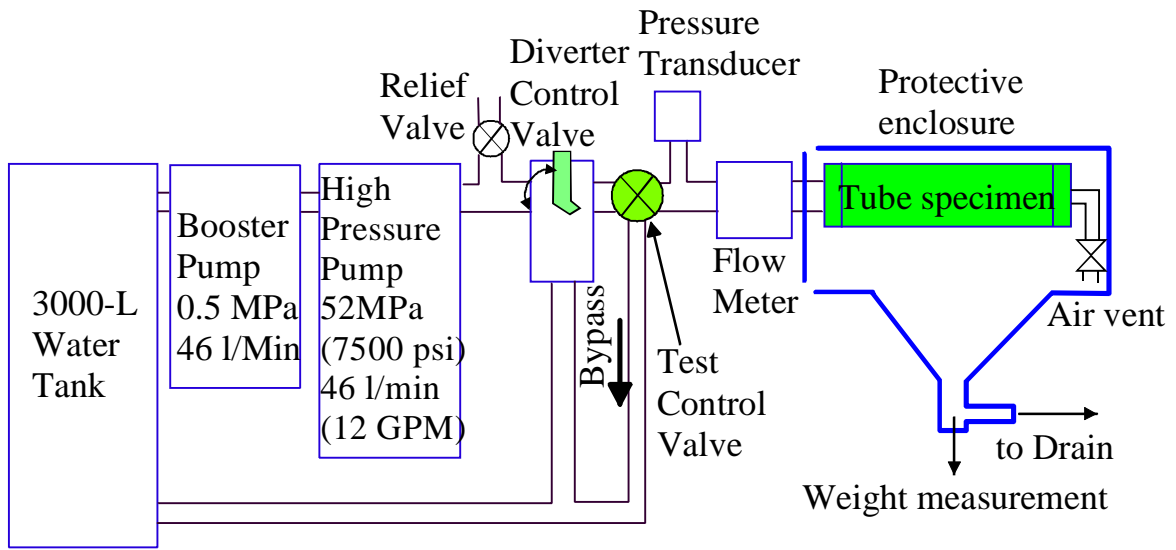
A. System:

- Room temperature operating
- Fluid : water
- Pressure rating: 51.7 MPa (7500 psi)
- Flow capacity: 45.6 liter/min.(12 GPM)

B. Units:

- Suction Tank : 3013 liter(793 gallon)
- High pressure pump unit
- Test module & Protective enclosure
- System programmer (Data acquisition)
- Control panel : Diverter valve(3 way)  
Control valve  
Pressure indicator(2 ea), and Flow rate indicator

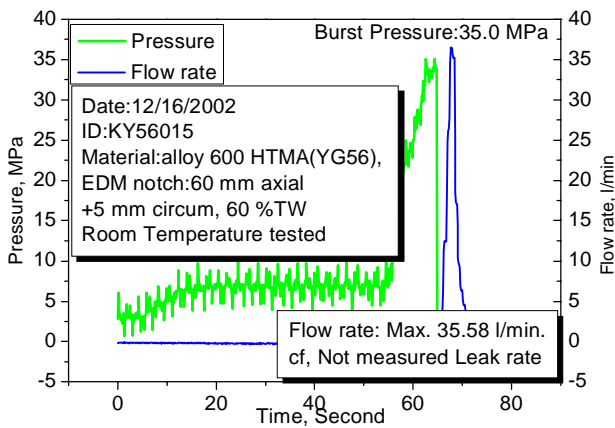
Fig. 4 /

(60 mm axial x 5 mm circum., 60 %TW)

33 MPa

Fig. 4 60 %

60mm

5 mm

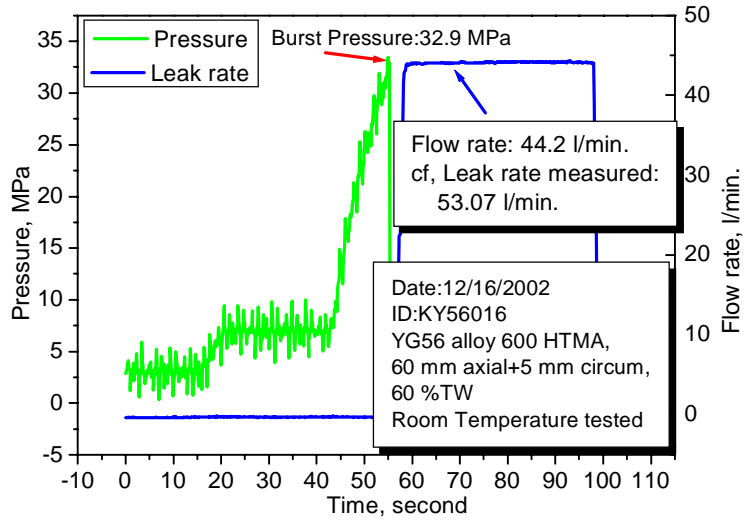
Fig. 5 (60 mm axial x 5 mm circum x 60 %TW)

Fig. 5  
53 l/min

44.2 l/min

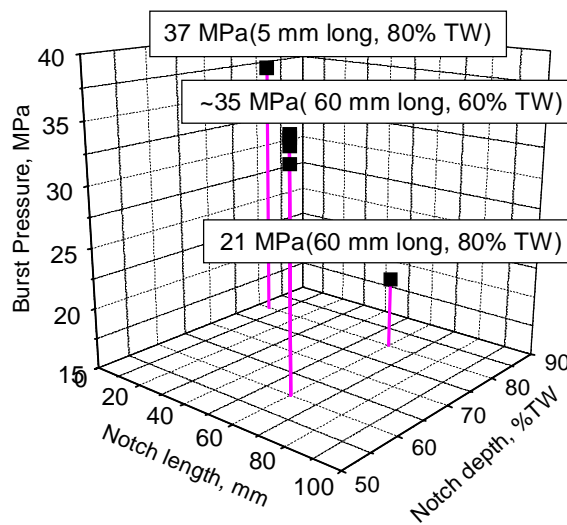
Fig. 6 Relationship among notch length, notch depth, and burst pressure

35 MPa 가 80% 가 80% 21 MPa  
 MPa 가 가 5 mm 37  
 가 가

Table 2 Fig. 6

60% 60 mm
