Assessment of Durability Soundness Domestic 48Y Type UF₆ Cylinder

Yun D Choi*, Woon H Cho, Kyu I Lee, Seung K Park, Jei K Moon,
Korea Atomic Energy Research Institute, 1045 Daeduk-daero, Yuseong-gu, Daejeon 305-353, Korea
*Corresponding author: ydchoi1@kaeri.re.kr

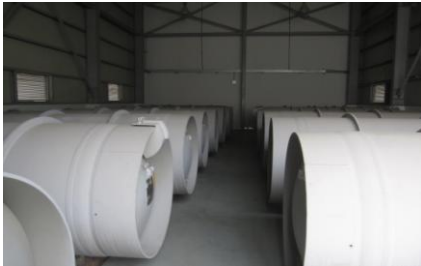
Currently, domestic DUF_6 cylinders are stored in a warehouse preventing exposure to rain. Figure 1 shows the 48Y cylinders stored.

Fig. 1. 48Y cylinder stored status.

The cylinders lie in two lines on a concrete floor. The surface of the cylinders has been coated with paint every 5 years.
