A Newly Developed Technique of Wireless Remote Controlled Visual Inspection System for Neutron Guides of Cold Neutron Research Facilities at HANARO

Hyung Huh*, Yeong Garp Cho, Jong In Kim

Korea Atomic Energy Research Institute, Research Reactor Design & Engineering Div.
10450 Deodeok-daero, Yuseong-gu, Daejeon, 305-353, Korea

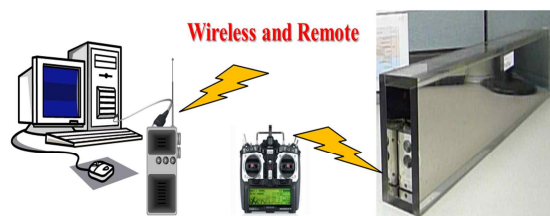
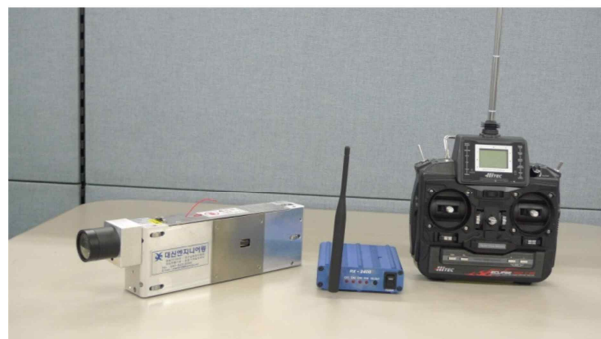
Fig. 2. A detailed view of the neutron guide visual inspection system.

A neutron guide visual inspection system consists of a wireless video transmitter-receiver using infrared camera, and a wireless remote controller for vehicle moving in the guide.

Video Receiver & Monitor Vehicle Controller Vehicle inside the guide

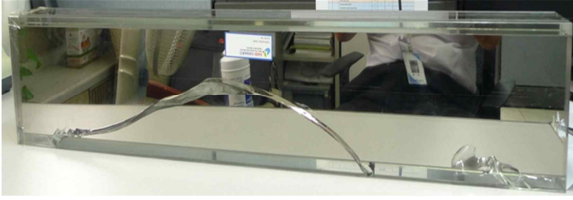
Fig. 3. The dimension of NG specimen.

A neutron guide specimen is 80 mm wide, 180 mm high and 935 mm long. There are several artificial flaws in the specimen, such as Ni-coating exfoliations and crack-like defect as shown in Fig. 3.

Thickness = 15mm

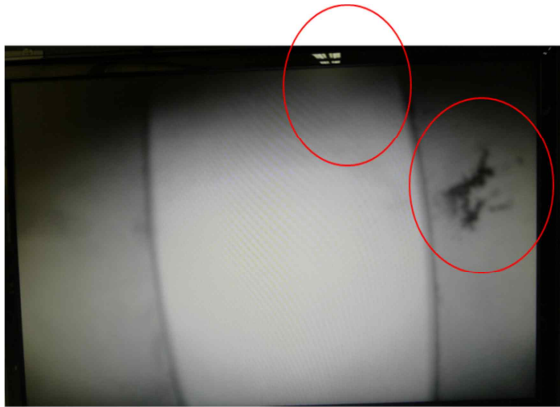
A neutron guide visual inspection system has managed to capture Ni-coating exfoliations and crack-like defects of the NG specimen as shown in Fig. 4 and Fig. 5.

Fig. 4. A wide angle shot of NG Ni-coating exfoliations which are detected from NG visual inspection system.
