Case Study on Large Component Removal in Decommissioning of Commercial NPPs in USA

Seong-Cheol Lee^{a*}, Chang-Lak Kim^a

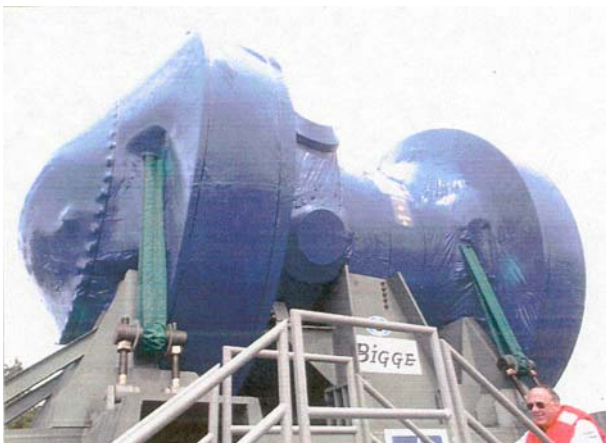
Fig. 4. Reactor Package, Trojan.

One of the important issues on decommissioning of NPP facilities is dismantling of reactor vessel which is one of the most radioactive components in NPP facilities. The procedures to remove a reactor vessel can be divided into two methods; 1) reactor vessel and internals are separated before removing, and 2) reactor vessel including internals is removed together without segmentation and separation. In the case of the first option, after separation of internals from a reactor vessel, reactor vessel can be removed after segmentation or can be removed as one piece without segmentation. The second option has been chosen for decommissioning of Trojan NPP while the first option has been chosen for the other four NPPs.

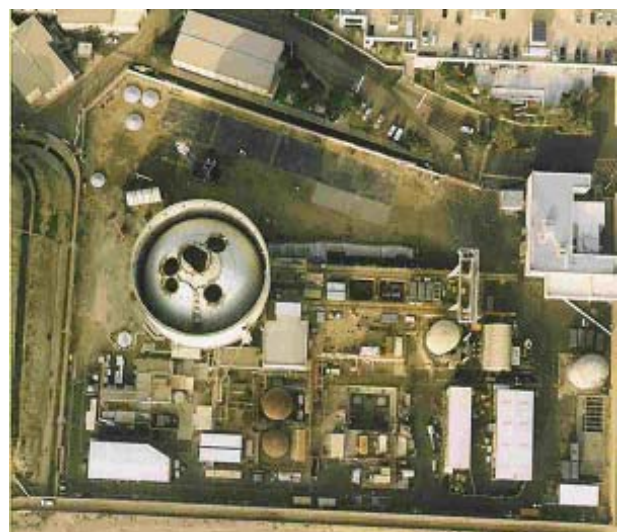
Fig. 6. Aerial View of Containment Sphere, San Onofre.

components. The reactor containment building consisted of two-layers of structures; the containment sphere made of steel and the Doghouse constructed of reinforced concrete. Therefore, it was decided that openings should be cut into the top of the containment sphere directly above each of the large components, after removing the entire roof of the Doghouse. Then, the steam generators and the pressurizer can be lifted and removed by a Lampson Transi-lift LT1200 crane approached to the containment building.

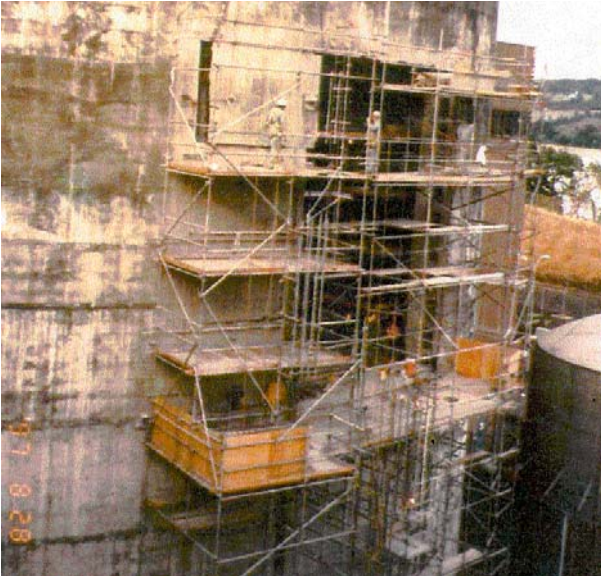
Fig. 7. Opening into Containment, Trojan.

In Trojan NPP, it was decided to dismantle the reactor vessel and internals together without segmentation, so an opening big enough to pass the reactor had to be prepared. Since the reactor containment building was unbonded post-tensioned, detensioning had been completed for all of the tendons. After detensioning and removal of the all tendons, concrete and reinforcement bars were cut in order to make an opening at the containment building wall in the path of the reactor vessel being removed.
