Thermal Embrittlement of Reactor Pressure Vessel Steel due to Aging

SungSoo Kim and Duck-Gun Park
Korea Atomic Energy Research Institute,

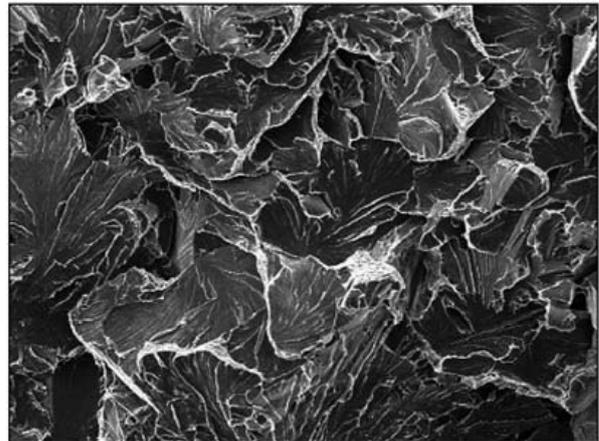
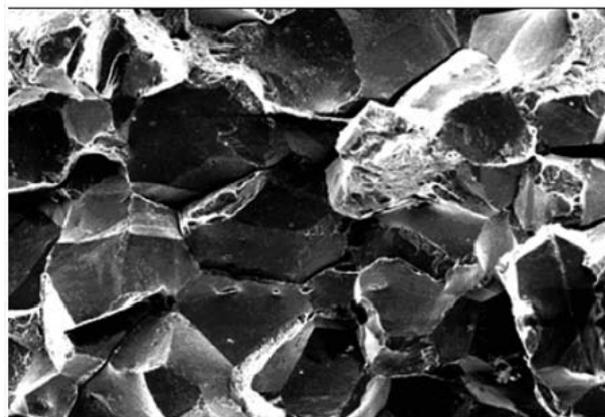
a) transgranular type

b) intergranular type

Fig. 1. Fracture surfaces of pressure vessel steel, a) transgranular type and b) intergranular type [1].

Although transgranular cleavage is the predominant mode of brittle fracture in RPV steels, solute (e.g. phosphorus) segregation to grain boundaries can result in another type of brittle fracture known as intergranular (grain boundary) fracture. Figures 1 a) and b) show examples of transgranular and intergranular (IG) fracture, respectively, as viewed in a scanning electron microscope [1-3]. The investigators have interpreted the intergranular cracking occurs as a result of segregation of sulfur and/or phosphorus at grain boundary [2, 3].

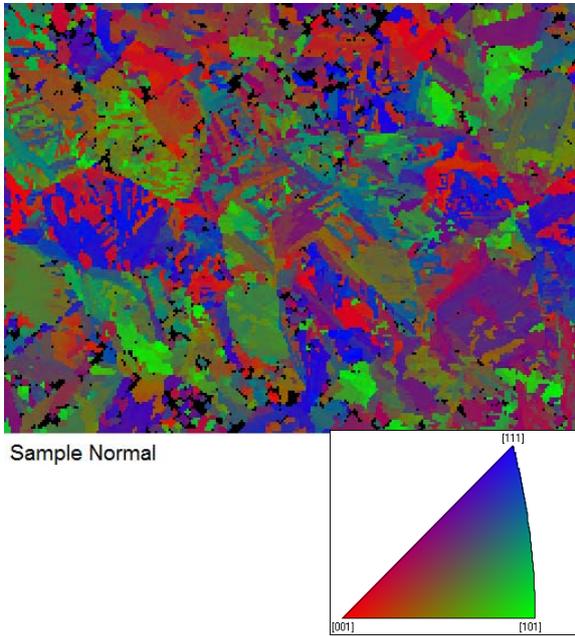
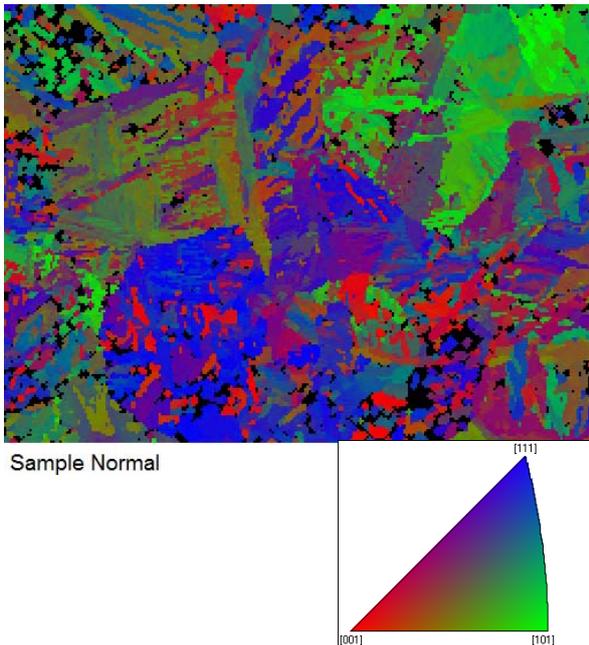
a) as-received

b) 400°C-2,250H

Fig. 2. Comparisons of grain orientation of SA 508 in a) as-received and b) aged at 400°C for 2,250H.

The microstructure and grain orientation examined by EBSD are shown in Fig. 2 a) as-received and b) aged at 400°C for 2,250H. The grain size is slightly

increased by thermal aging. Although the pole figure is not shown here, the grain orientation is slightly changed with aging.

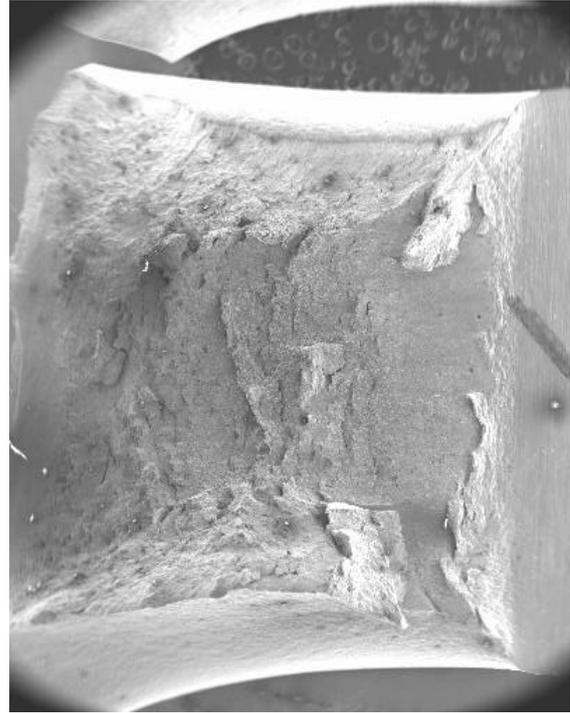
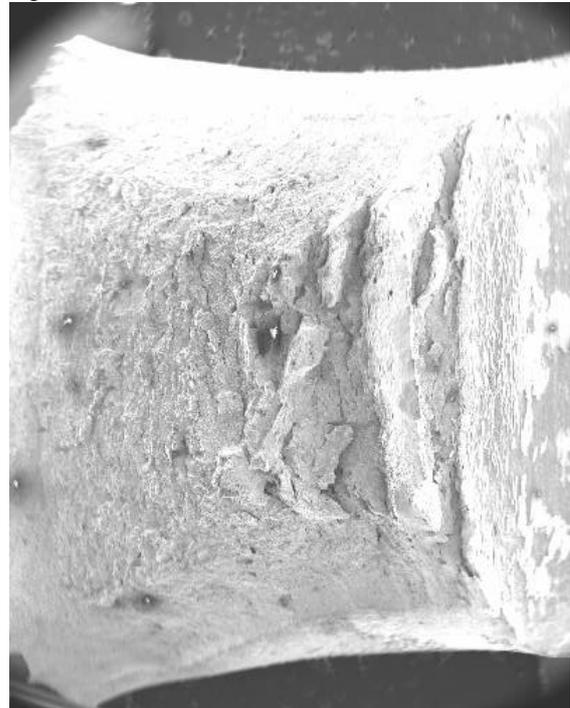
a) as-received

b) aged at 400°C for 2,250H

Fig. 3. Comparisons of fracture surfaces of SA 508 in a) as-received and b) aged at 400°C for 2,250H.

The fracture surfaces of Charpy impact specimen observed by SEM in low magnification are compared in Fig. 3. The fracture surface in aged at 400°C for 2,250H is different from that of as-received specimen. The aged at 400°C for 2,250H specimen shows a certain delamination, compared to as-received one. This

suggests that the aged specimen have suffered certain damage.

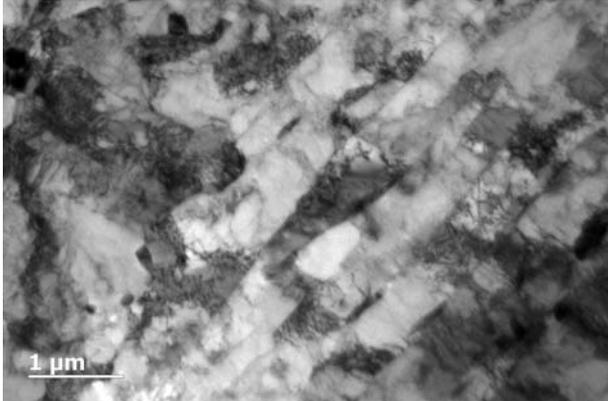
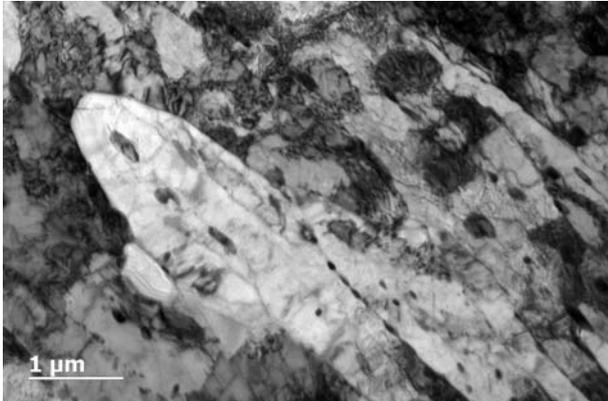
a) as-received

b) aged at 400°C for 2,250H

Fig. 4. Comparisons of TEM microstructure of SA 508 in a) as-received and b) aged at 400°C for 2,250H.

The microstructures by TEM in as-received and aged at 400°C for 2,250H is compared in Fig. 4. The as-received SA 508 shows elongated lath structure and there are little carbides. However, the microstructures

reveal that the aged at 400°C for 2,250H specimen shows a relatively larger lath and carbides frequently.

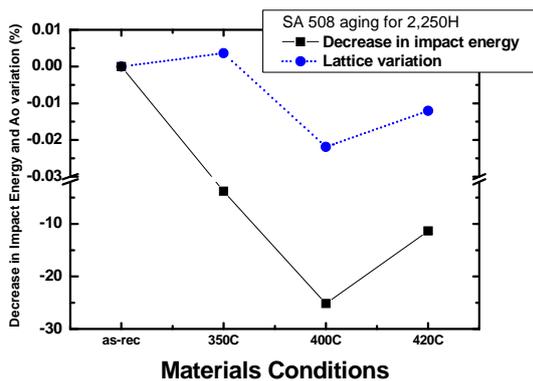
Fig. 5. Comparisons of lattice variations and decrease in impact energy in as-received and aged SA508.

The decrease in impact energy due to thermal aging and the lattice variation are compared in Fig. 5. The amount of impact energy decrease appeared 4-25% according to aging conditions, compared to as-received SA 508. The amount of decrease in impact energy appeared 4, 25, 11% in aged 350, 400, 420°C for 2,250H,

respectively. The lattice variation determined by XRD appeared +0.004, -0.022, -0.012% in 350, 400, 420°C for 2,250H, respectively. It is possible to understand that the decrease in impact energy is proportional to the amount of lattice contraction.
