# Development of Reactor Vessel Bottom Mount Instrumentation Nozzle Routine Inspection Device

[Khaled Atya Ahmed Abdallah](#), Ihn Namgung  
KEPCO International Nuclear Graduate School  
Ulsan, Korea

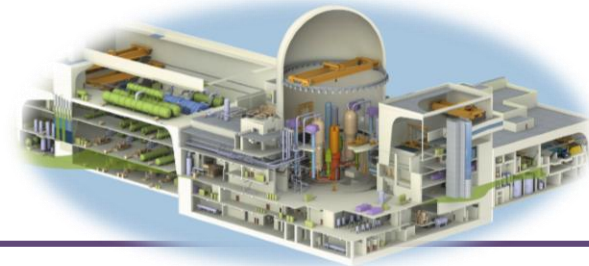
# Reactor coolant System (RCS)

- Reactor Vessel (RV)
- Reactor Coolant Pump (RCP)
- Steam Generator (SG)
- Pressurizer (PZR)
- Piping, etc.

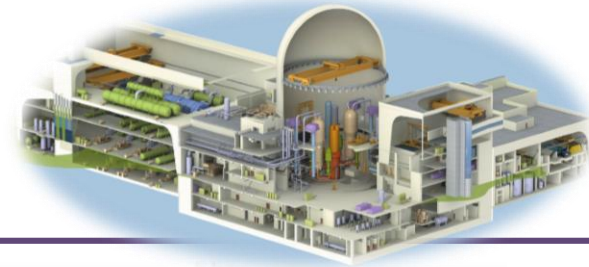
# Reactor Vessel

- RV is a unique component, as :
  - Nuclear reaction is realized inside RPV
  - RV **contains whole nuclear fission materials** as well as practically all radioactively induced materials
  - RV cannot be practically cooled down if it ruptured
  - RV is a large and **heavy component**
  - RV is practically **non-replaceable**

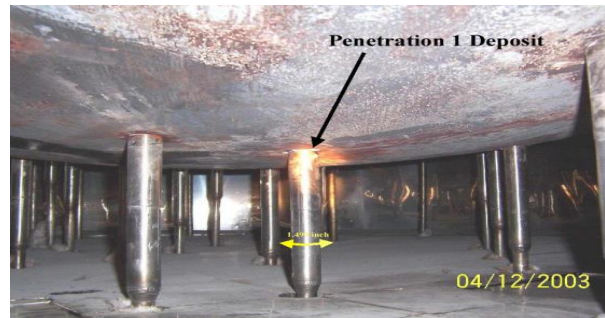
## <STP-1, BMI Nozzle>

- 2003.4 Crack found
- 2003.6~8 Repair
- 2003.8 Resume the operation
- Repair cost: \$5~10M
- Revenue Loss : \$130M(4 months)

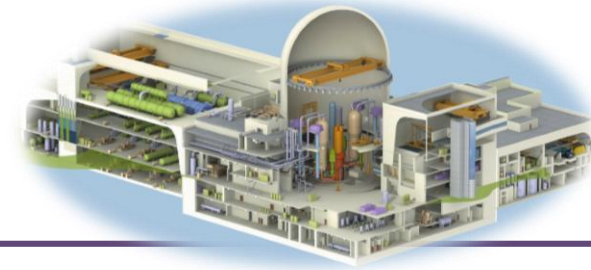
# South Texas NPP

- South Texas found two leaking BMIs in April 2003
- Small amount of residue discovered on 2 BMI penetration at south Texas plant unit 1
- Deposits confirmed to be boric acid from reactor coolant
- Very small amount of deposits- 150 mg and 3 mg

Visual inspection found a small amounts of boric acid residue around the OD of two STP Unit 1 Alloy 600 BMI nozzles on April 12, 2003

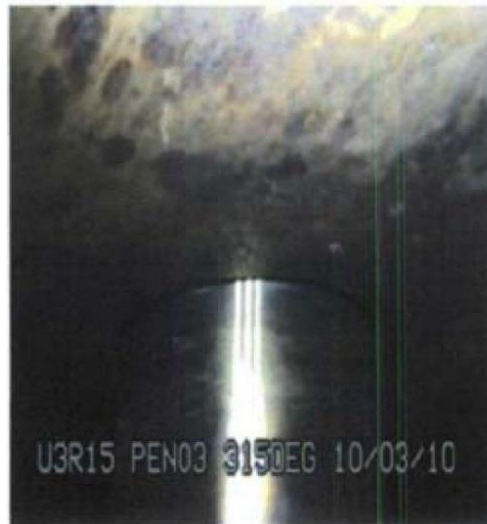
(Year 2010)

- On October 6, 2013, BMI nozzle number (#) 3 at Palo Verde Unit 3 (PVNGS-3) exhibited small white deposits around the annulus

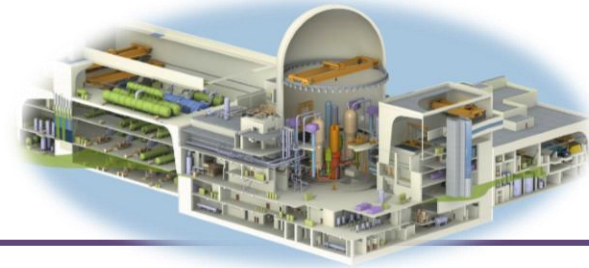
# BMI OF RV Inspection

- AREVA NDE Solutions introduced an inspection system to ease the J-weld inspection challenge including improved underwater remote manual scanner
- KPS developed an inspection technique of the OPR-1000 plant

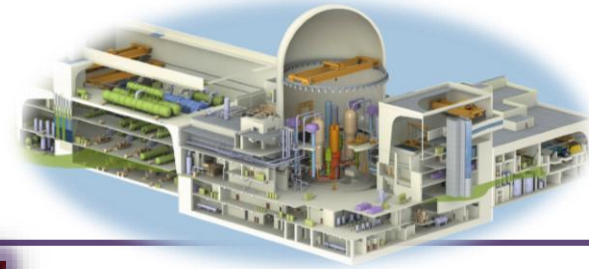
# BMI OF RV Inspection

Framatome developed underwater testing probes attached to a remotely operated, **65-foot-long pole**, this test have done after removing all reactor vessel internals

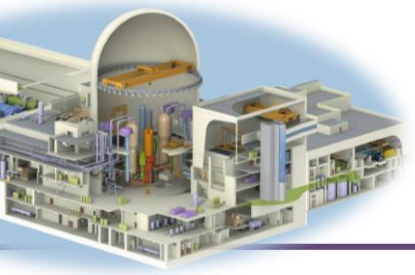
# Conceptual Design of BMI Inspection Trolley

- 3D model development of BMI Inspection Trolley.
- Equivalent stress and total deformation of Trolley Body and lower part of BMI inspection tool.
