## Test Methodology of Reproducing Fuel Rod Failure by Debris Fretting Wear

Oh Joon Kwon\*, Nam Gyu Park, Jae Ik Kim

KEPCO NF, Daedeok-daero 989 beon-gil, Yuseong-gu, Daejeon

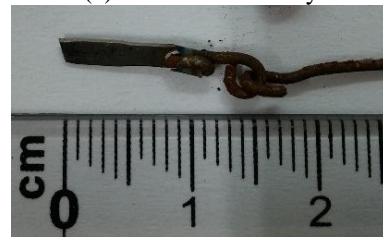
(b) Debris specimens

Fig. 2. Test specimens for debris fretting wear test

Debris specimens were selected to be a part of nuclear fuel component which is a portion of outer strap of protective grid, inner spring of bottom grid and inner spring of mid grid. Protective grid and bottom grid are made of inconel-718, and mid grid is made of zirconium Alloy which is a material of fuel rod cladding. To give degrees of freedom of motion, a simple linkage was installed. Fig. 2(b) shows the shape of debris specimen.

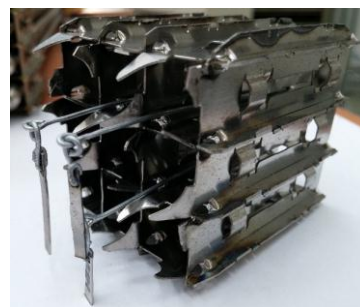
Fig. 3. Installation of debris specimens on mid grid.

Debris specimens were placed on the center of split vane which is just above a weld nugget. Installation of the debris specimens is shown in Fig. 3. Flow velocity was 4.8 m/s in rod bundle, temperature was 43°C and test duration was 75 hours.
