Enhanced Understanding of High Energy Arcing Fault Phenomena in NPPs

PARK, JongSeuk*, KIM, MeKyoung, LEE, SangKyu

Korea Institute of Nuclear Safety, 62 Gwahak-ro, Yuseong-gu, Daejeon, 34142

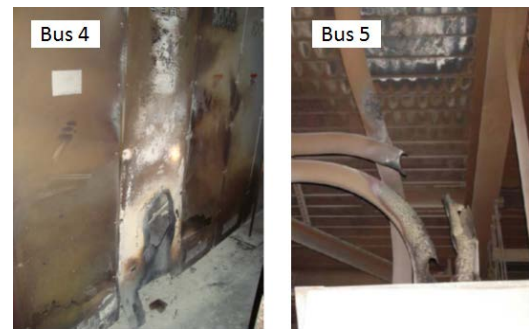
event, cables located in conduits exiting the top of a cabinet shorted together and damaged the conduit and potentially damaged electrical cables located in cable trays directly above the damaged conduit as shown in Figure 1.

Figure 1. Damaged Electrical Cabinet and Conduits

The first fire was caused by a fault on a 4.16kV feeder cable between bus 4 and bus 5 led to an arc flash which caused internal damage to the unit auxiliary transformer and a subsequent fire within the conduit.

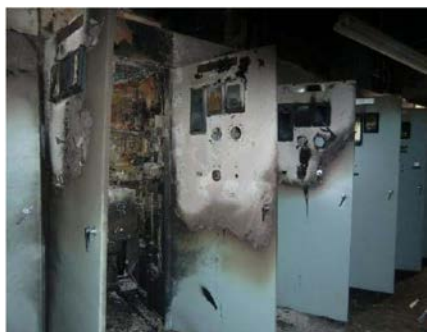
Fire took place due to short circuit inside MC 6-1A and subsequently spread to 10 other switch gear systems via power cable ducts. As a result, a pump in the residual heat removal system was inoperative for a short period. Fire could not be suppressed and was allowed to burn out almost 7 hours and electrical cabinets involved were heavily damaged and mostly burned as shown in Figure 2.

Figure 2. Damaged cabinets by HEAF incident

On Mar. 11, 2011, the successive fire incident due to HEAF occurred in the electrical cabinet in which the overhang type high voltage breakers were used. The remarkable thermal and structural damage to the cables and equipment of the adjacent cabinets were recognized due to the release of the hot gas propagation and high inner pressure.
