System development of pure nickel plating process for RPV cladding repair

Min Su Kim^{a*}, Seong Sik Hwang^a, Eun Hee Lee^a, Dong Jin Kim^a, Dong Bok Lee^b

^a Korea Atomic Energy Research Institute, 989-111 Daedeok-daero, Yuseong-gu, Daejeon 34057, Korea

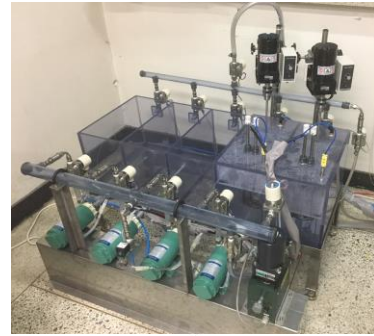
Fig. 1 shows the sequential plating tank, which is designed to allow the Ni plating solution to be transported sequentially, including the pretreatment solution. The four magnetic pumps quickly transferred the pretreatment solutions to induce degreasing, activation and strike layer formation on the Type 304 stainless steel specimen. The metering pump transferred the Ni plating solution at a rate of 300cc/min to induce a plating reaction. Since the strike formation and the Ni plating solution should be performed at a temperature of 40 to 60 degrees Celsius, a sequential plating bath is equipped with a heater. And a stirrer is equipped to stir the plating solution of 1.39mol/l of Ni sulfamate and 0.65mol/l of boric acid.

Fig. 1 Photograph of the sequential plating tank developed by KAERI.

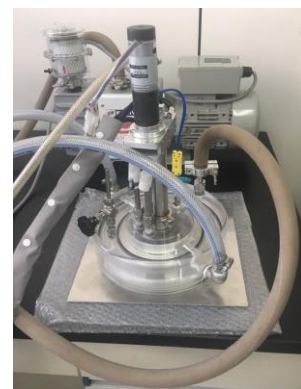
Fig. 2 shows the plating chamber connected to the sequential plating bath.

The plating chamber is located above Type 304 stainless steel. Which is pressed onto the specimen by

the suction force of the vacuum pump so that the circulating plating liquid does not leak out.

Fig. 2 Photograph of the plating chamber on the Type 304 stainless steel specimen developed by KAERI.

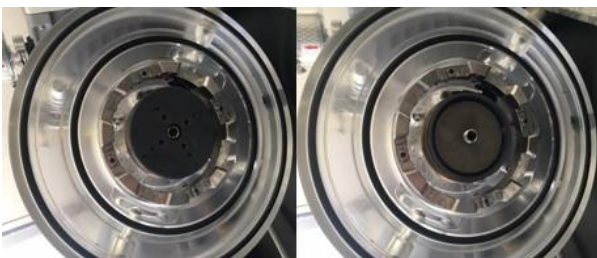
There is a special point in the plating chamber, in which the anode is located. Due to the characteristics of the plating, the current is more likely to be distributed at the edge of the cathode when the current is applied, which is why the plating layer is formed unevenly on the edge of the specimen [4]. To solve this problem, the nickel anode is wrapped in a PVC basket with a small hole as shown in Fig. 3. Then, the nickel cations generated by the oxidation of the anode are directed to the cathode, but it can not move along the current distribution but only through the hole. The next thing to do is rotate this basket. The cations will be uniformly deposited on the specimen through the rotating holes.

Fig. 3 Anode assembly with shielding basket (left side) and without shielding basket (right side)
