The Comparison of microstructures between air and steam oxidation of Zr alloys at high-temperatures

Seonho Noh^a, Kwangheon Park^{a*},

^aDepartment of Nuclear Engineering, Kyung Hee University, Kyunggi-do, 446-701

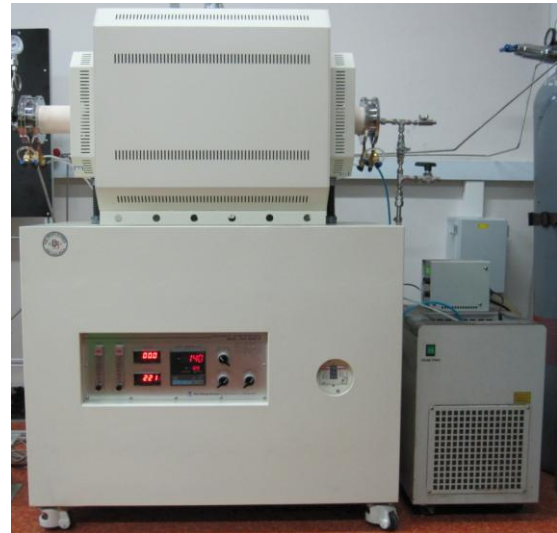
The apparatus for the high-temperature air testing of the Zirconium alloys used in this study is shown in Fig 1. In the tube furnace, there is an Alumina tube in the center and the heater is surrounding the tube. The furnace maintained a fixed temperature i.e., 1200C, and we put the specimens at the center of the tube. After a certain time passed, the specimens were pulled out. The weight of each specimen was measured before and after the experiment, and the weight gain was recorded. The part of the specimen was cut, grounded and polished. The microstructures of the polished surface of the specimen were observed by an optical microscope.

Figure 1. Apparatus (tube furnace) for high temperature oxidation of Zr alloys in air

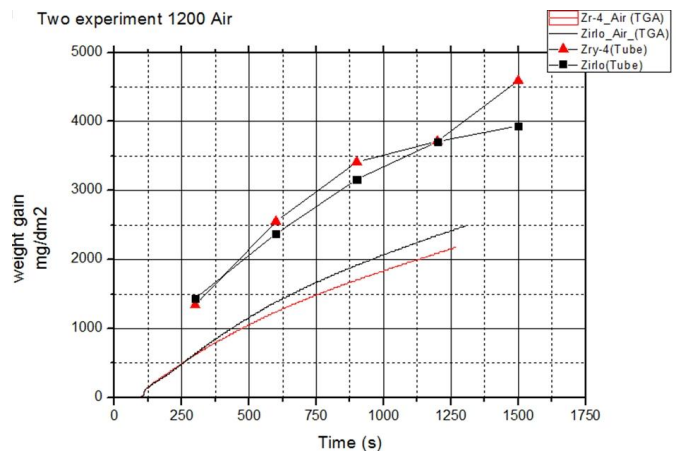
The weight gain results were shown in the figure 2. The weight gain by the oxidation in air was much higher than that in steam. Zry-4 claddings were somewhat more oxidized than Zirlo claddings. Below 1000C, it was observed that Zirlo claddings were oxidized more than Zry-4 claddings in air.

Figure 2. The weight gain of Zry-4 and Zirlo specimens oxidized in air. The weight gain curve oxidized in the steam was also shown for the comparison [1].

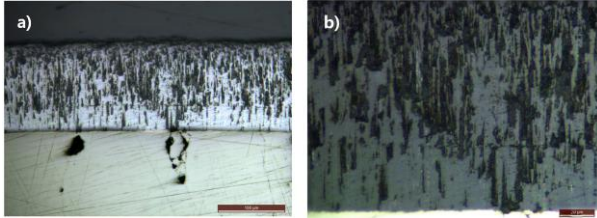
In the oxide formed in the steam, columnar grains were observed. Columnar oxide grains are known to be very effective against corrosion, since the columnar structure is stable under the compressive stress working at the side direction of the column. The oxidation in steam follows the parabolic rate law indicating the oxide layer is protective mainly due to these columnar grains.

Figure 3. The microstructure of a Zry-4 cladding oxidized in steam. a) oxide on the metal layer, b) oxide layer magnified.

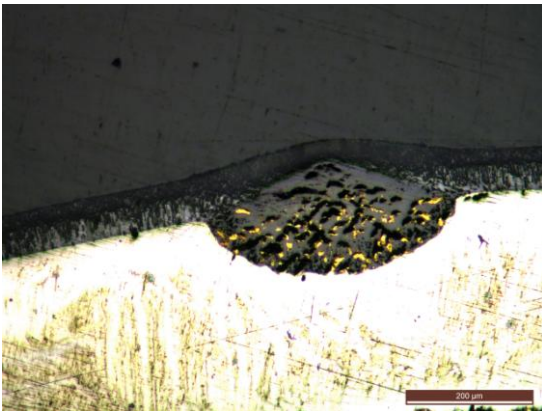
When Zr alloys were oxidized in air, most of oxide looked normal and took the form of columnar structure. However, some portions in the oxide layer looked abnormally grown. Figure 4 shows the abnormally grown oxide layer. In the abnormally grown area, there always were golden color compounds, i.e., zirconium nitride (ZrN). The oxides in between these ZrN's looked very different from the normal oxides originally formed on the surface initially.

Figure 4. The microstructure of a Zirlo cladding oxidized in air at 1200C for 5 minutes.

Thermodynamically ZrO_2 is absolutely more stable at 1200C than ZrN in the air based on HSC calculation. This means the compound formed in the mixture of N_2 and O_2 (i.e., air) should be ZrO_2 . The formation of ZrN at the inner side of the oxide layer needs some explanation. Duriez et al., explained that N_2 diffuses through oxide layer and forms ZrN beneath the oxide layer [2]. However, how nitrogen can reach to the metal beneath the oxide layer should be explained.

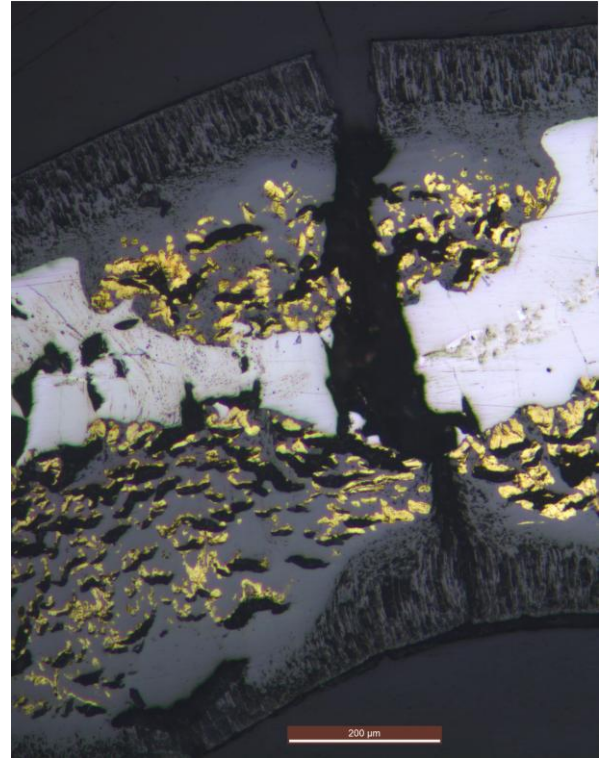
Once the nitride formed beneath the oxide layer, the oxide took different form from the columnar structure. And ZrN continuously formed with the growth of the abnormal oxide. Figure 5 shows the microstructure of the abnormally grown oxide layer. Throughout the

abnormal oxide, ZrN were observed. Near nitrides, cracks were also found. The cracks looked to normal to radial direction indicating the existence of tension in this direction.

Figure 5. The microstructure of abnormally grown oxide layer in a Zr-4 cladding oxidized in air at 1200C for 20 minutes.
