Installation of Test-stand for Conditioning of the Microwave Ion Source at KOMAC*

Microwave Ion Source for 100 MeV Proton Linac

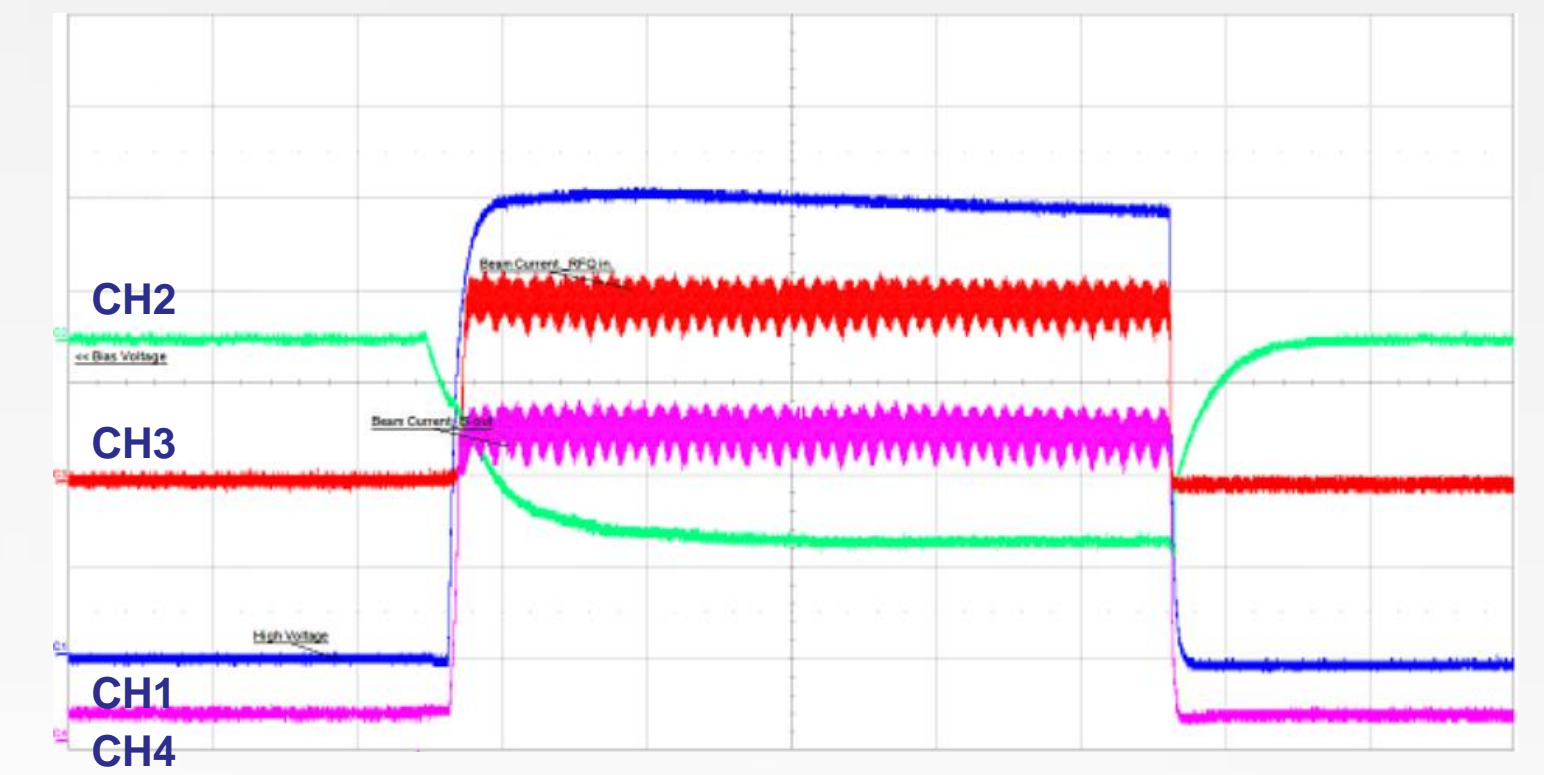
Operation Conditions

CH1: Extraction voltage, CH2: Bias voltage, CH3: LEBT CT, CH4: Ion Source CT

- Gas flow rate : 3.0 SCCM
- Extraction voltage : 51 kV
- Bias voltage : -4 kV
- Solenoid magnet current : 72 A

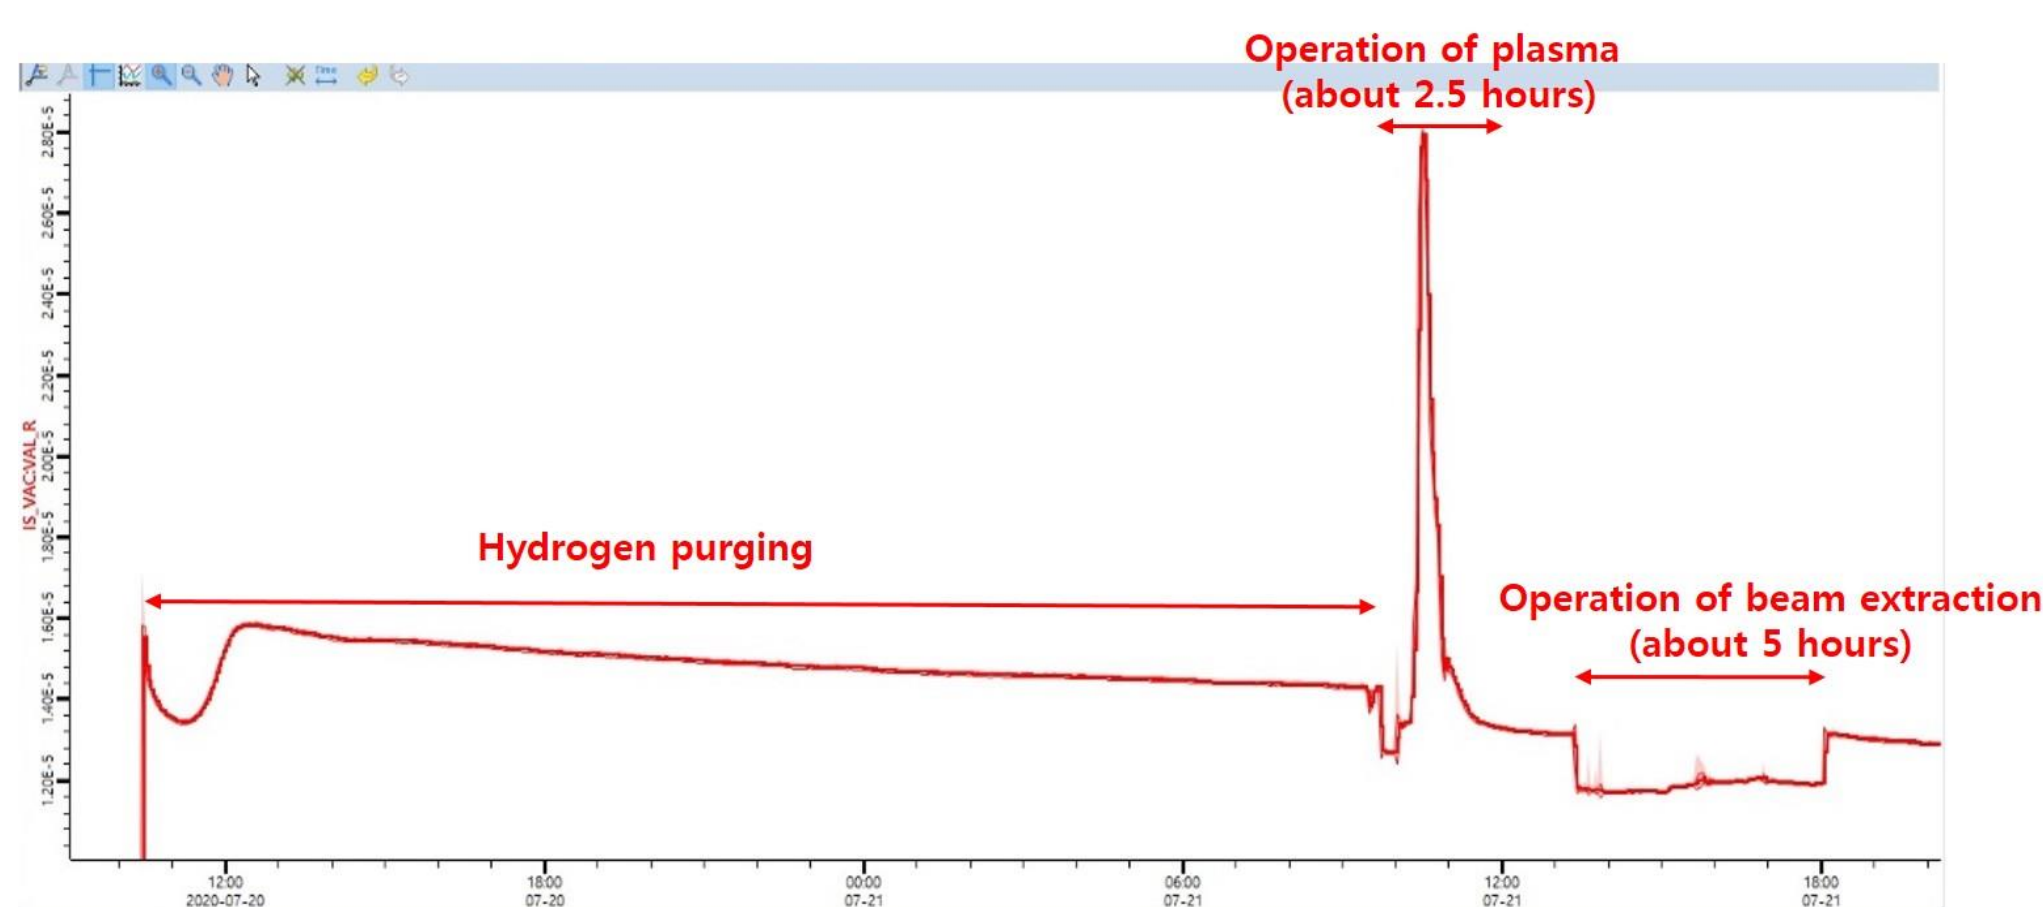
Vacuum trace of microwave ion source

- Purging the initial hydrogen gas
- Plasma discharge after replacing the microwave window and plasma chamber
- Operation of beam extraction

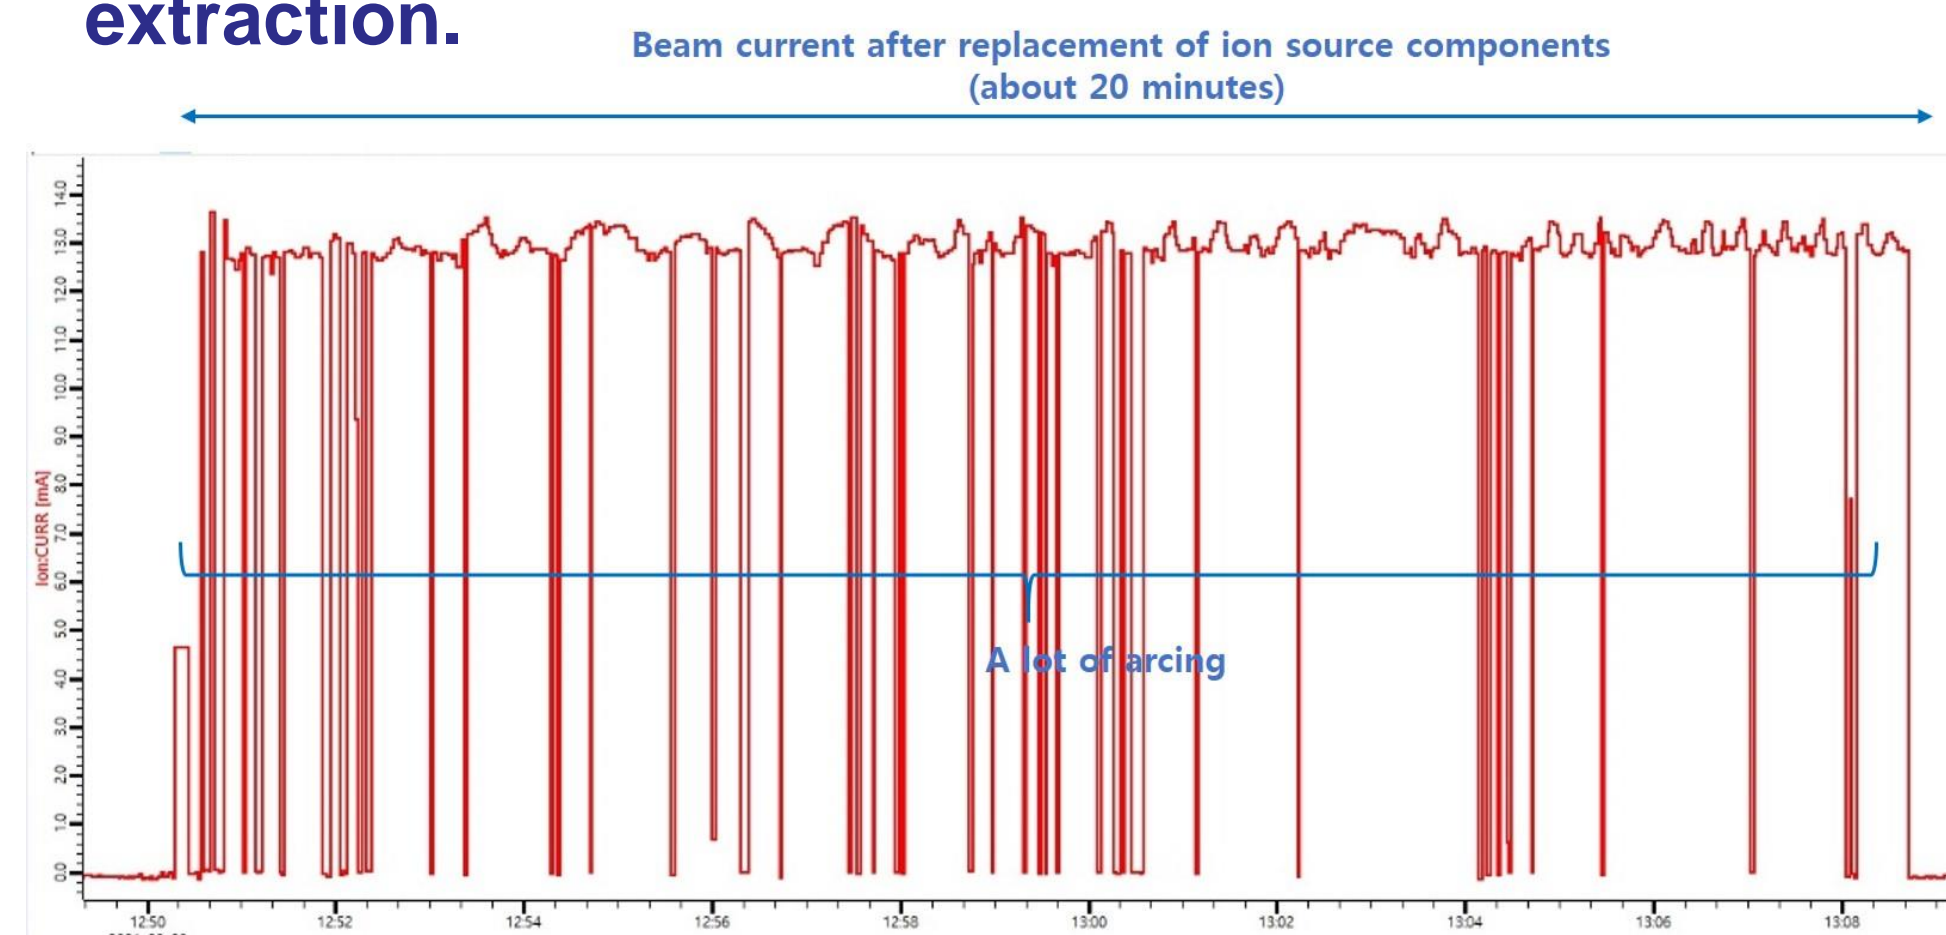
Beam current in LEBT during conditioning of microwave ion source

- Continuous arcing occurred.
- It can be seen that the number of arcing occurs decreases toward the second half of the beam extraction.

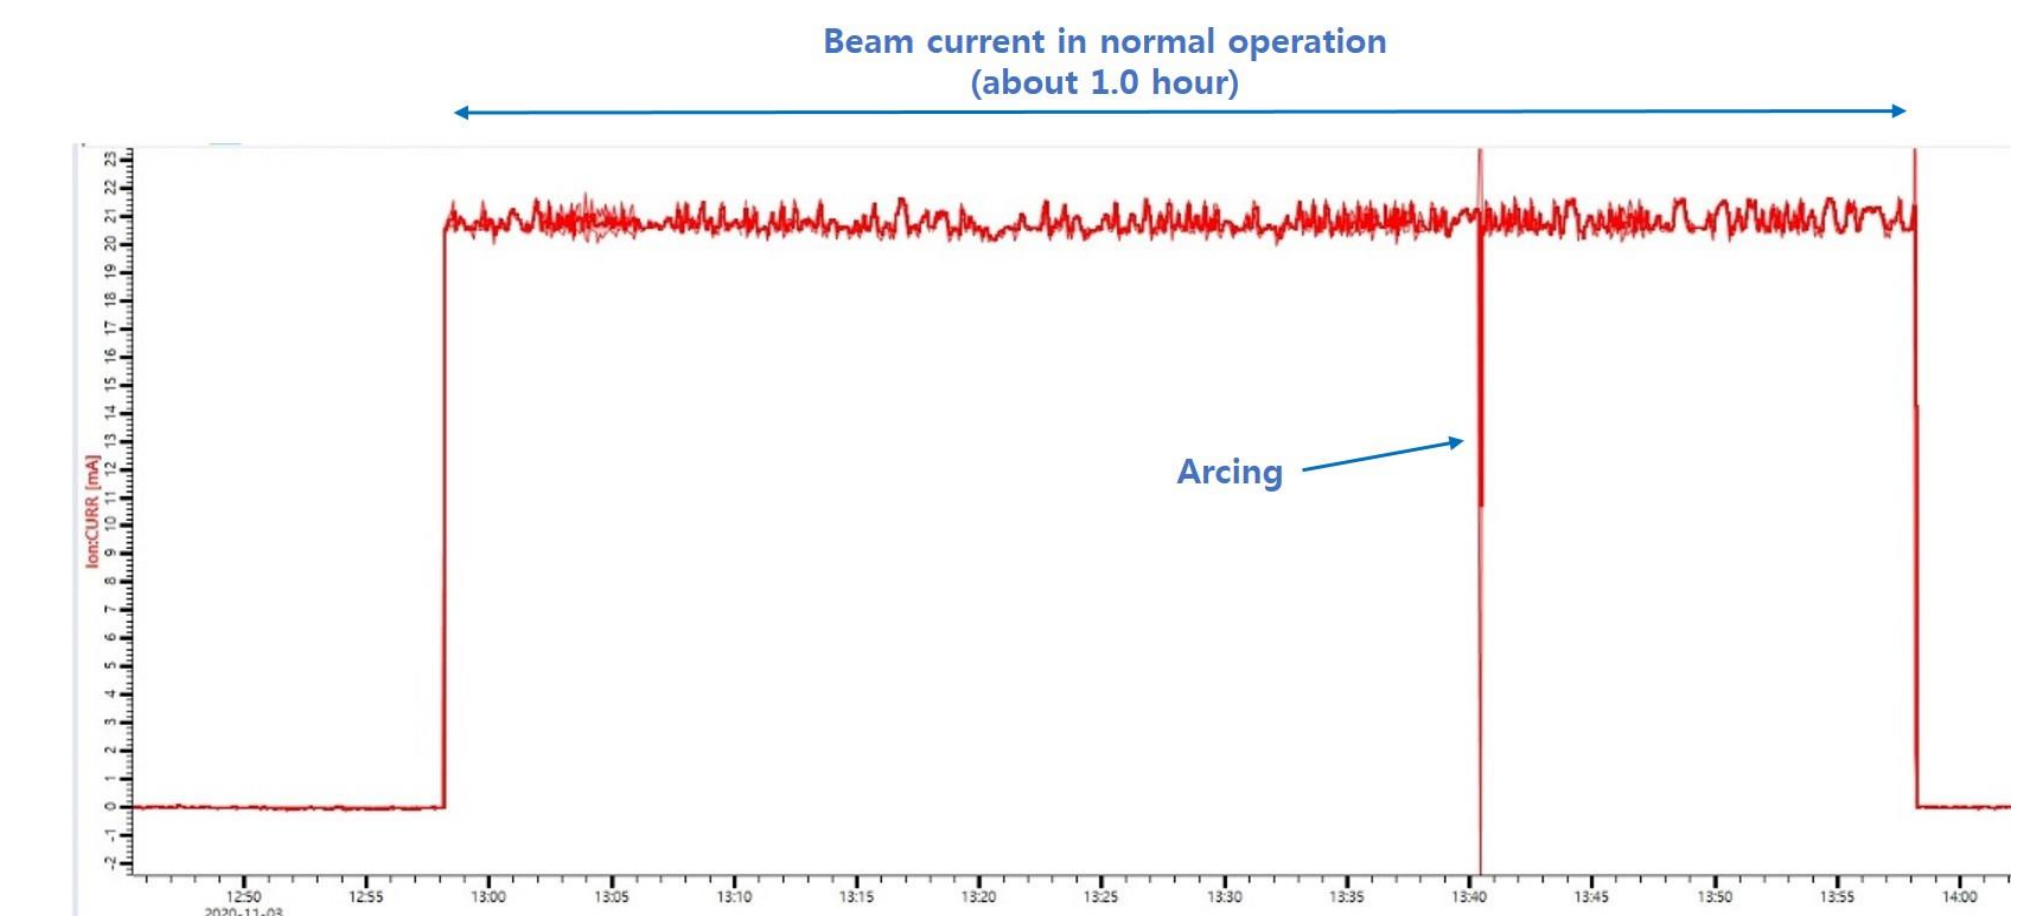
Beam current in normal operation after conditioning of high voltage of microwave ion source

- The average beam current is 20.8 mA.
- The beam stability is ± 3.9 %.

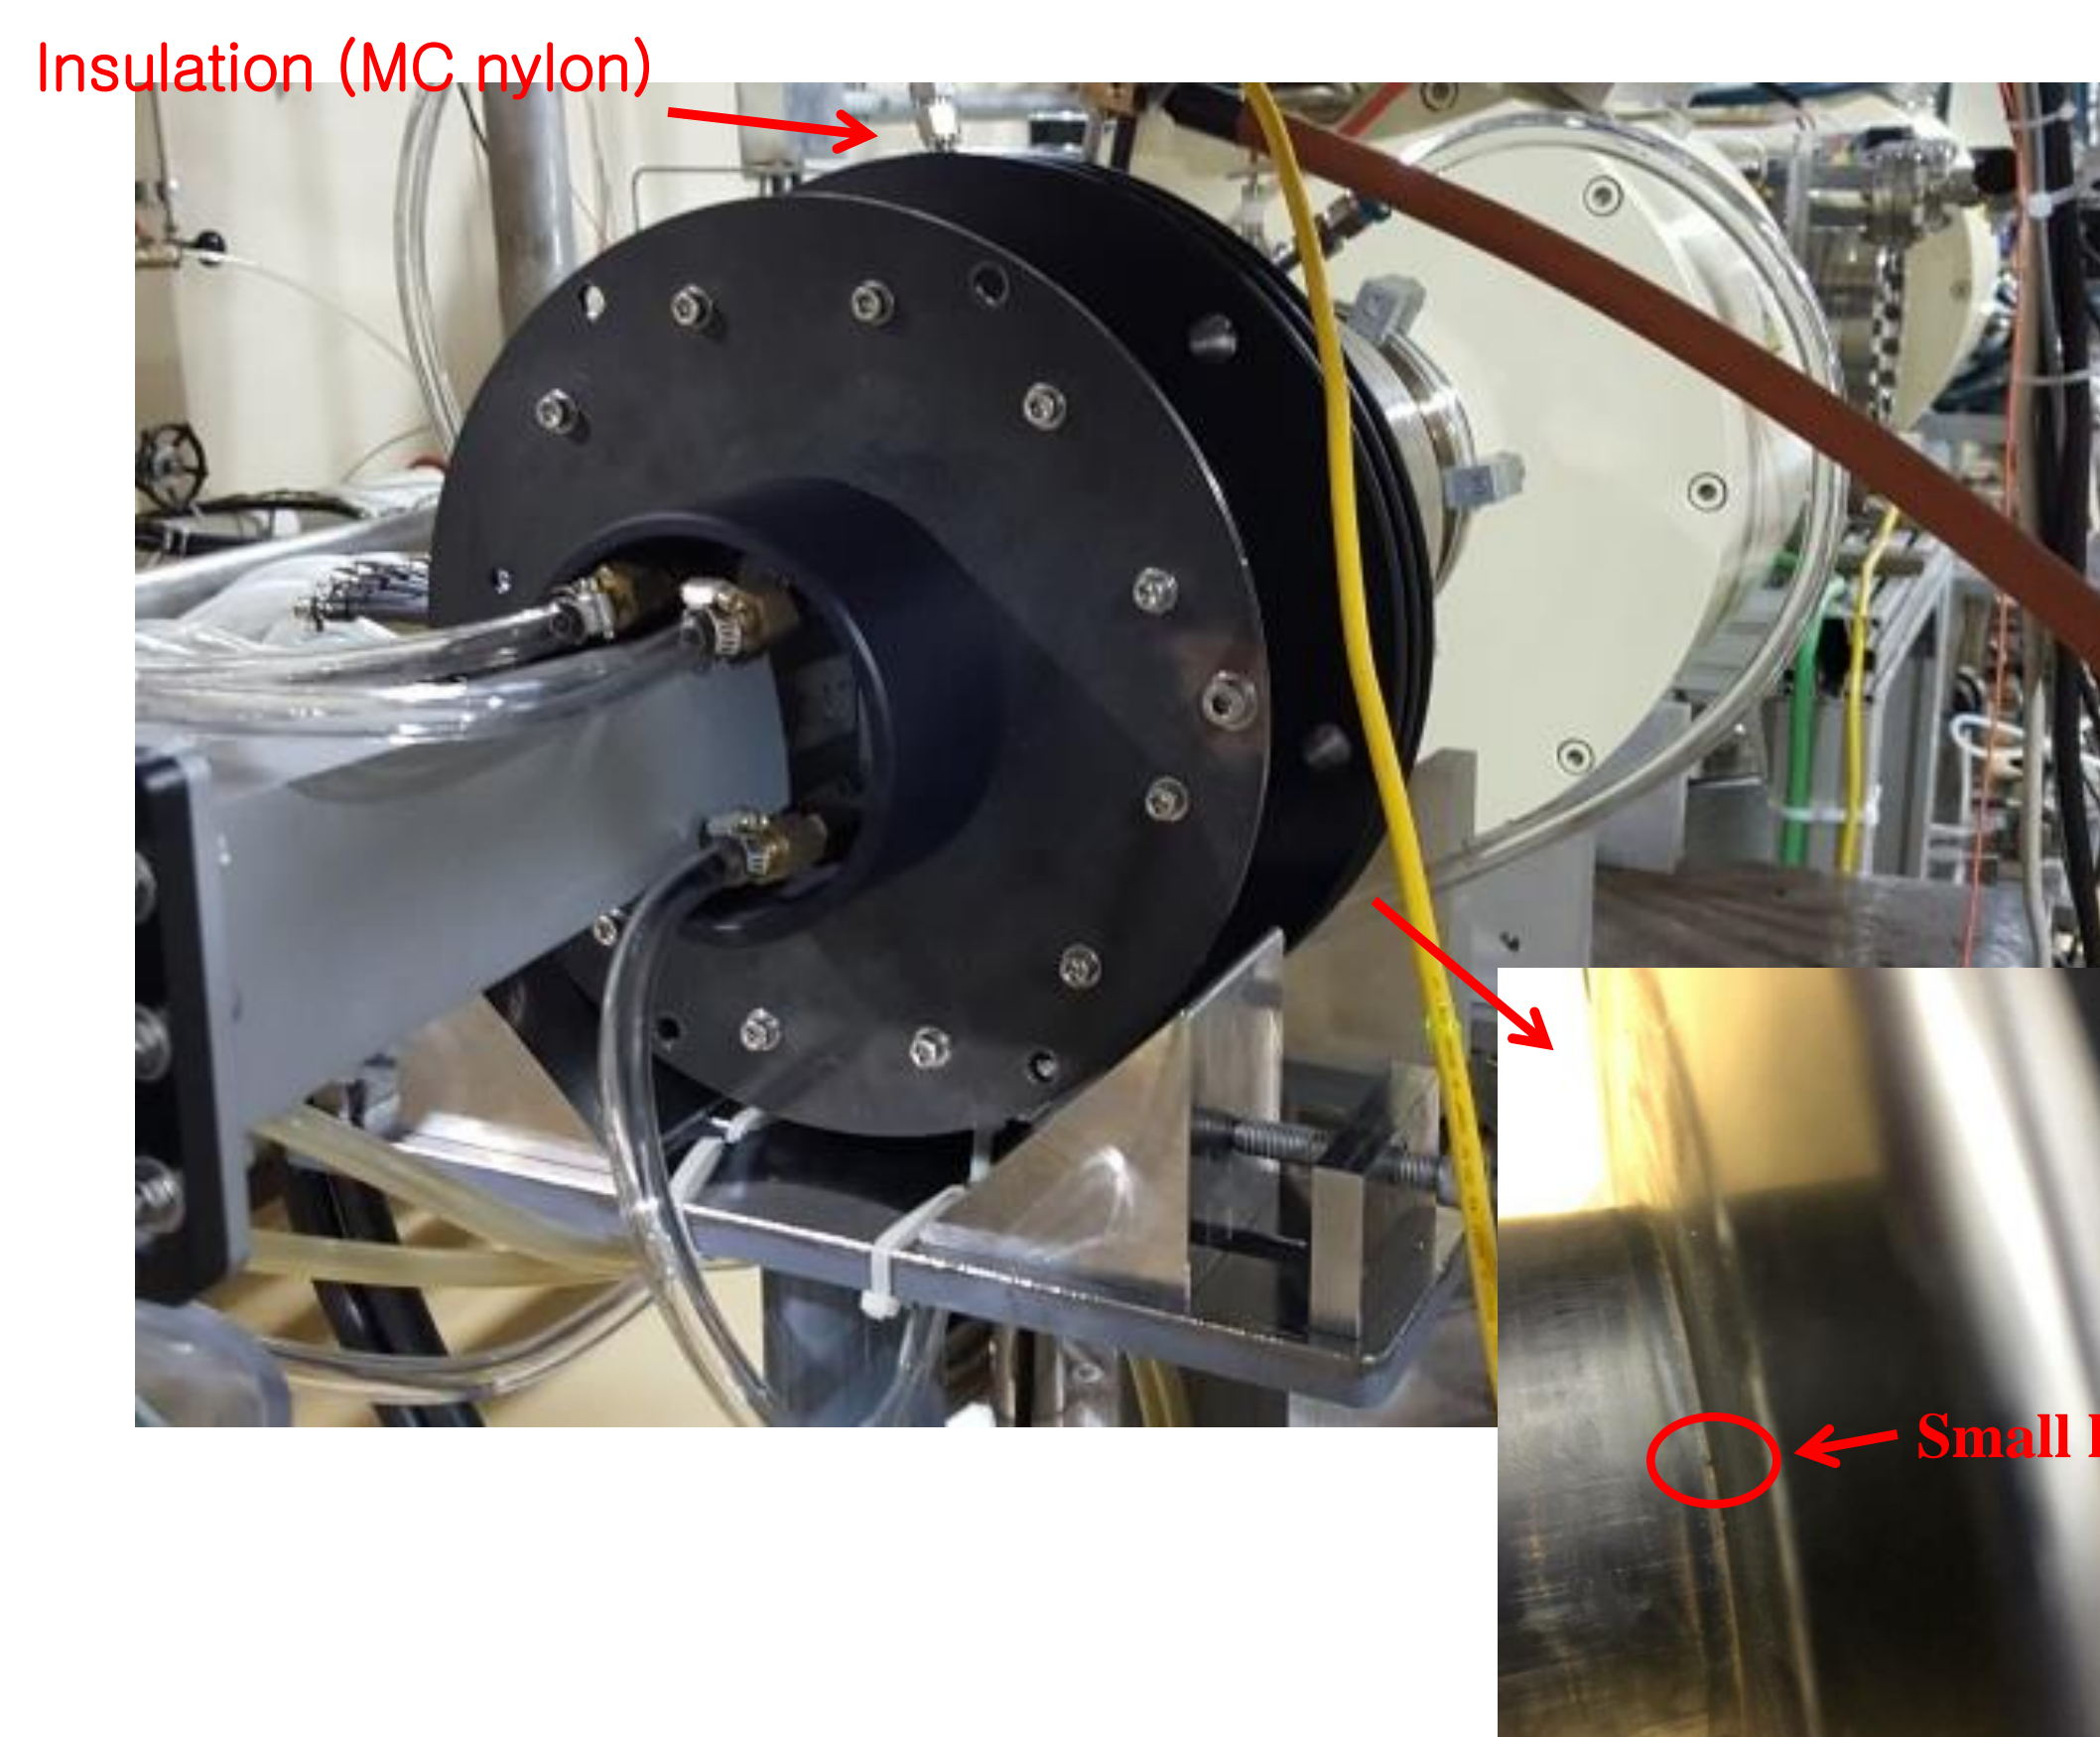
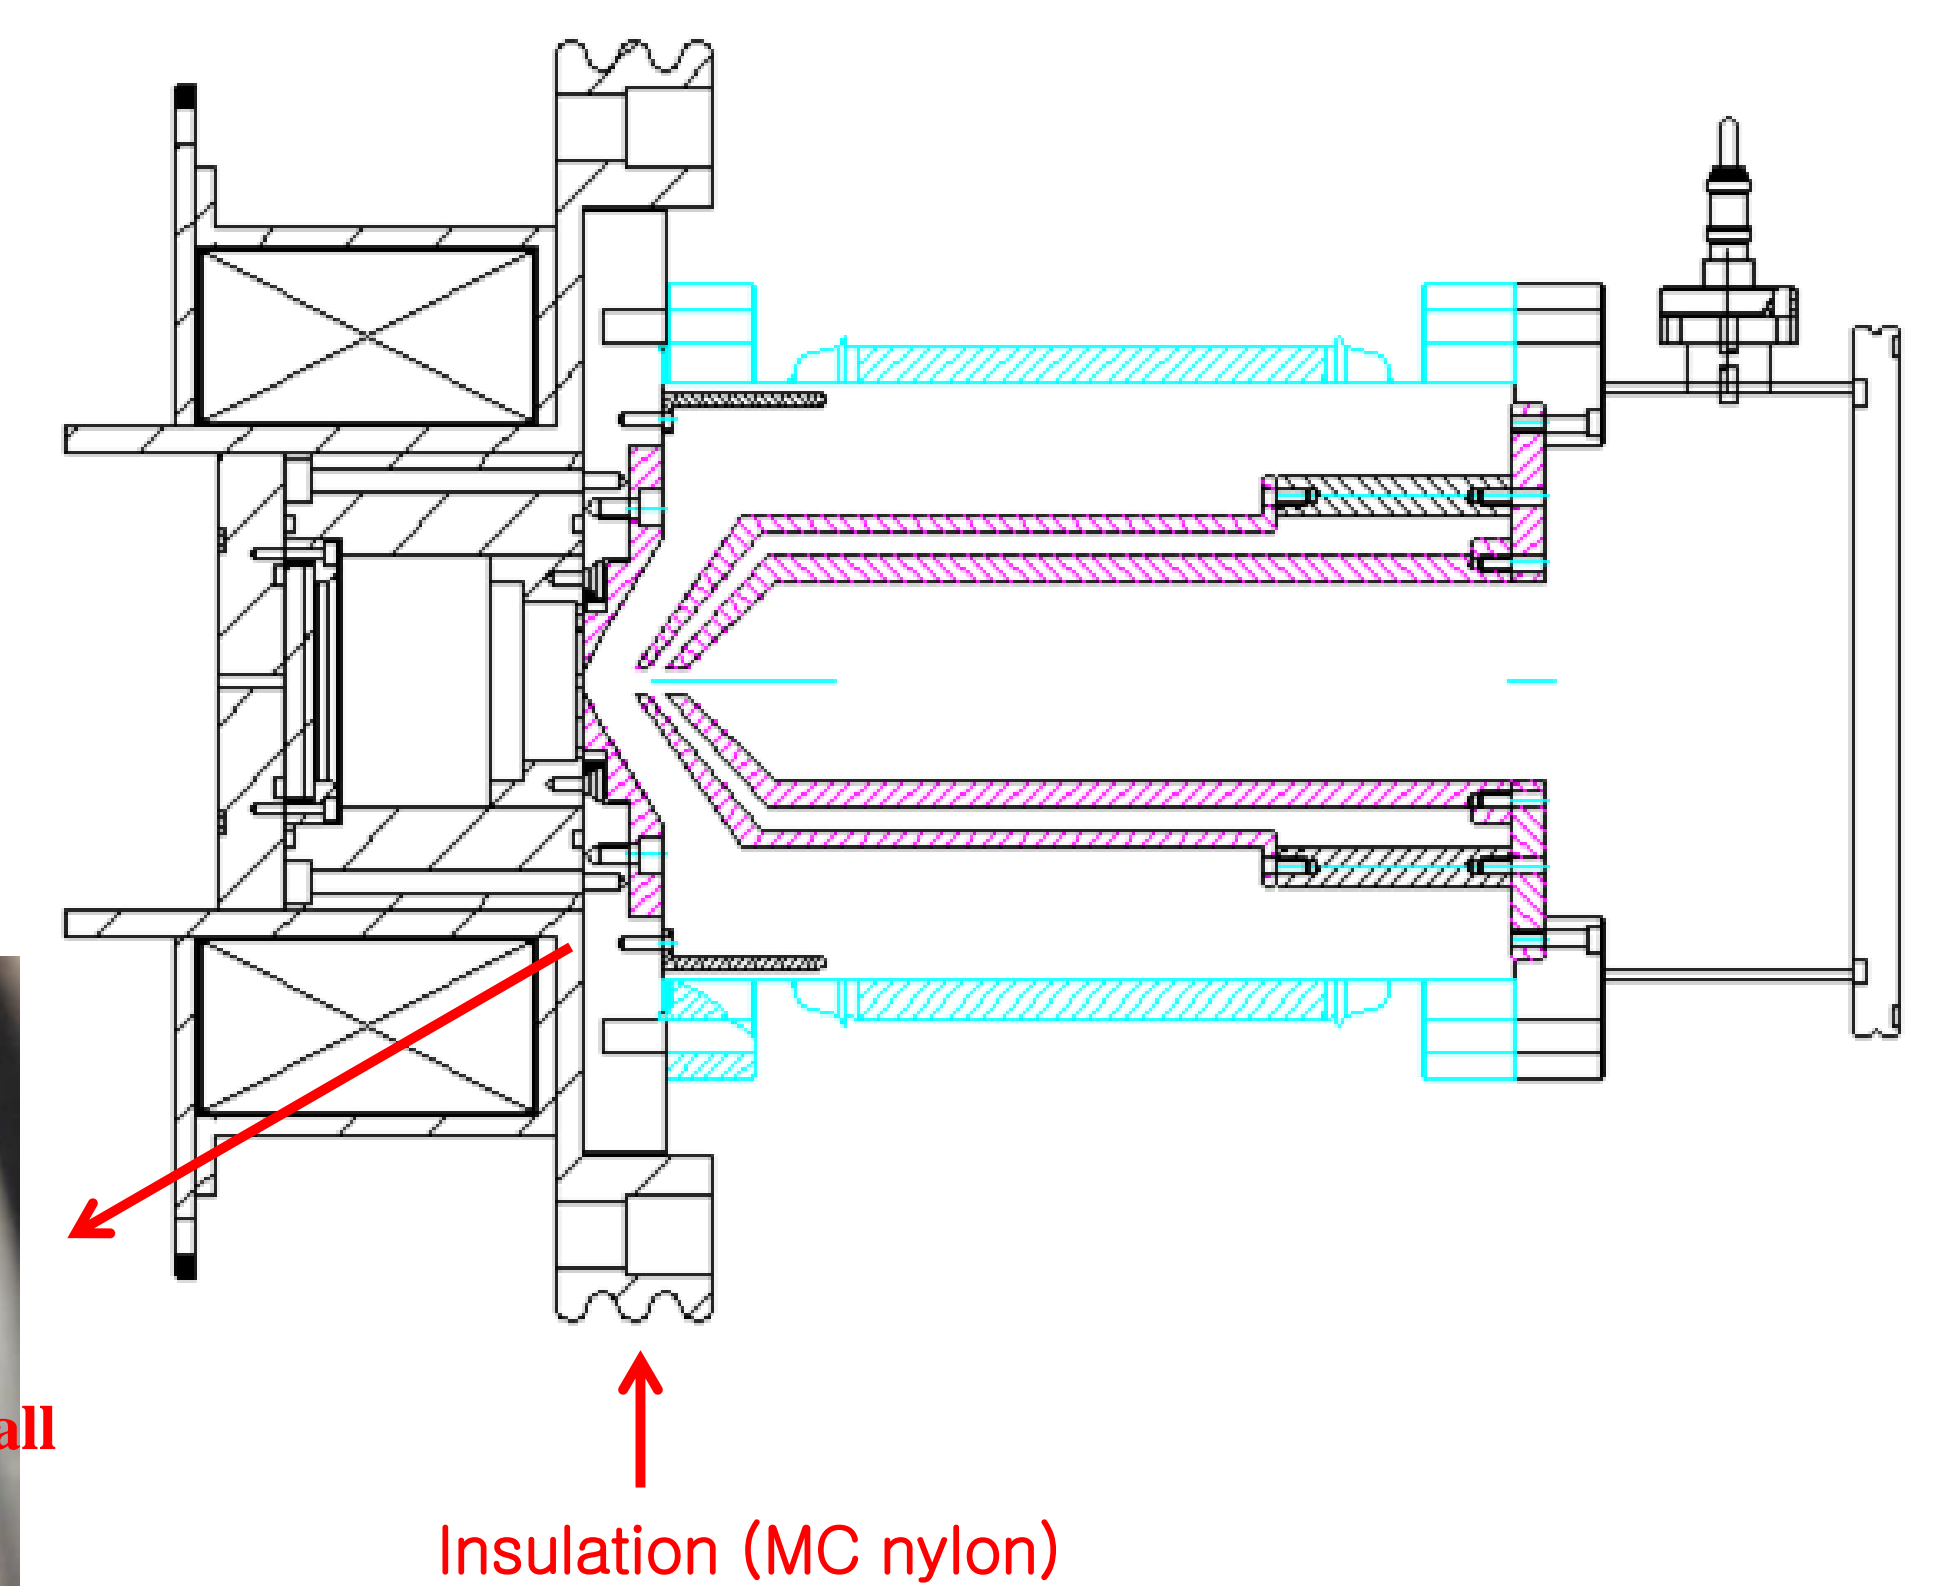
Trouble-shooting

- Occurs during operation
- It hasn't been long since it was replaced.

- : Insulation breakdown due to accumulated fatigue(arcing)
- : Reduced insulation strength of insulators due to the heat generation source of plasma chamber

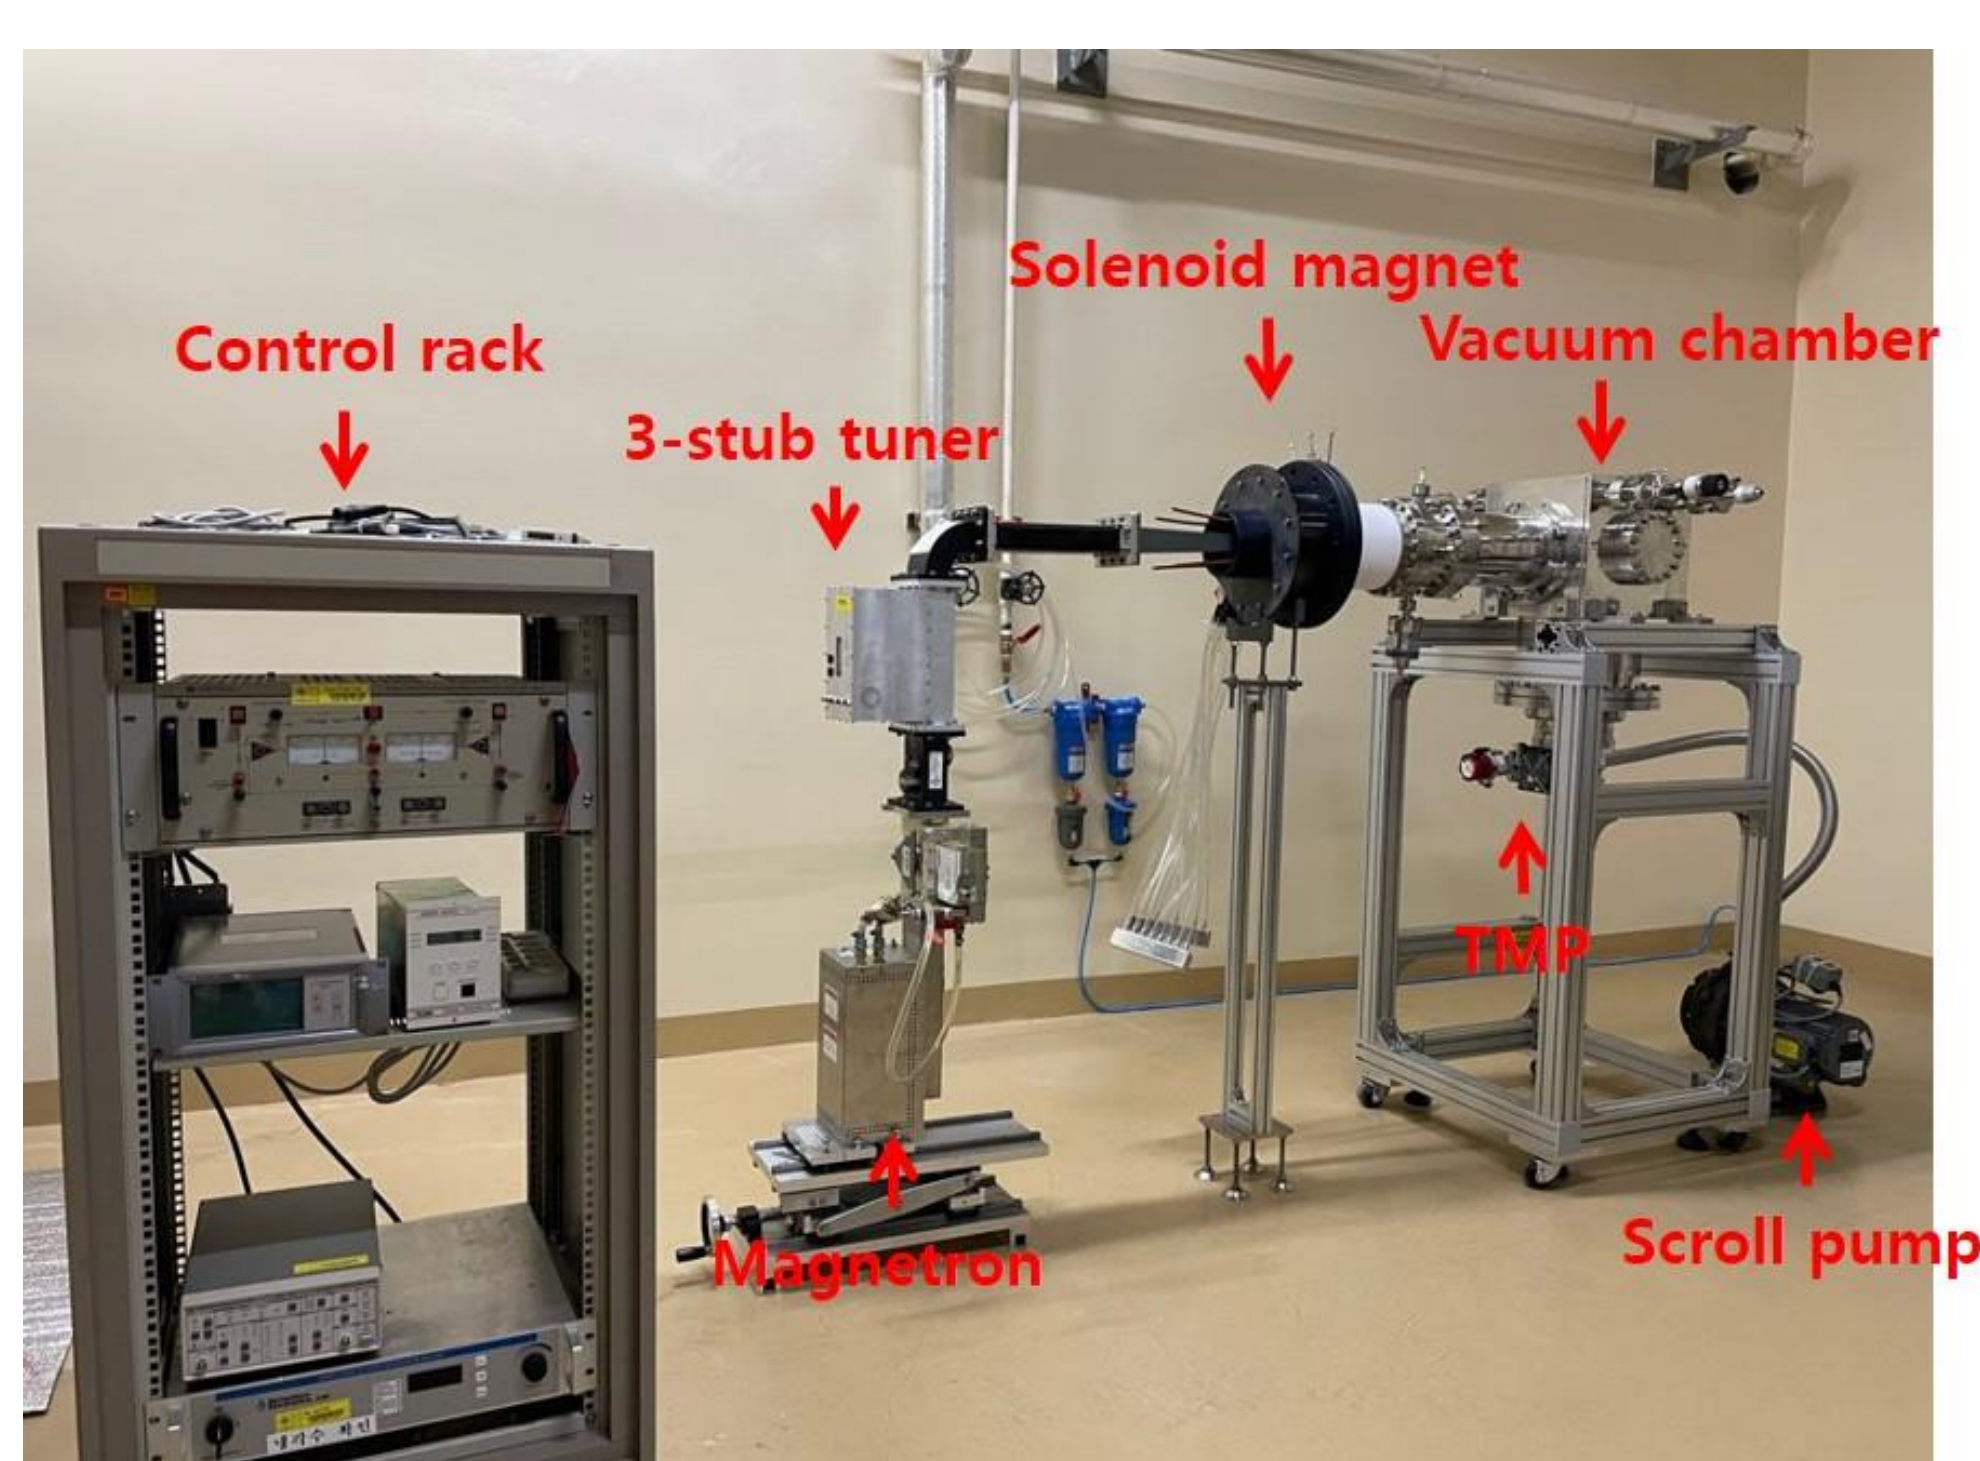
Test-stand for the Microwave Ion Source

- The microwave ion source of the test-stand is a spare part and has the same shape as the existing microwave ion source, and it is a concept that changes it to the whole when it is regular or irregular.

- : Plasma conditioning
- : High-voltage conditioning
- : High current beam conditioning
- : Components test for improvement

Components related to the high voltage test are omitted.
