Corrosion Performance of Coating for Venturi Fouling Mitigation at Nuclear Power Plant

Wonjun Choi^a, Young-Jin Kim^b, Dong-Seok Lim^b, Hyun-Chul Lee^b, Chi Bum Bahn^{a*}
^aSchool of Mechanical Engineering, Pusan National Univ., Busan, 43241, South Korea
^bFNC Technology Co. Ltd, Yongin-si, Gyeonggi-do, 16954, South Korea

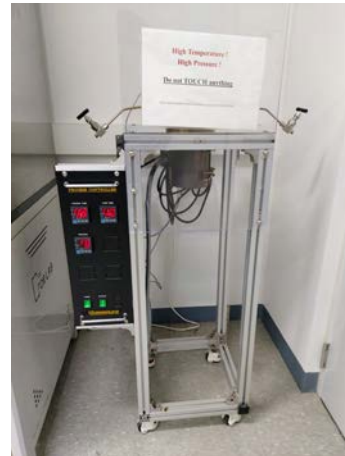
Fig. 1. Static autoclave corrosion test apparatus.

The experiments were conducted in a static autoclave operating at 235°C in secondary water chemistry condition, at a saturation pressure of 27 bar. Fig. 1 shows the static autoclave system. The pH=9.3 of simulated secondary water condition was adjusted with ETA. And then, 60 ppb hydrazine was added to the solution. Also, carbon steel pieces were put in to simulate Fe injection. The pieces were divided into 4 parts of carbon steel with a diameter of 25 mm and a thickness of 2 mm. The solution was deaerated using Ar gas for the initial 2 hours, maintained at 130 °C for 2 days to sufficiently dissolve Fe in the test water. Then, the temperature was raised to 235°C, and experiment was conducted for 300 hours.

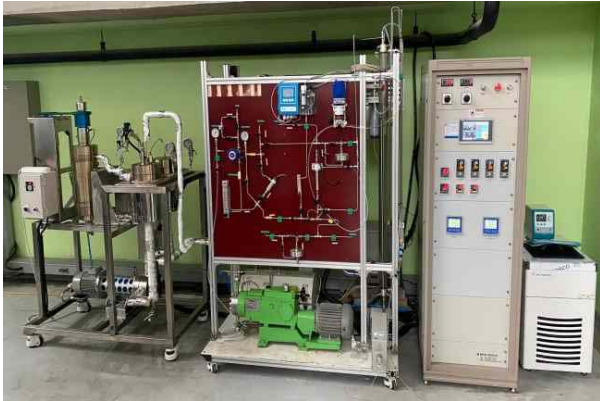
Fig. 2. Flow accelerated corrosion test facility.

The test facility for simulating the secondary water chemistry condition is shown in Fig. 2. The test facility consists of water chemistry control and monitoring system and Magnet drive rotating system for simulating the high flow rate as FAC test. The test solution was the same as static corrosion test solution. However, the pressure was set to 82 bar, which is the same as the secondary water condition. The accelerated flow rate was

set at about 6 m/s. The FAC experiment was conducted for 700 hours.

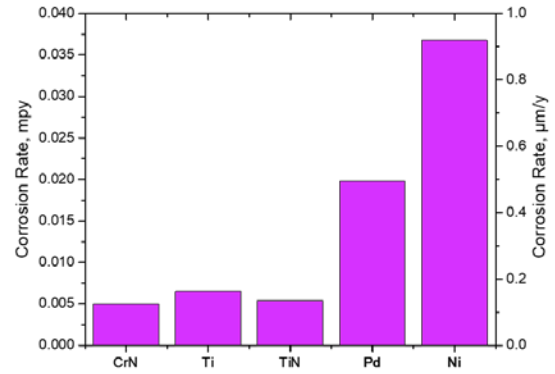
Fig. 3. Corrosion rate calculated from static corrosion test.

After the static and FAC test, each coated specimen was ultrasonically washed for 20 minutes in the order of acetone, ethanol, and distilled water. Thereafter, after drying the specimen fully, the mass change of specimens was measured. The corrosion rate was calculated through the measured mass change. Fig. 3 shows the corrosion rate calculated from the mass change of the specimen after the static test. The specimen coated with the PVD method had a relatively low corrosion rate. On the other hand, the specimen deposited by Ni indicates the highest corrosion rate.

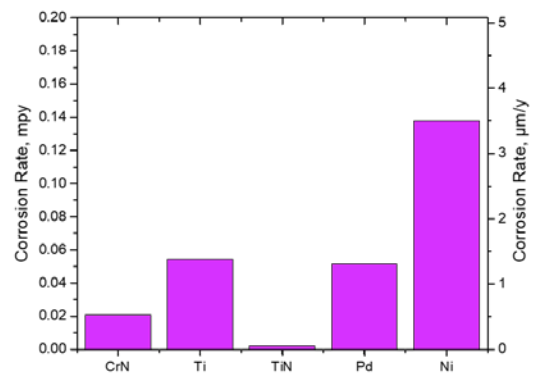
Fig. 4. Corrosion rate calculated from Flow accelerated corrosion test.

Fig. 4 shows the corrosion rate for the specimen after the FAC test. These results also show that the corrosion rate of the specimen deposited by Ni was the highest.

The reason why the specimen deposited by Ti-based coating has a relatively low corrosion rate is Ti is an active metal and has very high reactivity and is oxidized rapidly. Especially, it is known that the TiO₂ oxide film through the oxidation reaction has excellent corrosion resistance due to its passivation property. On the CrN coated specimen, an oxide film of Cr₂O₃ is formed, which has an electrically stable passivation property upon oxidation. Therefore, it shows a low corrosion rate. Pd is a very noble metal with good corrosion resistance. However, the specimen used in this experiment had partially cracked on the surface even before the experiment. [5] Therefore, it was considered that the palladium oxide film could not be formed due to the existing crack during the corrosion test, and the mass change was largely due to the falling off of the Pd layer.

Although Ni is also known to have excellent corrosion resistance at high temperatures, the corrosion rate was high. However, since this corrosion rate result was calculated as a result of short-term experiments of 300 hours and 700 hours, respectively, the initial corrosion rate appeared somewhat higher. If the experiment is carried out over a period of several months or longer, the corrosion rate will be significantly lower for all types of coated specimens.

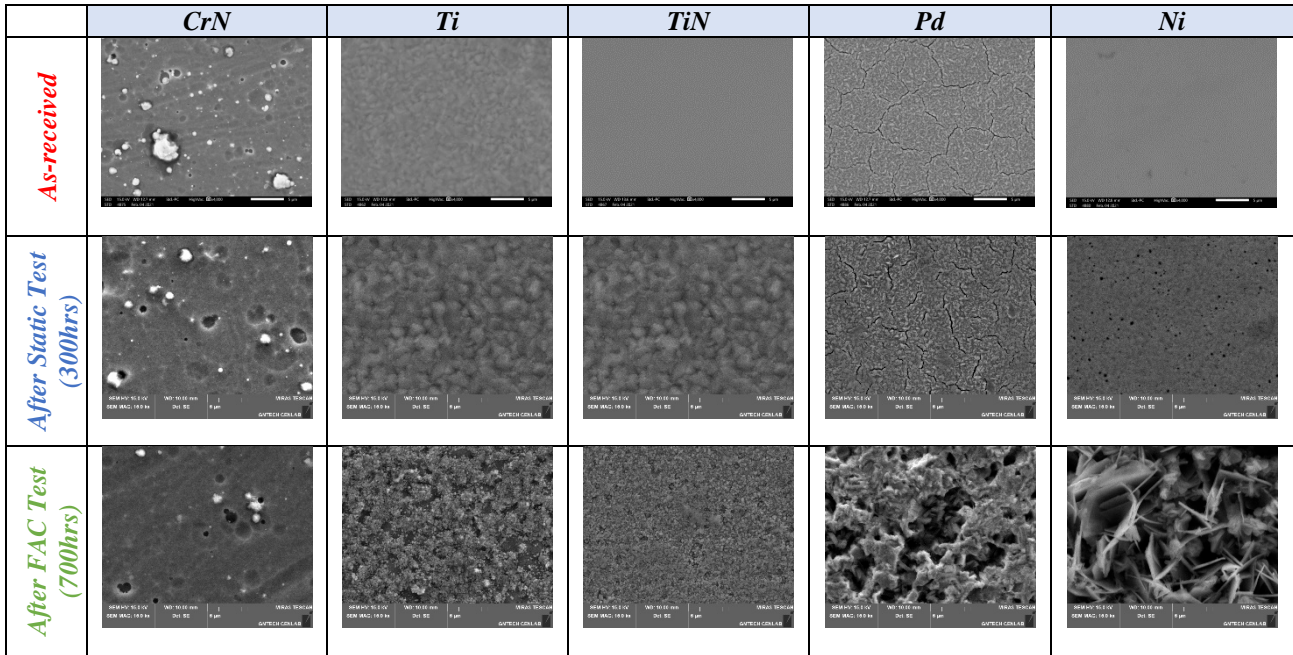
Fig. 5. SEM images for the surface of Samples (As-received, After Static Test, and After FAC Test).

Fig. 5 shows the surface before and after corrosion tests of coated specimens of five materials. In general, as CrN is known to have good stability in the secondary environment of nuclear power plants, there was no significant difference in the surface after static or FAC test. This is because Cr quickly formed a Cr_2O_3 oxide film regardless of the duration of the corrosion test.

The surface coated with Ti or TiN was smooth before the experiment. However, after 300 hours of static experiment, TiO_2 nanoparticles were generated on the surface. The surface after the FAC experiment revealed that a maximum size of several micrometers of TiO_2 particles and higher number density of particles compared with the case of the static test. This suggests that as the corrosion period increases, the TiO_2 particles become larger.

When Pd corrodes, PdO forms and becomes a very dense and stable state. However, in the FAC test, the existing crack fell off due to the flow and changed into a porous structure. If the specimen was completely coated with Pd without cracking on the surface, it is considered that the surface with a dense structure was observed. In the case of Ni, it shows that NiO was formed on the surface after the FAC experiment. On the other hand, after the static test, only Ni oxide particles were found on the surface, but there was no significant difference in surface shape.
