# Preliminary Test for Improving Plasma Chamber Cooling of Microwave Ion Source at KOMAC

## Microwave Ion Source for 100 MeV Proton Linac

## Preliminary Tests

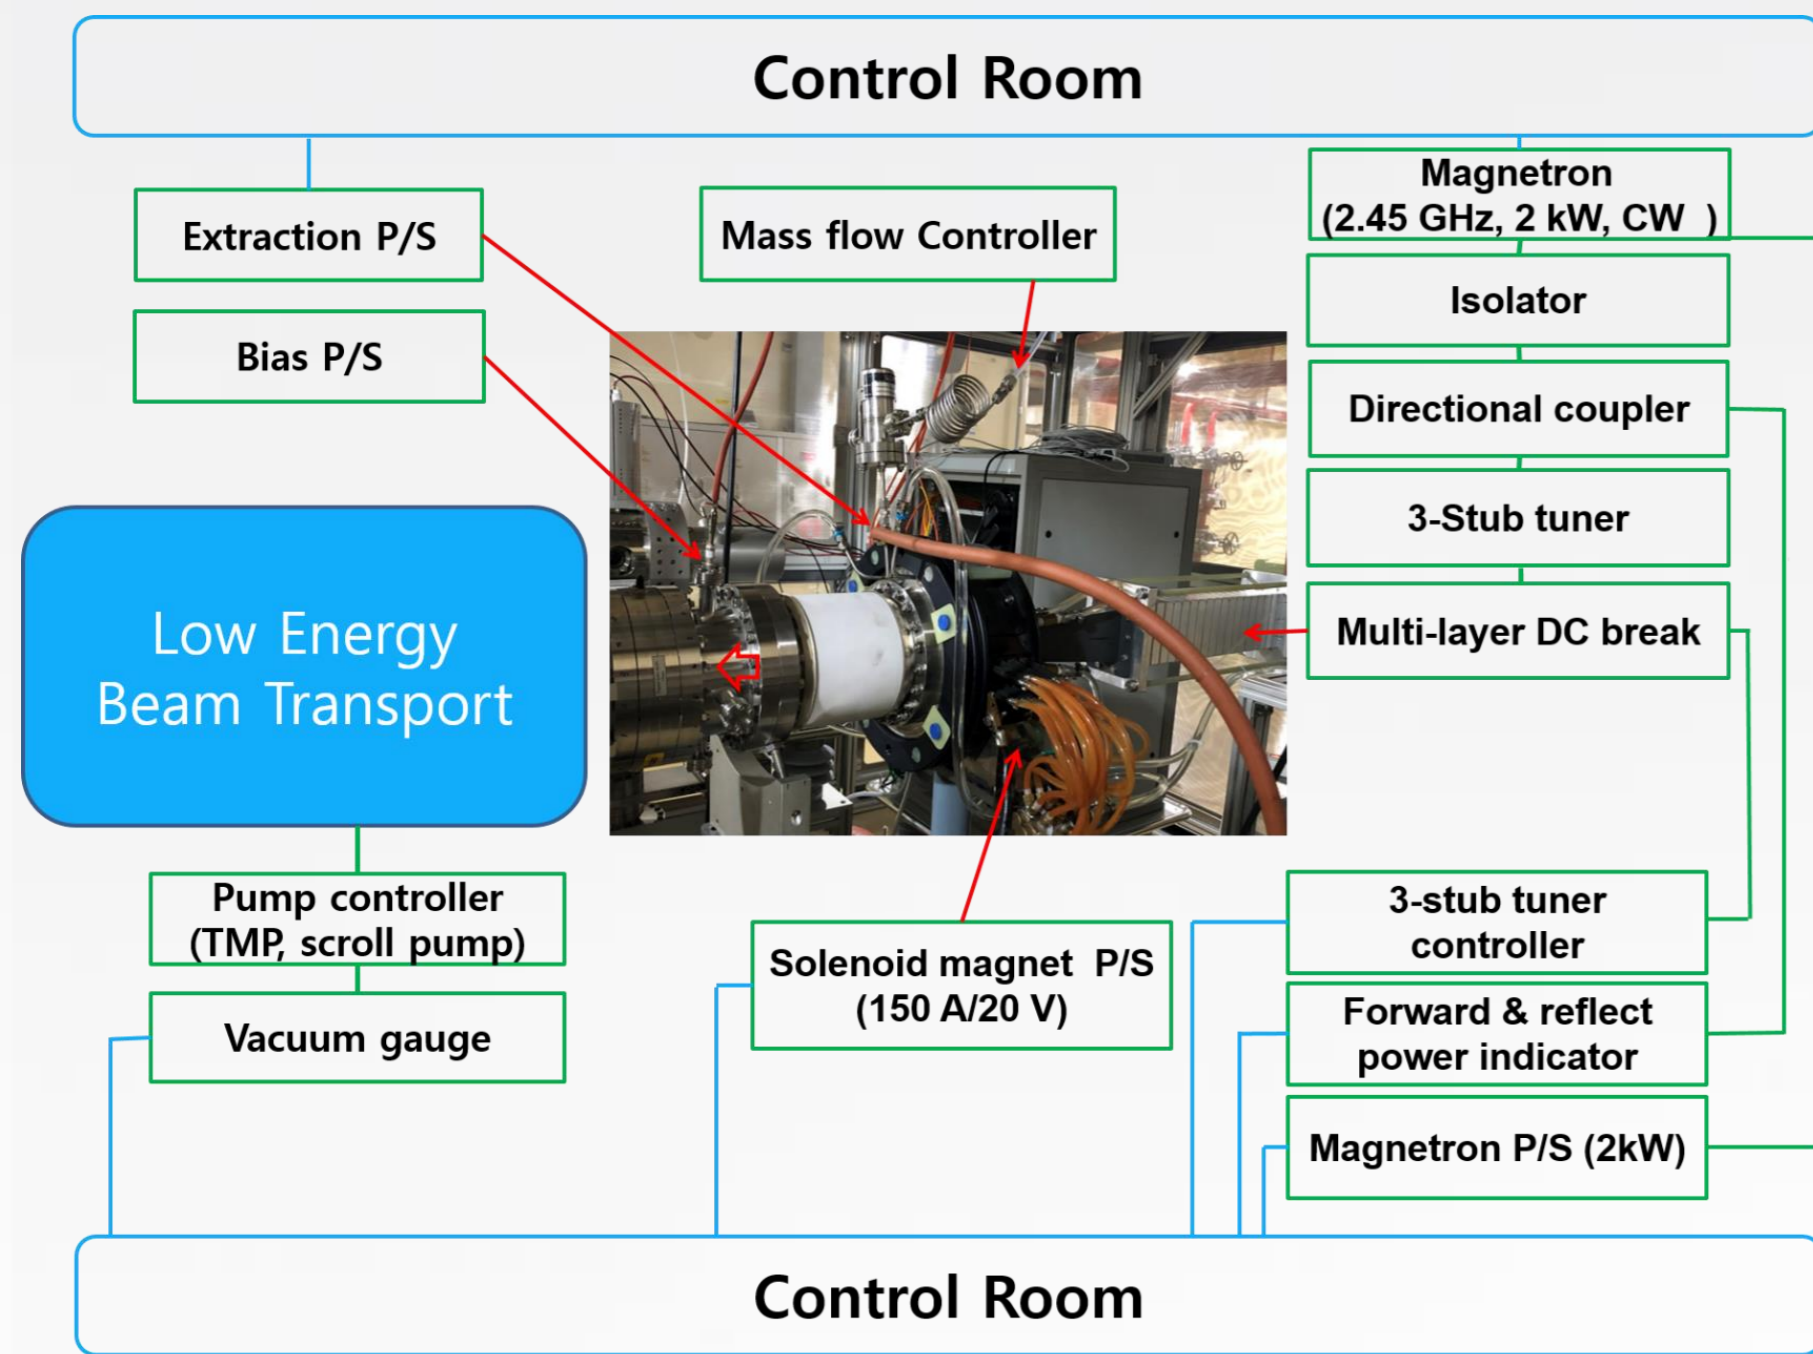
### System Block Diagram

- Particle : proton
- Beam energy: 50 keV
- Operating current : ~ 20 mA
- Emittance(Normalized rms) :  $0.2 \pi$  mm mrad
- Proton fraction : > 80%
- Microwave frequency : 2.45GHz

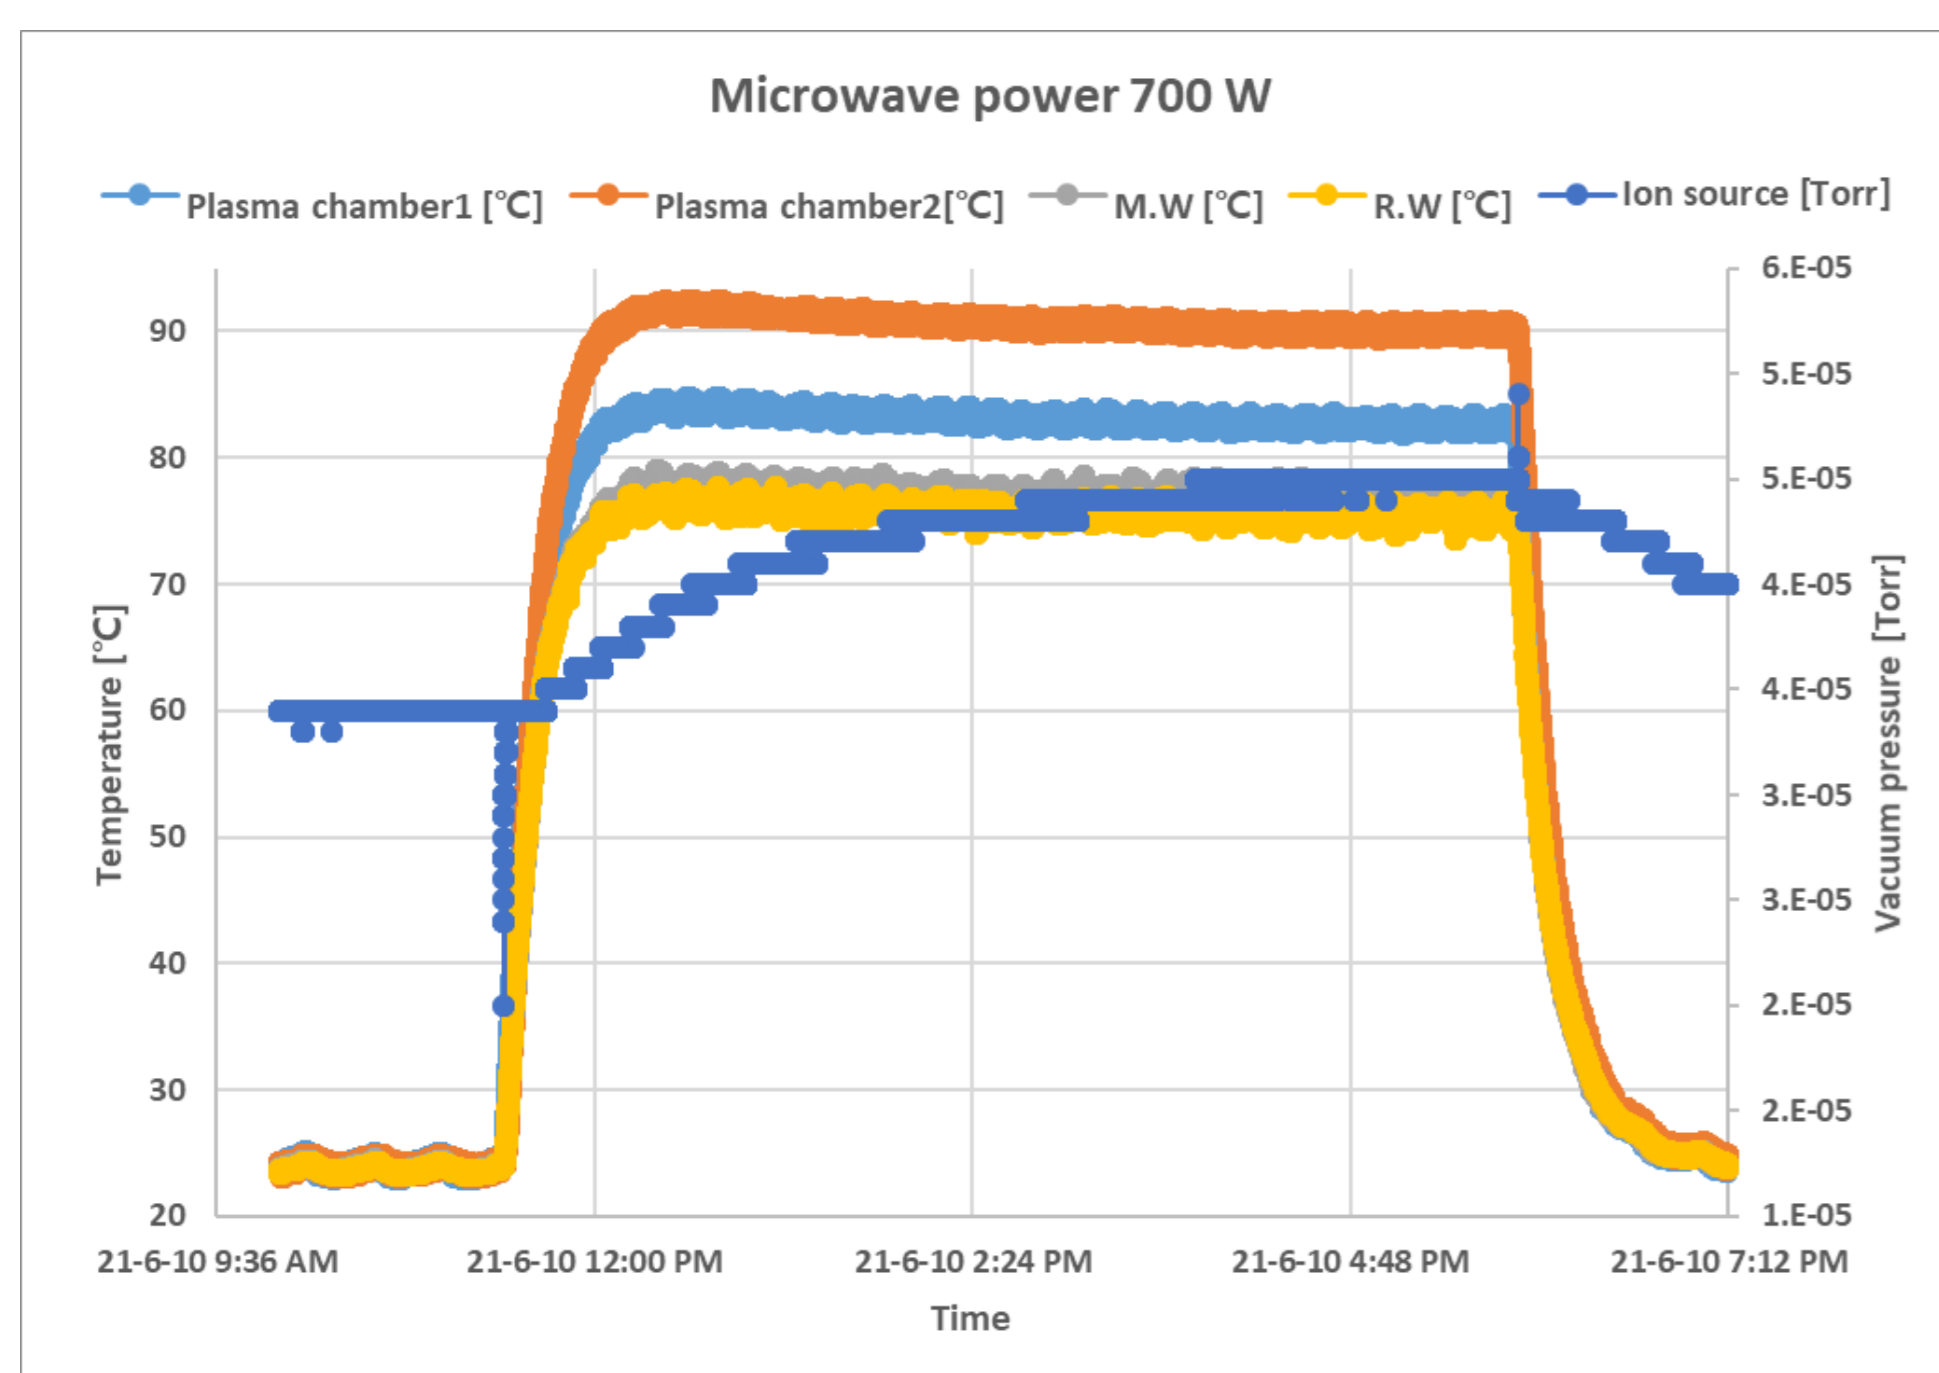
### the temperature for each location at 700 W

: The temperature of the plasma chamber outer wall increased to about 93°C. (The room temperature is 23°C.)

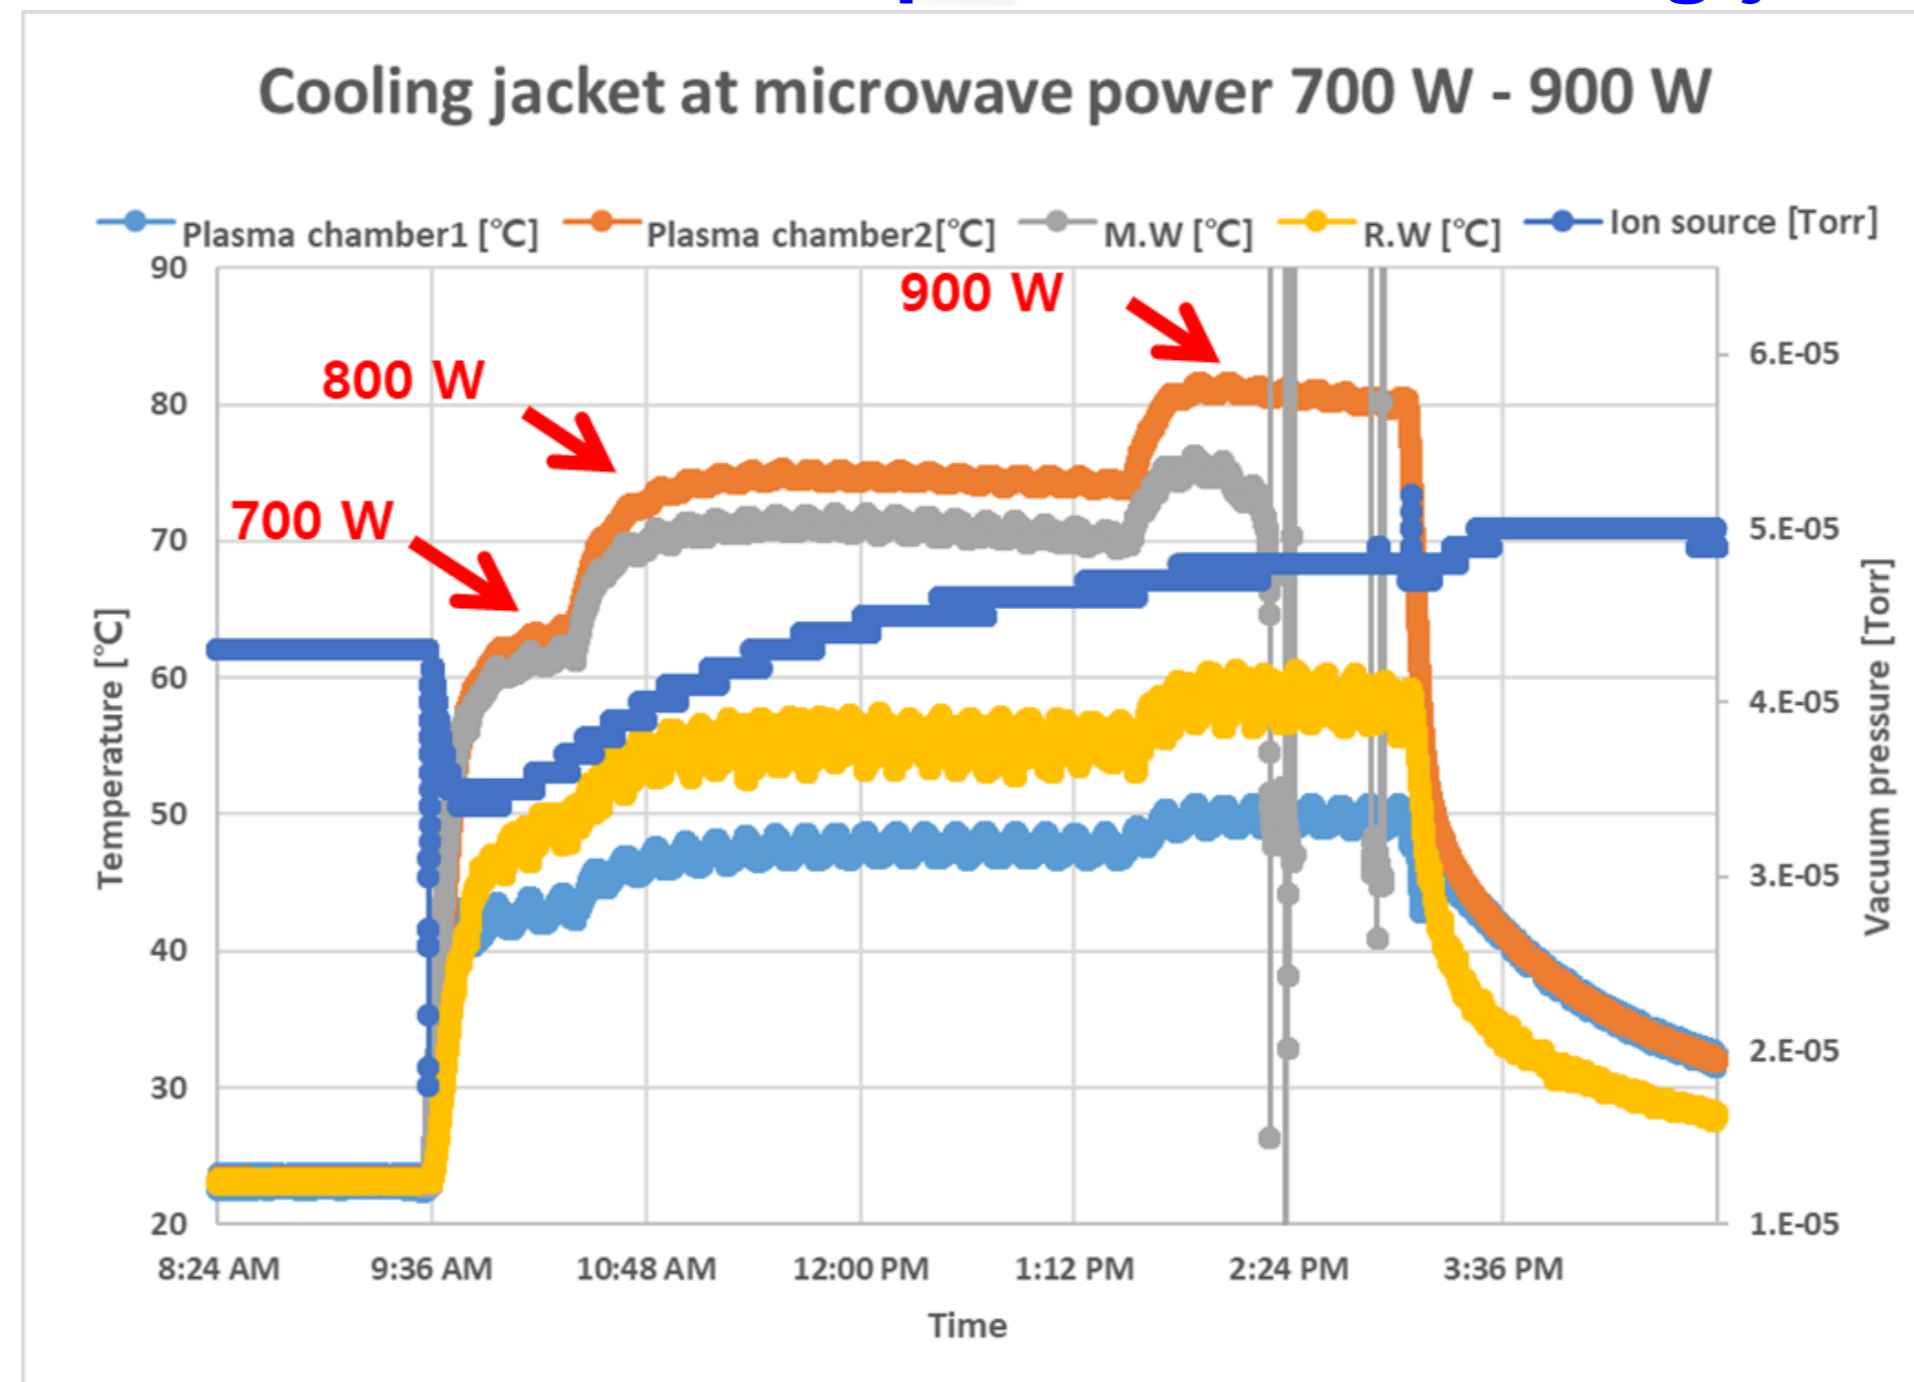
### Temperature variation by each location at 700 W - 900 W of microwave power with cooling jackets

: The temperatures of the plasma chamber outer wall converge at about 63°C, about 74°C, and about 81°C. (The room temperature is 23°C.)

For dielectric breakdown of high voltage insulators, two tests were performed to improve the cooling of the plasma chamber against dielectric breakdown of high voltage insulators. Using the cooling jacket, it was possible to operate at a temperature of about 63°C at a microwave power of 700 W. Through this, it was possible to confirm the temperature compensation of about 30°C. In the case of air cooling, temperature compensation of about 20°C was confirmed. In the future, based on the experimental results, it is necessary to optimize the structure for cooling the ion source in the direction of minimizing the change in the existing structure.
