Direct Inspection Technology of Buried Piping for Managing Tritium Contamination in Groundwater at Wolsong NPP (CANDU-6 Reactor)

Hyoung Tae Kim^{a*} and Duck-Gun Park^b

^a Intelligent Accident Mitigation Research Division, KAERI, Daeduk-daero 989-111, Daejeon, Korea

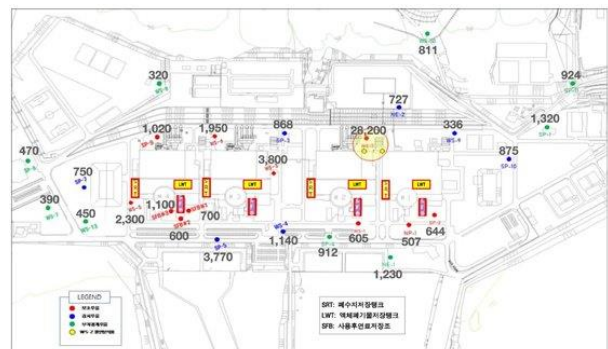
Fig. 2. Groundwater monitoring wells and maximum concentration of tritium on May 2019 at Wolsong NPPs (unit: Bq/L).

In Wolsong NPPs, radioactivity is measured once a month in the sentry well and once a quarter in the surveillance well, and site boundary well to monitor unplanned outflow of radioactive material. On May 2019, the maximum concentration of tritium radioactivity measurements among 27 monitoring wells was reported up to 28,200 Bq/L in sentry wells near Wolsong Unit 2, up to 3,770 Bq/L in surveillance wells, and up to 1,320 Bq/L in site-bound wells as shown in Figure 2.

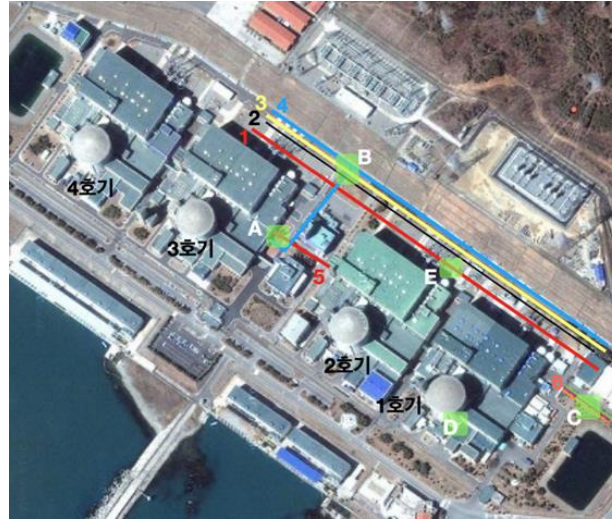
Fig. 4. The buried pipe lines at Wolsong NPP site (by civil investigation team on April 2021 [4]).

The NSSC conducted the first-phase investigation at the Wolsong NPP site on April 2021. Figure 4 shows the buried pipe lines tested by civil investigation team [2]. The buried pipe lines that have become a major concern are as follows:

- Pipe No. 5 (red) is a pipe buried at the time of construction of Unit 3, which supplies fire-water in the event of a fire.

- Pipe No. 2 (black) is presumed to be a sewage pipe.
- Pipe No. 3 (yellow) is the drain pipe of Unit 3 turbine gallery newly buried in 2020. Originally, pipe No. 1 was used, but it was discarded and newly replaced with pipe No. 3.
- Pipe No. 4 (blue) is a drain pipe in the neutralization tank and is made of PVC.

- This is where a separate excavation for investigating three pipes.

- This area is excavated for removal of the CFVS facility at Unit 1. Due to excavation, the cooling pipe of the SFB is exposed to the outside.

- This is the point where 28,200 Bq/L of high-concentration tritium was detected. Pipe No. 1 (red) is not in use now, but inspected.
