Improvement of the switch plate with a modulator at KOMAC

Won-Hyeok Jung*, Hae-Seong Jeong, Seong-Gu Kim, Kyung-Hyun Kim, Hyeok-Jung Kwon
Korea Multi-purpose Accelerator Complex, Korea Atomic Energy Research Institute, Gyeongju 38180
*Corresponding author: kingwh0401@kaeri.re.kr

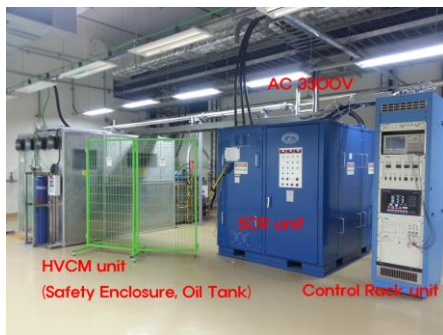
KOMAC (Korea Multi-purpose Accelerator Complex) has been operating four modulators since 2013 to run the 100 MeV linear proton accelerator at the facility. The modulator is composed of three main parts: an SCR unit that rectifies 3-phase 3300V power, an HVCM that outputs the pulsed high voltage through switching modules and transformer, and a controller that drives various monitoring and control functions.

The modulator operates in the following manner: 3-phase, 3300-Vac power is rectified by the SCR unit, which utilizes a transformer and 12-pulse thyristor to generate 2.1kV. The HVCM filters the voltage through a capacitor bank and then feeds it into an inverter IGBT switching module to convert it back into 3-phase at a frequency of 20 kHz, using 3 pairs of full-bridge modules. The output voltage is then transformed into a high-voltage using a transformer and capacitor (for charging and ripple filtering). Finally, the high voltage being supplied to a klystron.

Figure 1. Overview of the modulator at KOMAC

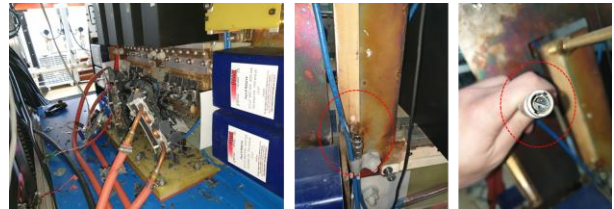
In March 2022, we experienced an IGBT failure at the 4th modulator caused by a short circuit between the 2kV line and ground of the Rogowski coil. The cause and solution of the troubles that occurred in that time will be described.

We have confirmed that the insulation of the cable for the Rogowski coil, which is used for monitoring IGBT signals, has been damaged. This happened because the cable insulation was stripped off during the tightening of assembly bolts, causing it to stick to the high-voltage switching plate during assembly. This cable is responsible for feeding the interlock and monitoring signal for the controller through an integrator. We have discovered that the high voltage carried by the signal cable can cause abnormal operation of the controller.

Figure 2 The IGBT blast (left) short between the high voltage line and Rogowski coil(right)

When an IGBT blast occurs with the switch plate, the driver board that is stacked on the IGBT cooling plate can also be damaged. To resolve this issue, it is necessary to physically separate and protect the IGBTs and IGBT driver boards. As shown in Figure 3 below, the driver board was separated from the IGBT and reassembled.
