Remote-Controlled Robots Used for the Management of Severe Accident of the Fukushima Nuclear Power Plant

Jai Wan Cho and Kyung Min Jeong

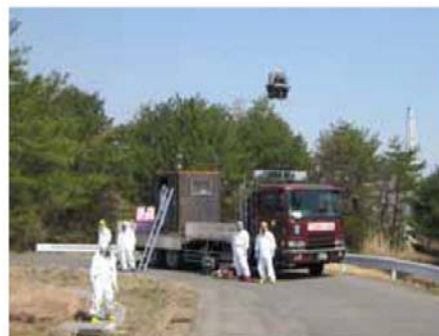
Fig. 2. T-Hawk flying in the air [4]

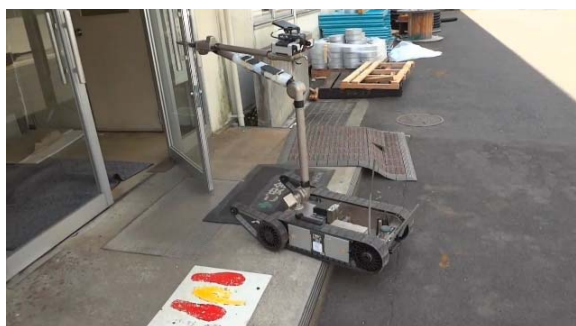
Fig. 3. Packbot robot (provided by iROBOT)

From April 17 to Aug 2, unmanned wireless-controlled military robot, Packbot and Warrior, have executed missions 14 times. The military ground robot's activities are as follows.

- An investigation of the status (radiation dose, humidity, temperature, and water leakage from the primary containment vessel, etc.) inside the reactor building of Unit 1, 2 and 3.
- Cleaning work in the reactor building (south west side on the ground level) to decrease dose at the first floor of Unit 3.

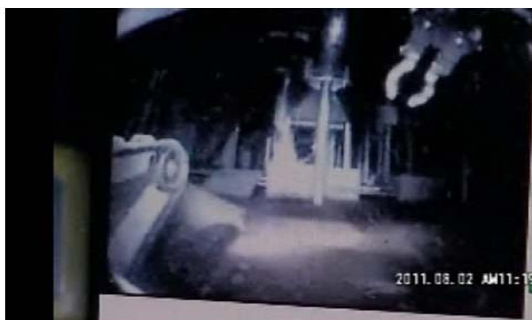
Place: Near the entrance of the train room for emergency gas treatment system, 2nd floor of Turbine Building, Unit 1

Time: At around 11:19 am, on August 2, 2011

Fig. 4. Detection of high dose-rate place

Recently Aug 2, Packbot entered into reactor building for investigation. It was confirmed that the air dose rate was higher than 5 Sv/h at around the entrance of the train room for the standby gas treatment system on the second floor of the turbine building of Unit 1.
