2010 Status of Uranium Conversion Plant Decommissioning Project

D.S. Hwang*, K.I. Lee, Y.D. Choi, U.S. Chung
KAERI, Daeduck-daero, Youseong-gu, Daejeon 305-353, Korea
*Corresponding author: dshwang@kaeri.re.kr

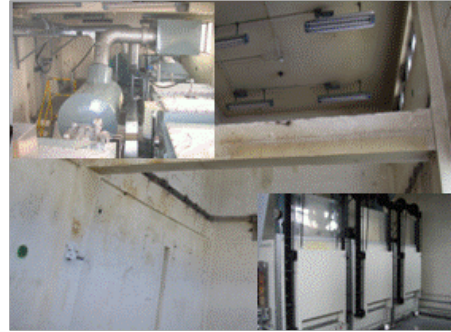
Fig.1. Before and after dismantling of lagoon sludge waste treatment facility

The decommissioning work that has been performed until now is as follows. All of the process systems and steel structure in the plant had been dismantled. The steel structure and the waste treatment facilities such as lagoon sludge waste treatment facility and melting decontamination equipment in the AUC process region has been dismantled.

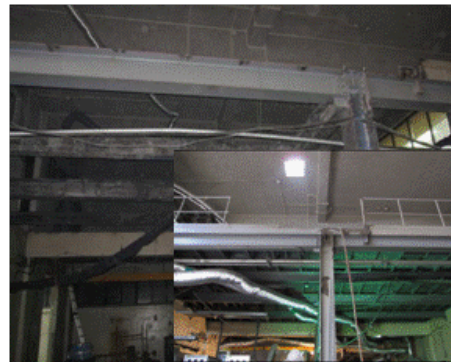
Fig.2. Before and after dismantling of the steel structure in the AUC process region

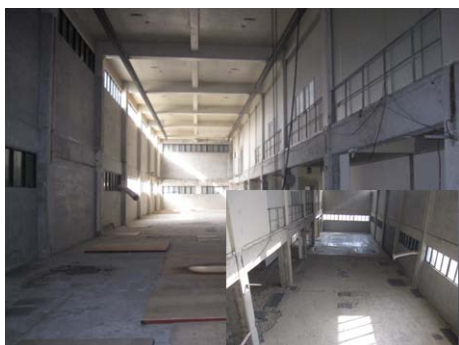
Fig.3. Concrete decontamination of the plant

Concrete inside the building was decontaminated by using a grinder, breaker, scabbler, and mini-excavator. The concrete in the building has been decontaminated. And the final survey of the building and the site perform has been surveyed now.

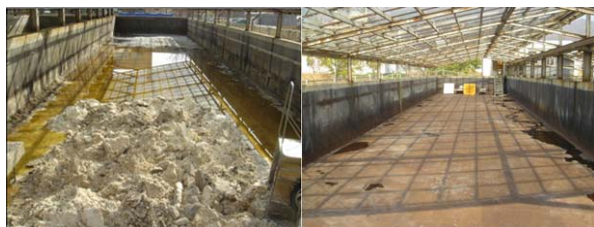
Fig.4. View of lagoon before and after sludge waste treatment

The major compounds of lagoon sludge waste were ammonium nitrate, sodium nitrate, calcium nitrate, and calcium carbonate, and natural uranium of 1 wt%. The sludge waste from the lagoon was treated using a thermal denitration process. The process consisted of sludge transportation, filtration, thermal denitration, off-gas treatment, and final solid waste package. The lagoon sludge waste of 300 tons was treated completely. This process reduced the sludge volume by 70%. The lagoon structure was coated with rubber but this had hardened. Some hardened rubber was taken off by torch and the rest was decontaminated by grinder. The lagoon was remodeled for use as an interim waste storage facility. This will be demolished after disposing of the radioactive waste.

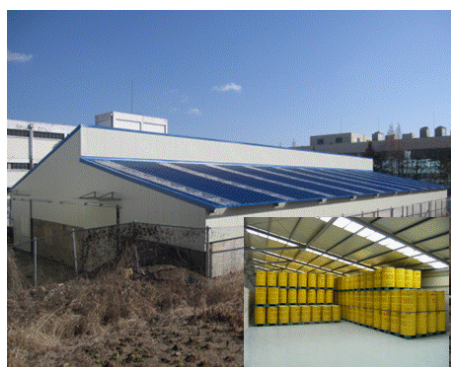
Fig.5. View of lagoon remodeled for use as an interim waste storage facility

All the facilities in the plant have been dismantled. Dismantled stainless steel waste was decontaminated by a chemical decontamination with ultrasonic and 53 ton was released. Carbon steel was decontaminated by a melting and 76 ton was released. And the final survey of the building and the site perform has been surveyed now. Lagoon sludge waste had been treated and the final solid waste after treatment is a stable compound for storage. Volume of the lagoon sludge waste could be decreased by over 70 %. The lagoon was remodeled for use as an interim waste storage facility. This will be demolished after disposing of the radioactive waste.
