TEM Study on the Proton Irradiated Type 316 Stainless Steel

Yun Soo Lim*, Seong Sik Hwang, Hong Pyo Kim, Hai Dong Cho
Nuclear Materials Research Division, Korea Atomic Energy Research Institute
1045 Daeduk-daero, Yuseong, Daejeon, 305-353, Korea
*Corresponding author: yslim@kaeri.re.kr

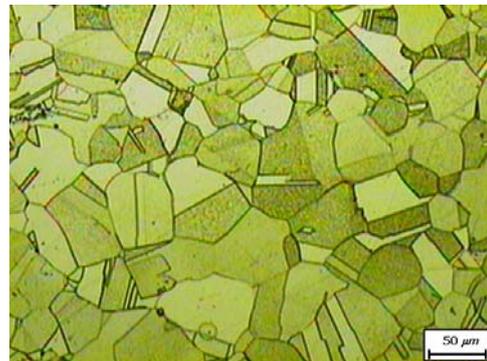
The specimen used in this study was identified to be an austenitic phase having an fcc structure with a lattice constant of 0.3597 nm. The OM image of the un-irradiated type 316 SS is shown in Fig. 1. The microstructure was homogeneous without any abnormal grain growth and texture. Any intergranular and intragranular precipitations were hardly found. String-like ferrites were often found in the austenitic matrix.

Fig. 1 OM image of the un-irradiated specimen.

The microstructure of the un-irradiated type 316 SS was a homogeneous austenitic phase with some string-like delta ferrites, and no other intergranular/intragranular precipitates were found. The number density of dislocation was relatively small, and stacking fault images were frequently observed due to its low stacking fault energy.

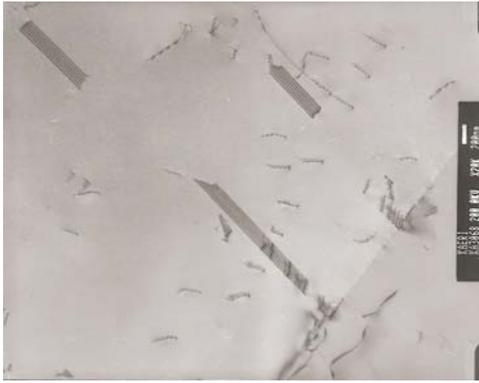
A TEM image of the defects taken under a two-beam condition in the un-irradiated specimen is shown in Fig. 2. The number density of dislocation was relatively low, and they were mainly arranged on the {111} slip planes. Stacking fault images were frequently found due to its low stacking fault energy [5]. However, any other defects except dislocations and stacking faults were hardly found in these specimens.

Fig. 2 TEM bright image of the un-irradiated specimen
