# Causes of PWSCC in a Alloy 600 Nozzle of a PWR

Seong Sik Hwang, Yun Soo Lim, Jangyul Park, and Hong Pyo Kim Nuclear Materials Research Division, Korea Atomic Energy Research Institute, 1045 Daedeog-daero, Yuseong-gu, Daejeon, 305-353, sshwang@kaeri.re.kr

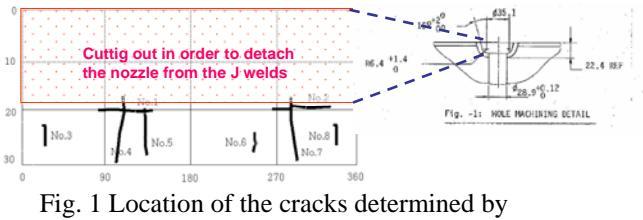
The drain nozzle, which was contaminated with radioactive materials was transferred to a hot laboratory at the Korea Atomic Energy Research Institute (KAERI).. The location of the cracked area was marked on the nozzle before the destructive examination. Fig. 1 shows the alloy 600 nozzle sample in this work.

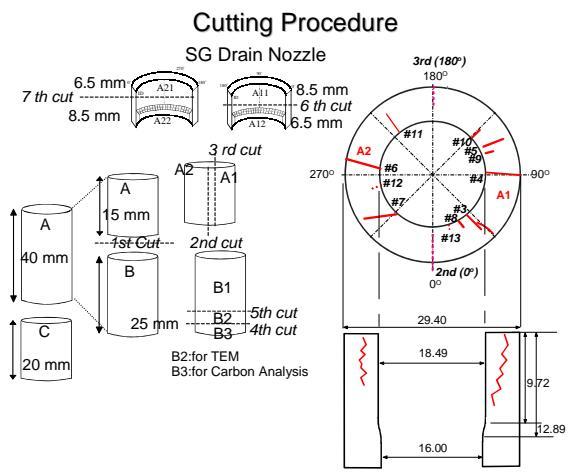
Fig. 2 Cutting procedure of the cracked nozzle.

Dye penetrant test was performed to confirm the location of the cracks. After marking a reference position for the radial and the longitudinal directions, the nozzle was cut longitudinally and circumferentially in order to observe a fracture surface and as many cracks as possible as shown in Fig. 2.
