## Fractography of the fracture surface of a Small Tube

Myung Hwan Boo, Han Sang Kim, and Eun Sub Yun  
 Nuclear Engineering & Technology Institute, Korea Hydro & Nuclear Power Co. Ltd.,  
 25-1Jand-dong, Yuseong-Gu, Daejeon, KOREA, 305-343, bright@khnp.co.kr

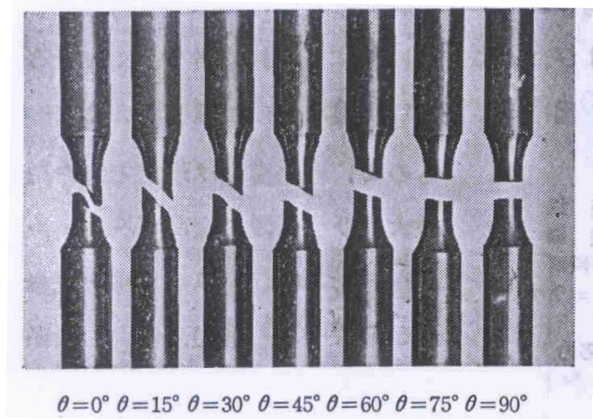
Fig. 3 Fatigue fracture for combined stress  
 ( $\tan\theta = \sigma/2\tau$ ,  $\sigma$ : tensional stress,  $\tau$ : torsional stress)

Figure 3 shows the fatigue fracture for combined stress [1]. In Fig. 3,  $\theta$  denotes  $\tan\theta = \sigma/2\tau$ , the point at which the tensional cyclic load and torsional cyclic load was applied the specimens: the fatigue fracture angle was  $\theta=0^\circ$  and  $\theta=90^\circ$ , respectively, for these two loads. The crack propagation angle is 30° in the damaged tube is similar to the fatigue fracture angle of  $\theta=45^\circ$  in Fig. 2. If  $\theta=45^\circ$  for the combined stress, the stress ratio is  $\sigma/\tau \doteq 1.7$ . Based on the result shown in fig. 3, it can be considered the damaged tube was cracked by combined stress (tensional and torsional cyclic stress) and that the

tensional cyclic stress was larger than the torsional cyclic stress by 1.7 times.
