ASME code for RPV cladding repair by Ni electrodeposition

Seong Sik Hwang^{a*}, Min Su Kim^a, Eun Hee Lee^a, Dong Jin Kim^a,

^aKorea Atomic Energy Research Institute, 989-111 Daedeok-daero, Yuseong-gu, Daejeon 34057

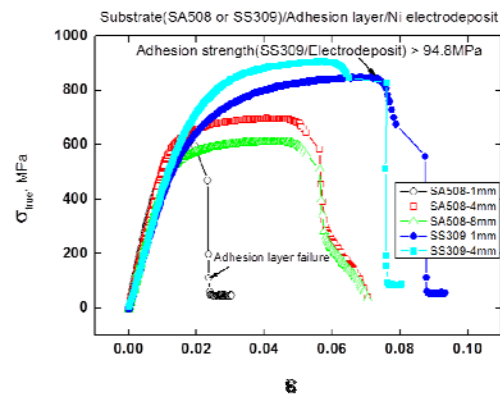
Fig. 4 Stress-strain curves with different adhesion area

The tensile strength of the ECD layer with an SS309 substrate was measured as 94.8 MPa or above. With this strength, the deposit layer adhered to the SS309 substrate after the tensile test. The measured adhesion strength was considered appropriate for considering the suitable integrity of the ECD deposition for plant operation/service conditions.

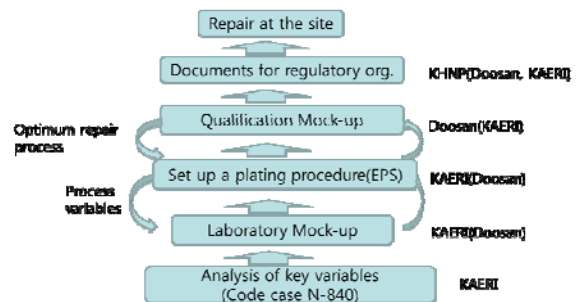
Fig. 5 General scheme of the project for field application.

With those laboratory-scale performances, it is necessary to develop practical Ni plating facilities that can enable the operator to control the deposition variables remotely in high radiation operating reactor condition. Then, the utility initiated a new research project including all steps from setting up the electrodepositing variables to resolving the regulatory issues with a plan to repair the damaged by 2020, as shown in Fig. 5.
